Anatomy of an Iron Age Roundhouse

The Cnip Wheelhouse Excavations, Lewis

Ian Armit

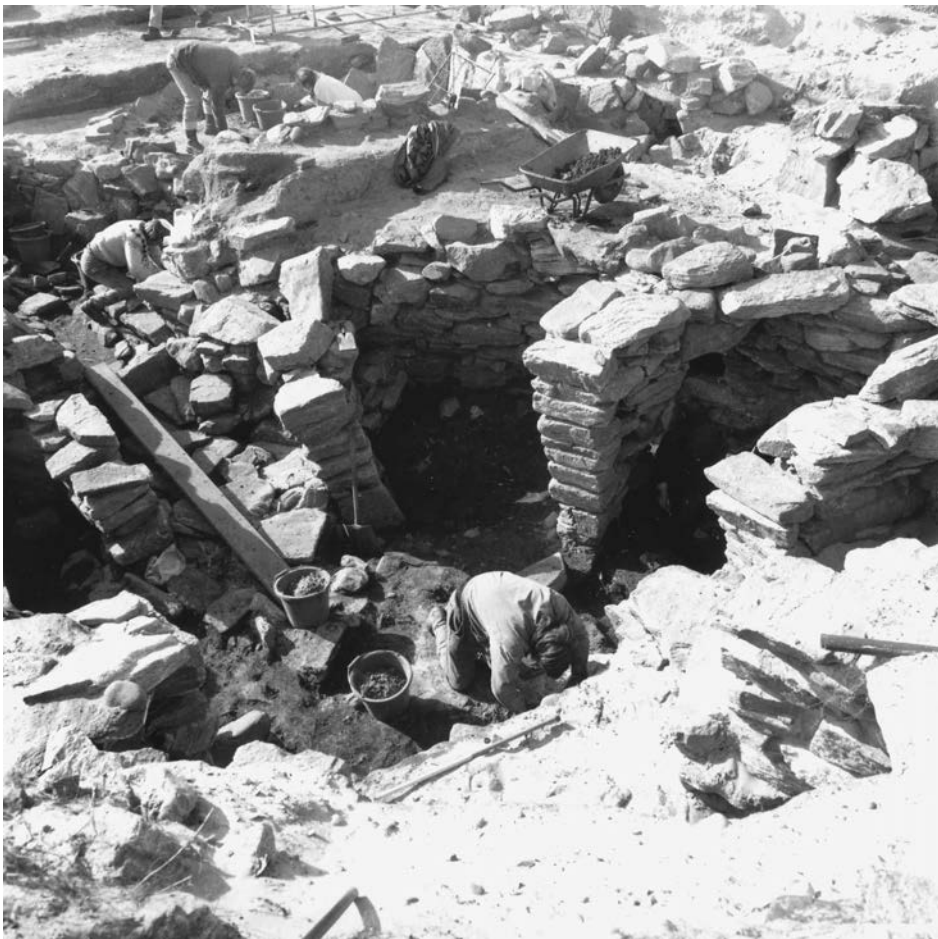
ILLUSTRATION 1.6

This photograph shows the cramped and rather precarious working conditions inside Wheelhouse 1 and gives some idea of the scale of the surviving stone elements.

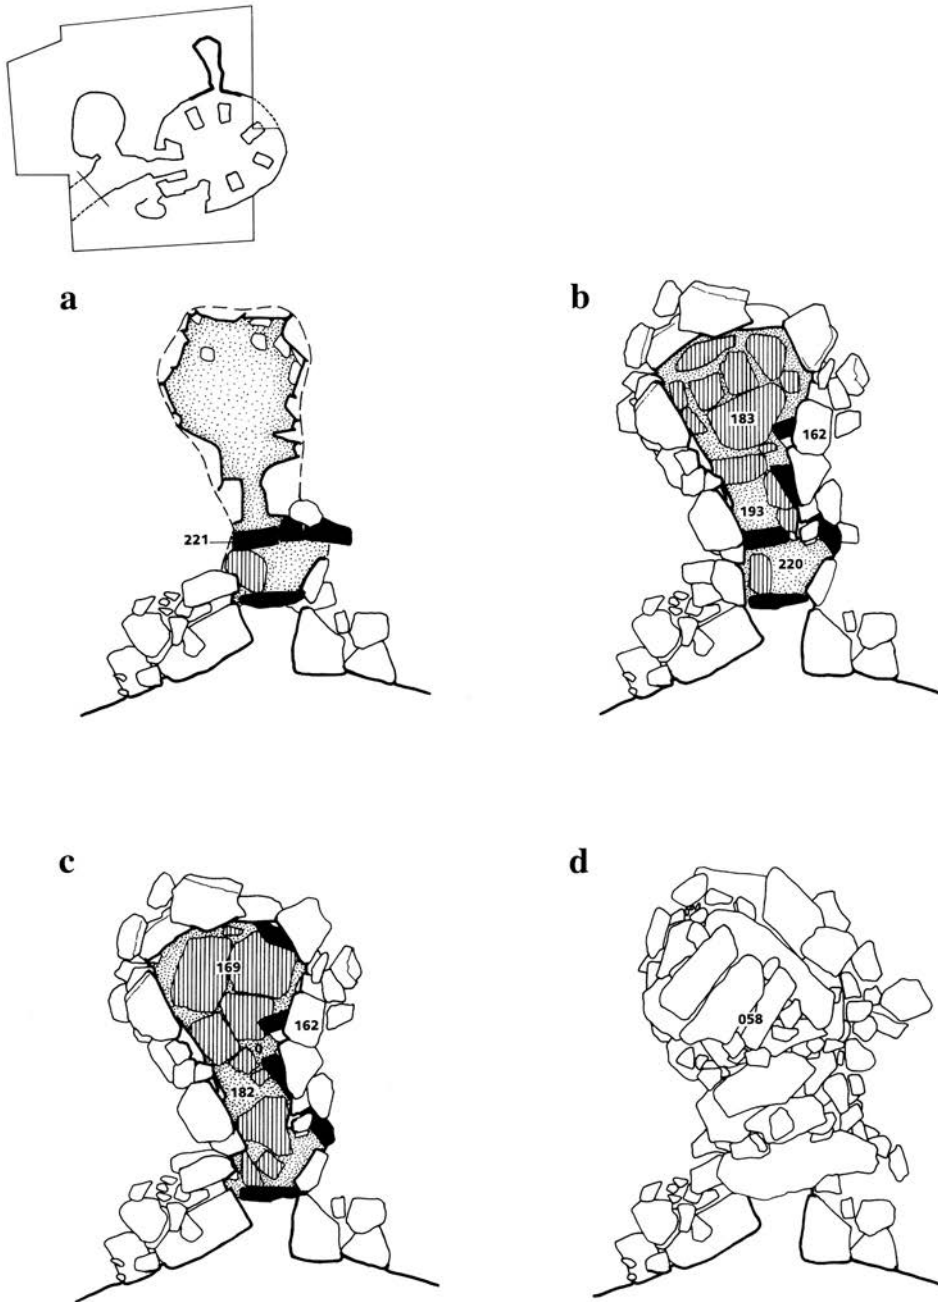
ILLUSTRATION 2.23
Structure 3 plans.

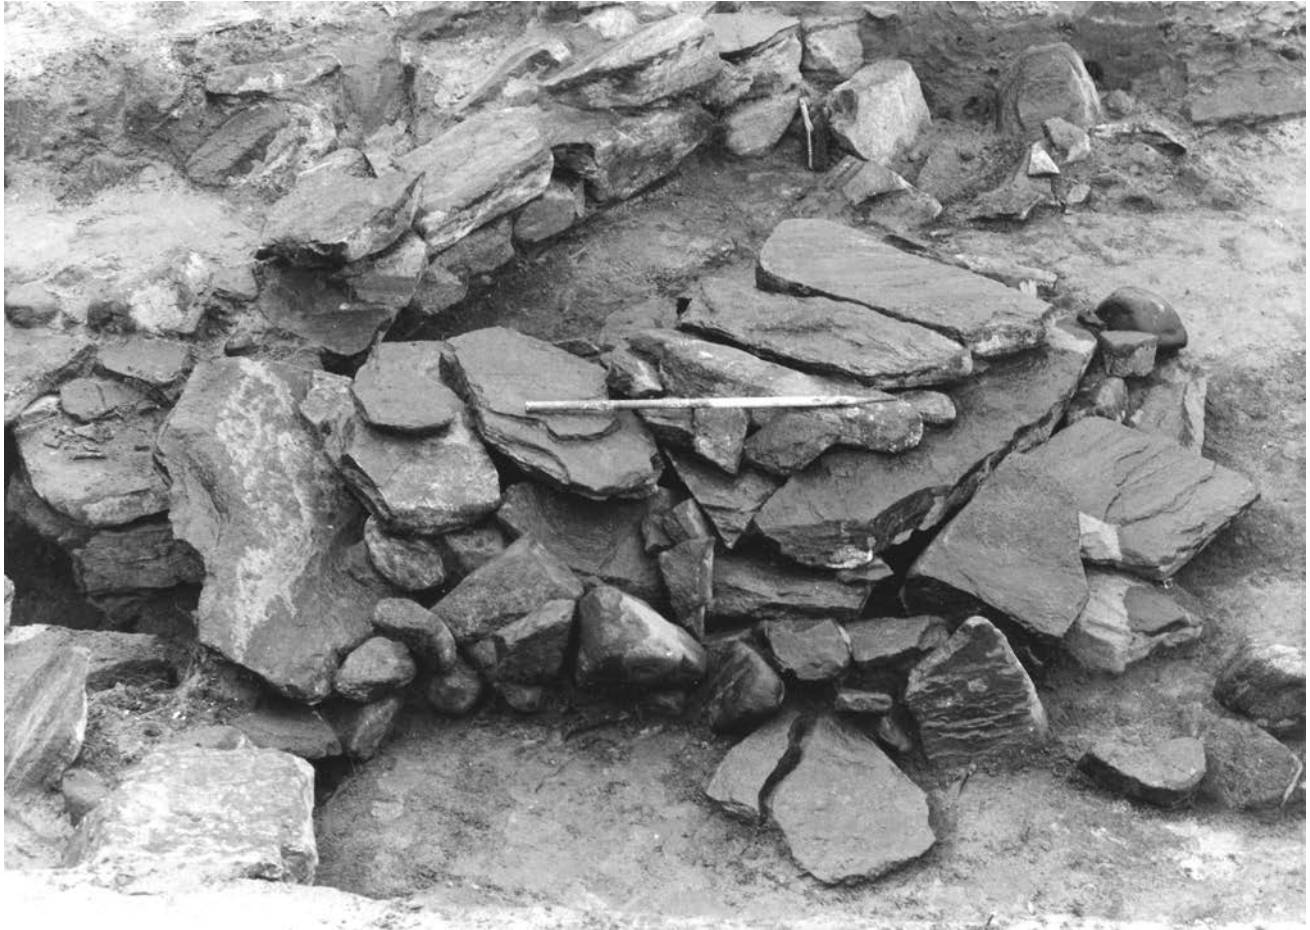
ILLUSTRATION 2.24
Structure 3 roof.

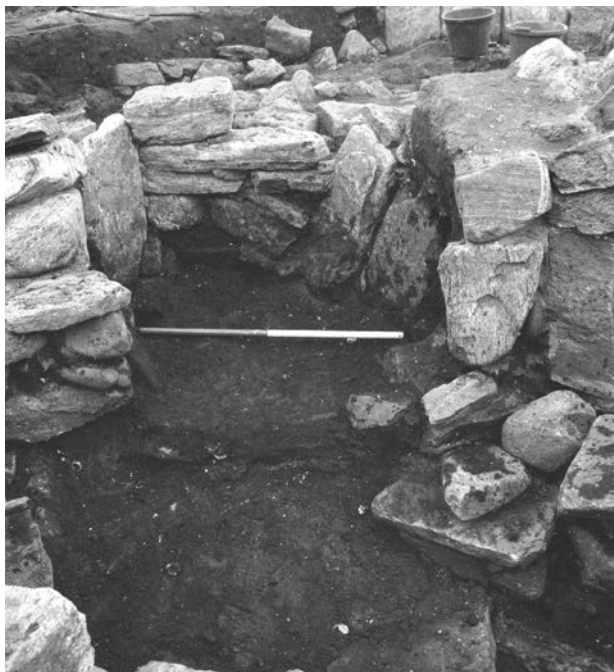
ILLUSTRATION 2.33
Structure 7.

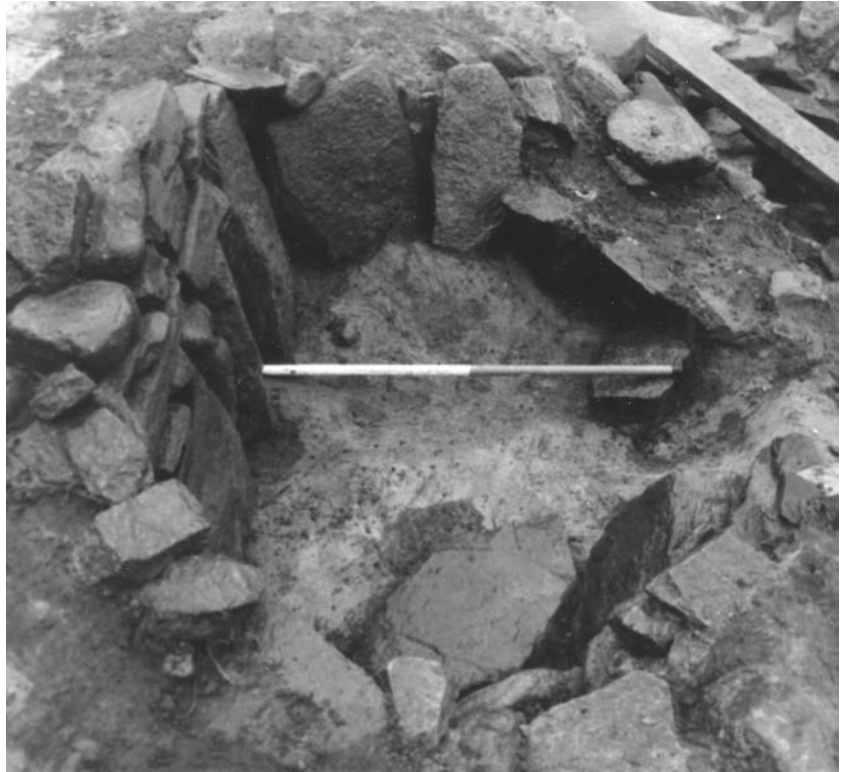
ILLUSTRATION 2.35
Structure 5 from south (fully excavated).

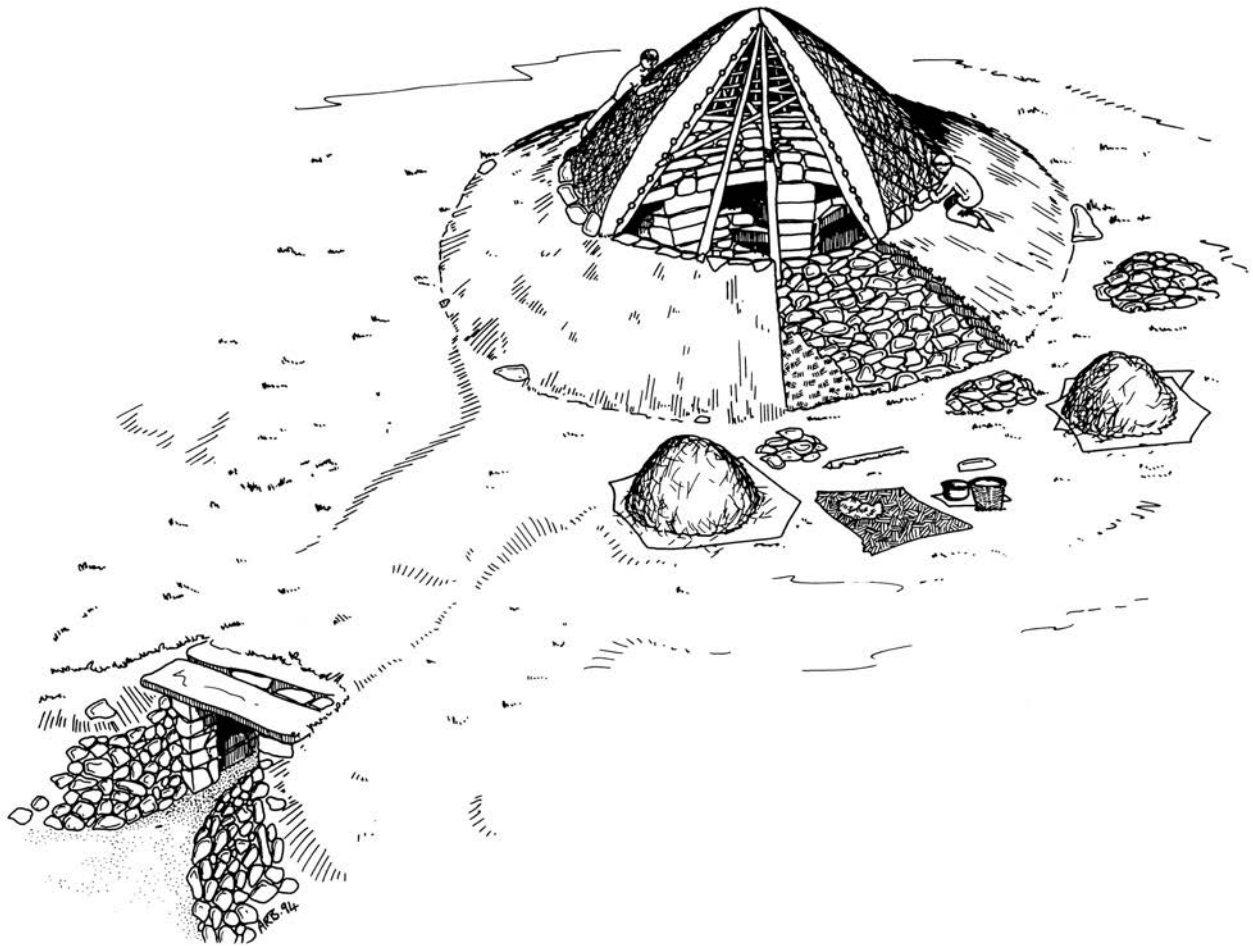
ILLUSTRATION 5.4(b)
Wheelhouse construction: Drawing Four.
