Anatomy of an Iron Age Roundhouse

The Cnip Wheelhouse Excavations, Lewis

Chapter 5

Anatomy of a wheelhouse

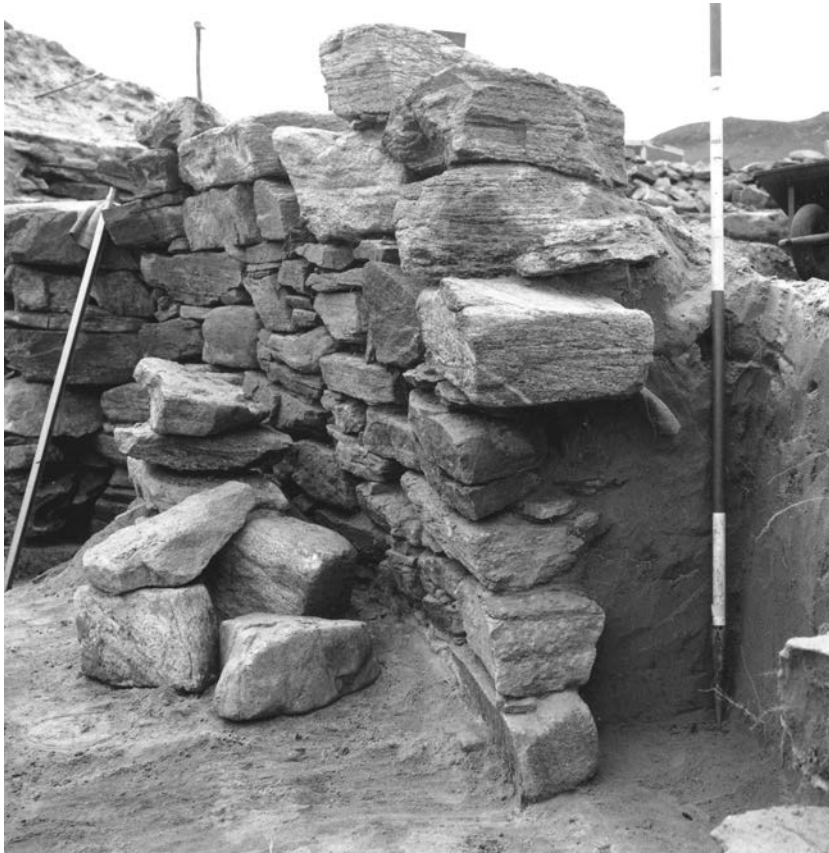
ILLUSTRATION 5.2

Section through the wall of Wheelhouse 2 (c 1.2m south of the main entrance).

A section through the wall of Wheelhouse 2, just to the south of its entrance, shows the nature of this walling (Ill 5.2). Although only one stone in thickness, the wall widened as it rose, through the use of progressively larger stones. The inner face at this level appears to have been essentially vertical. No packing is visible in the section, although it is possible that some of the excavated clean sand was replaced to pack the stones securely. This is unlikely to be detectable

archaeologically, but it could explain the position of the small stone, angled steeply downwards, to the rear of the wall, visible in the section (Ill 5.2). This must either have been forced into clean sand, or else held in a matrix of re-packed sand indistinguishable from the natural sand dune backing.

In reconstructing the later Iron Age house at Bostadh, Jim Crawford (pers comm) found that the liberal application of water, and the compression of the clean sand packed behind the walls, added immeasurably to the stability of the construction. This form of mortar used to secure the stones of the wall, set against a face of undisturbed clean sand, would be entirely consistent with the evidence in the wall section of Wheelhouse 2 at Cnip.

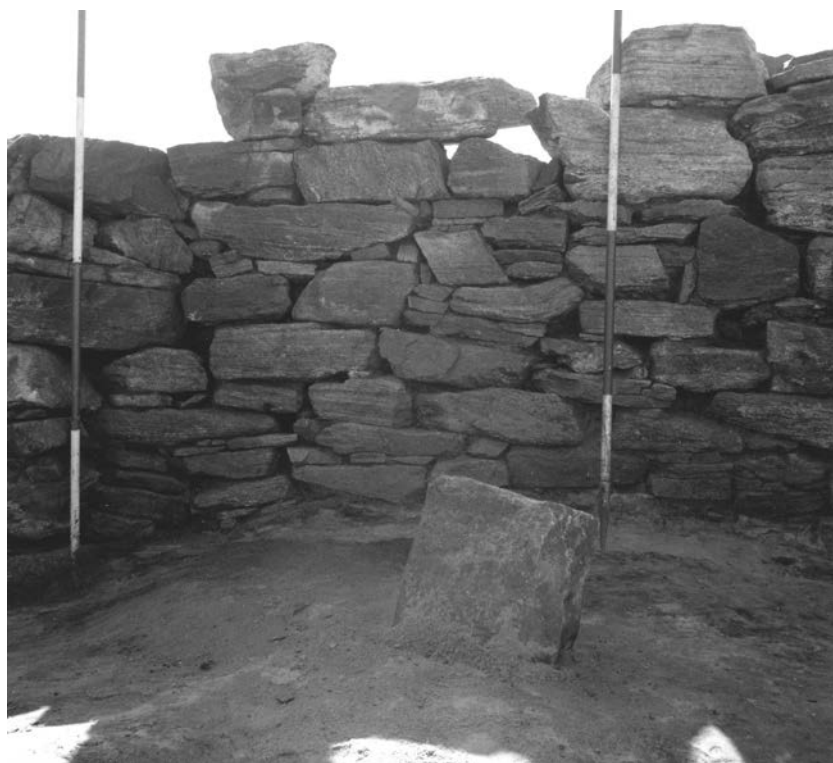
ILLUSTRATION 5.3

The marker stone for the 'missing pier' in Wheelhouse 2, seen from the interior.

It seems that the intention at this stage was to build each of the piers up to the height at which it was joined to the enclosing wall, before embarking on the construction of the upper levels. This was the stage, however, at which the construction of Wheelhouse 2 was abandoned. Indeed at least one of the Wheelhouse 2 piers was apparently never built at all, its position being marked by a single boulder (Ill 5.3). Indeed, it is possible that the positions of all of the intended piers were marked in this way during the early stages of construction.

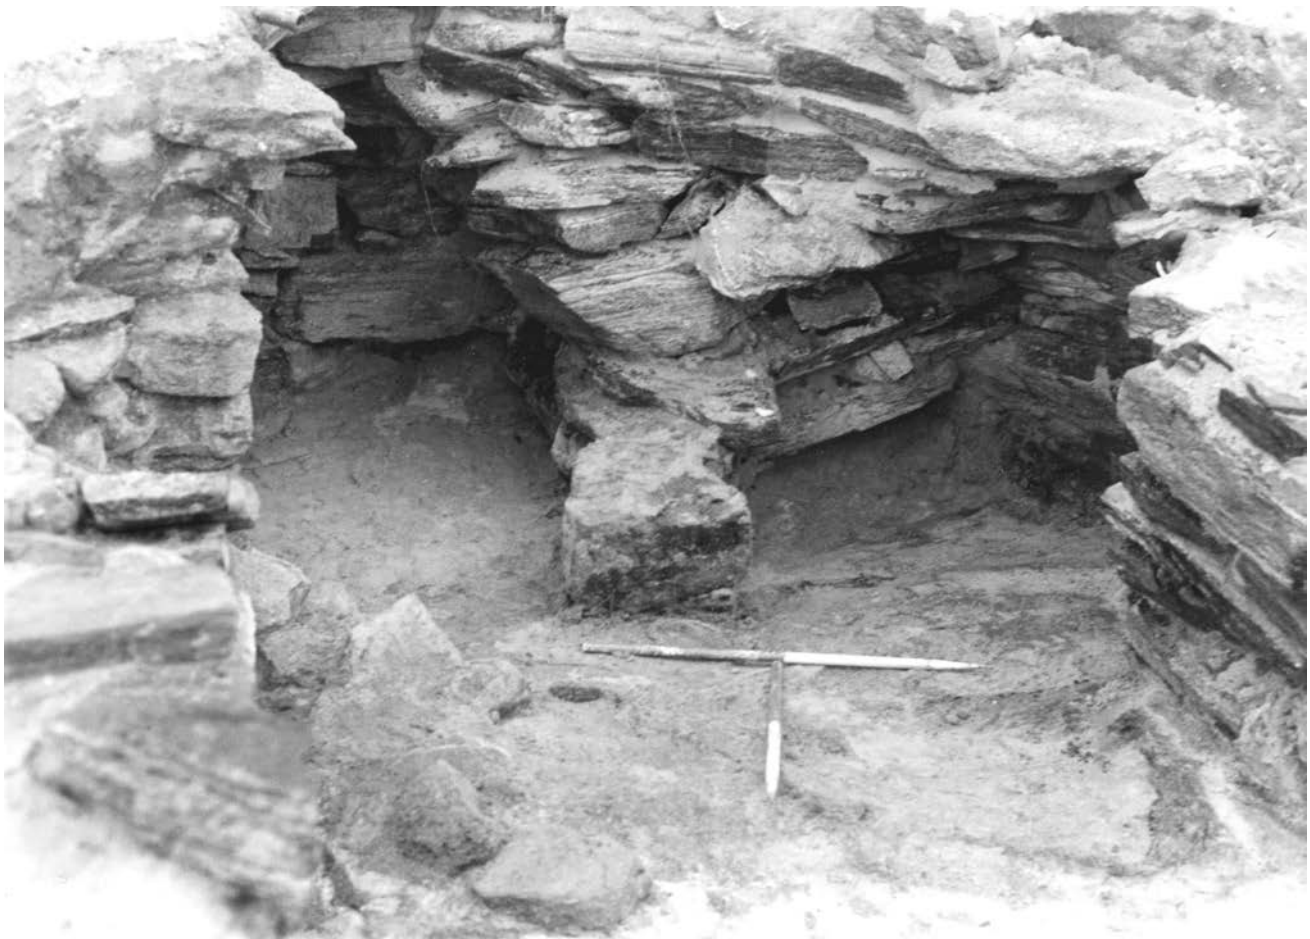
ILLUSTRATION 5.5

Bays 4 and 5, Wheelhouse 1: the frontal portions of the bays had not survived (although a few stones which had been preserved had fallen away before this photograph could be taken and are visible in Ill 1.5). The internal deposits shown are elements of the post-abandonment sand infill of Structure 8.

Clearly this did not happen, but unfortunately the missing frontal portions of the surviving bays make it impossible to tell how this apparent flaw was overcome. It is possible that the outward thrust of the timber central roof (see Section 5.3.4) was important in counter-acting the inward thrust of the corbelled bays, but this would presumably have made the whole structure highly unstable during periods of re-roofing and roof maintenance. Again, it is likely that, with a structural form so alien to modern constructional techniques, only practical experiment will clarify the issues and illuminate likely solutions.
