A Cromwellian Warship wrecked off Duart Castle, Mull, Scotland, in 1653

Colin Martin

THE SHIPWRECK OFF DUART POINT

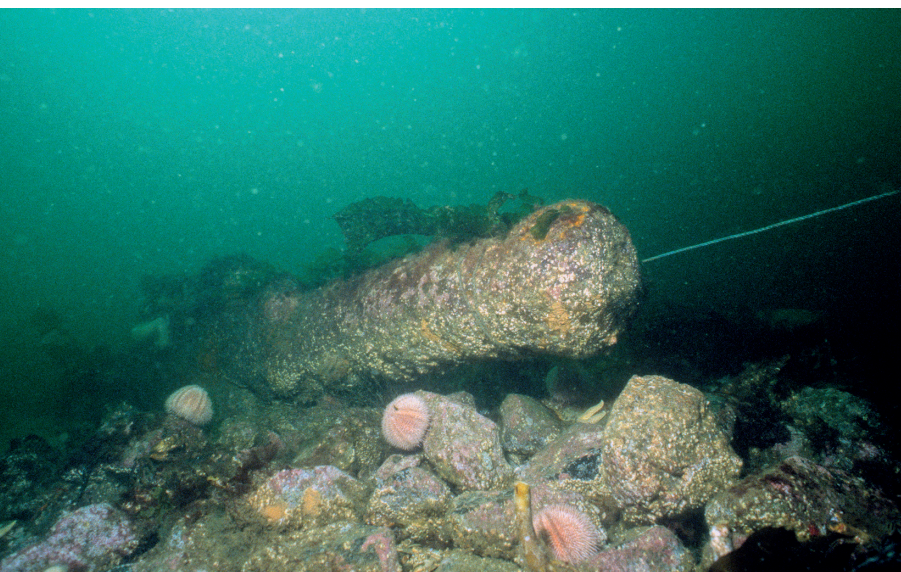
Illustration 17

One of the cast-iron guns (Gun 3) lying prominently on a pile of ballast-stones. This drew John Dadd's attention to the wreck (DP 173689)

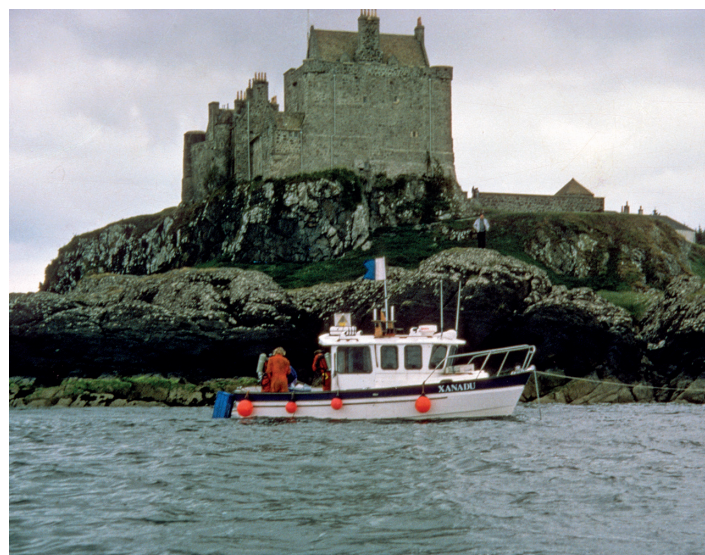
Illustration 18

The Archaeological Diving Unit's research vessel *Xanadu* anchored over the site in 1991 (DP 174724)

At Historic Scotland's request the ADU visited the site in June 1991, accompanied by John Dadd (Illus 18). The presence of a historic shipwreck was confirmed, and further

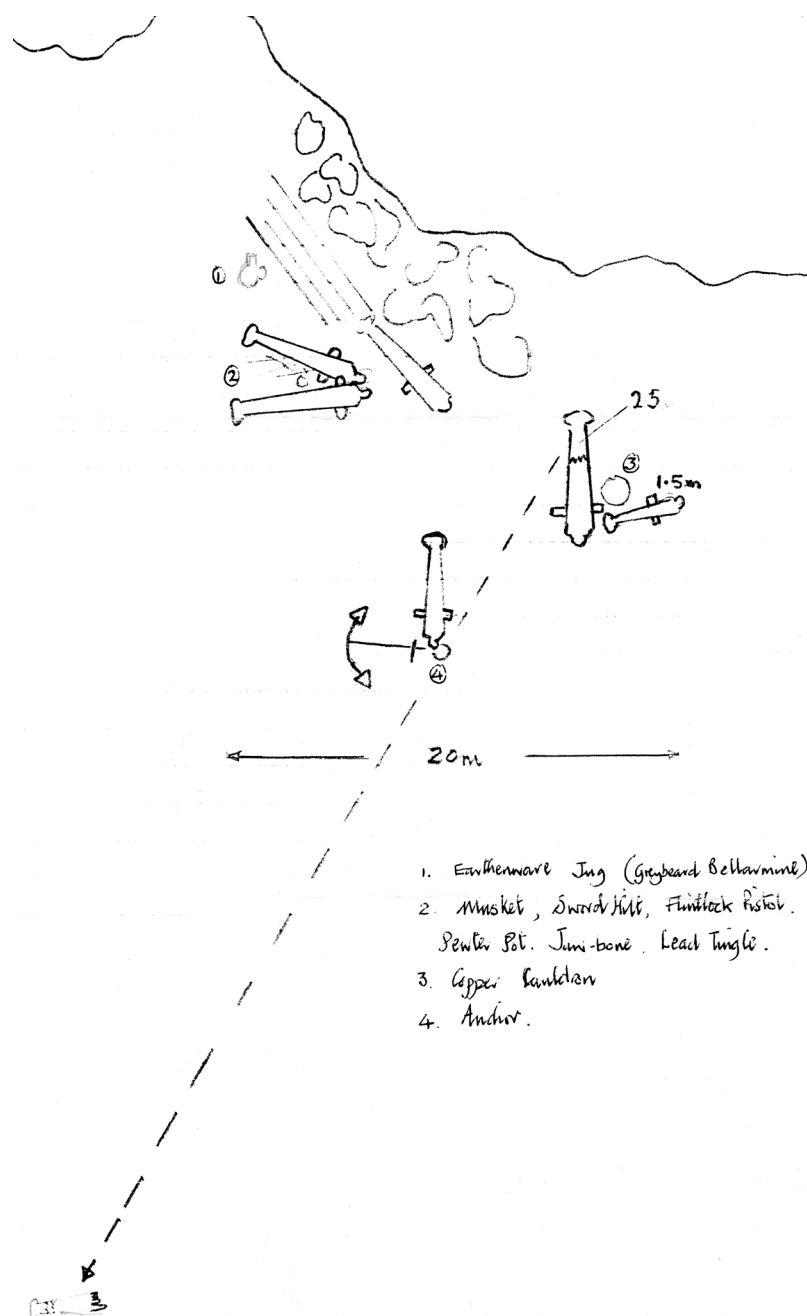
Illustration 19

Sketch-plan of the wreck-site by John Dadd, drawn in 1991 recalling what was visible on his first visit in 1979 (ADU Collection BD 161/1)

No orientation or scale is given, but the extent of the observed remains – 20m – is broadly accurate (Illus 19). The plan clearly shows the line of the cliff-face, and the tumble of boulders along its foot. The mouth of the gully running in towards the shore is also recognised. Parallel runs of timber are indicated in an area which can be identified as the collapsed stern complex, and adjacent to it the location of a Frechen stoneware flagon is

noted, and site-grid references can be estimated based on this information (08.10). Six guns are recorded. One, next to the tumbled stones at the base of the cliff, is clearly Gun 1 of the later survey (12.10). There is no indication of the adjacent Gun 5, which may well have been buried at the time of the visit. Guns 2 and 3 are clearly identifiable, centred on 14.07, though the orientation shown is different from that observed today. Gun 3 may have been turned to its present axis to investigate the adjacent deposit, recorded on the plan as including a musket, a sword-hilt, a pistol, a pewter flagon, a human bone and a lead tingle. Gun 4 (28.02) is clearly identified by its proximity to the anchor, while Gun 6 lies beyond it, at 28.09. It is shown with its muzzle apparently broken, though when excavated in 2000 the gun was found to be intact. Beside Gun 6 the location of a copper kettle is indicated. Almost abutting Gun 6 a much smaller gun is shown, its length of 1.5m being marked beside it. This gun is no longer at this location.

A dotted arrow runs from the end of Gun 6 to what is clearly depicted as the broken end of a gun. The number 25 at the start of the arrow clearly records the distance involved, and in this approximate direction, though only 15m and not 25m away, there is a gun-shaped concretion 1.2m long (Gun 7). The swell of its breech is evident, and it is certainly not a broken-off muzzle end. It may with some confidence be identified as the missing small gun identified in John Dadd's plan and it was this piece, not the muzzle of Gun 6, that he shifted in 1979.

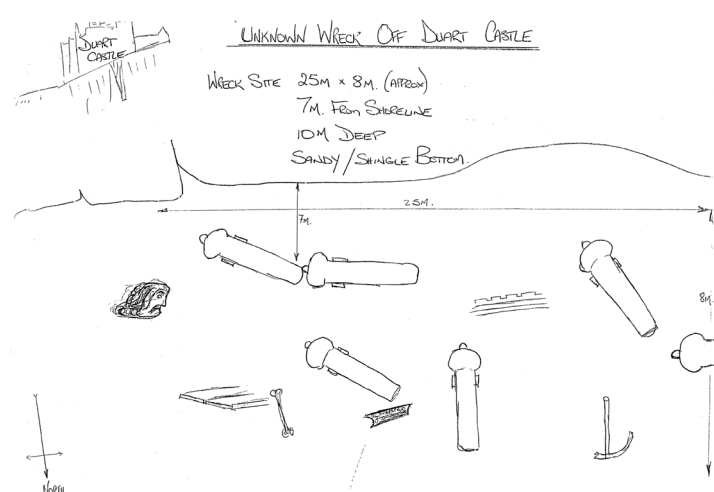
Illustration 20

Sketch-plan of the wreck-site by members of the Dumfries and Galloway branch of the Scottish Sub-Aqua Club, 1992 (ADU Collection BD 161/2)

computer version is symbolic, and all the guns and the anchor are aligned either horizontally or vertically, whereas in the freehand sketch their positions are closer to actuality. The northerly orientation is broadly correct, and the extent of the site observed during the visit is recorded as 25m x 8m.

The cliff-base is shown, with Guns 1 and 5 identifiable. Gun 5 appears to have been completely uncovered. It does not appear in John Dadd's survey, its breech end is covered in the ADU's survey, and it has been almost completely buried since the pre-intrusion survey of 1993 until the time of writing (2016). Guns 2 and 3 are identifiable, though their relative positions are questionable, while Guns 4 and 6 are likewise skewed somewhat from their actual positions. The anchor is recorded, as is the run of exposed frame-ends and planking along the port midships side of the wreck. An object which looks like the bottom part of the carved badge of the Heir Apparent is shown on both plans, close to the muzzle of Gun 2.

A number of finds are noted on the computer-generated plan. These include the warrior's head carving, a hoard of silver coins together with a touchstone, musket ball, and wooden board (a bone and planking are also indicated on the drawing), and a note to the effect that an excavation to a depth of 24 inches was conducted along the run of exposed frame-timbers and planking. It is likely that the majority of small finds recovered by the Club in 1992 came from this excavation.

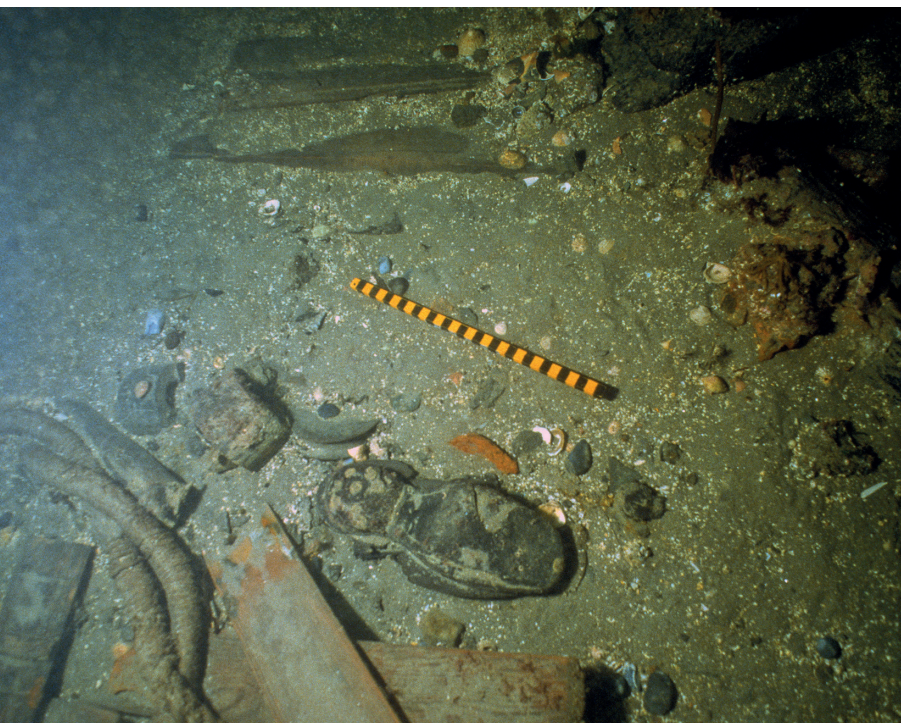
Illustration 22

Freshly exposed artefacts observed and recorded during a monitoring visit in the winter of 1992–3. They include a leather shoe, pieces of rope, a wooden sheave, two lower pump-valves, and part of a cartridge-box. Scale in centimetres (Steve Liscoe, DP 173698)

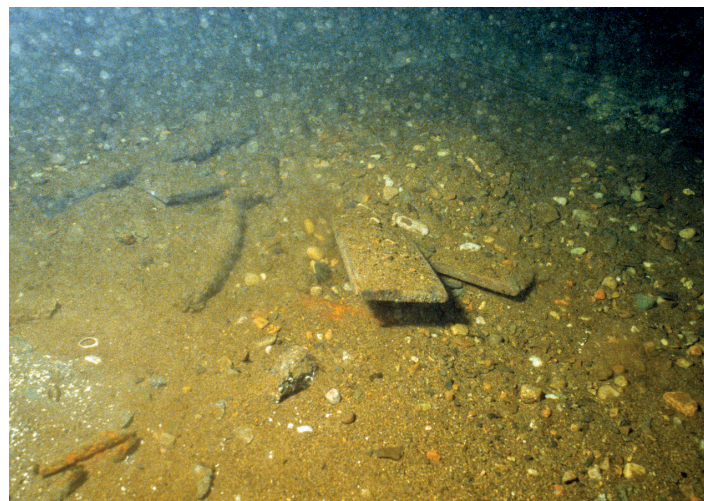
Illustration 23

The exposed deposit shown in Illus 22 in the process of reburial with fresh gravel. When this area was excavated nine years later all the items were in good condition, and remained in their original locations (DP 173696)

from the surface, was spread over the eroded area to replicate as closely as possible the original sea-bed configuration (Illus 23).

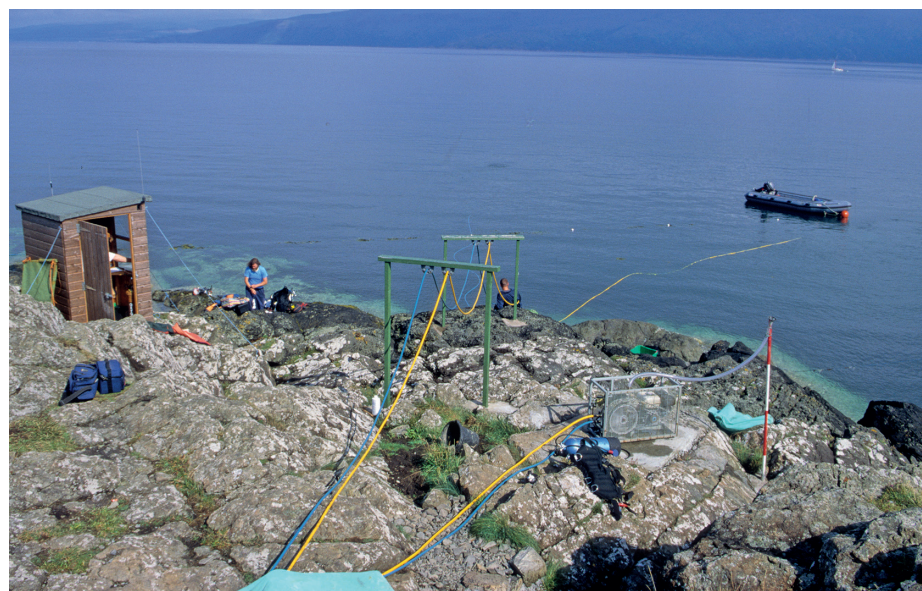
Illustration 24

The shore base, with the boat moored over the wreck. From left, the supervisor's hut, the air-hose gantries leading from the surface-supply compressor, and the high-pressure SCUBA compressor (partly visible with green cover in the foreground) (DP 173470)

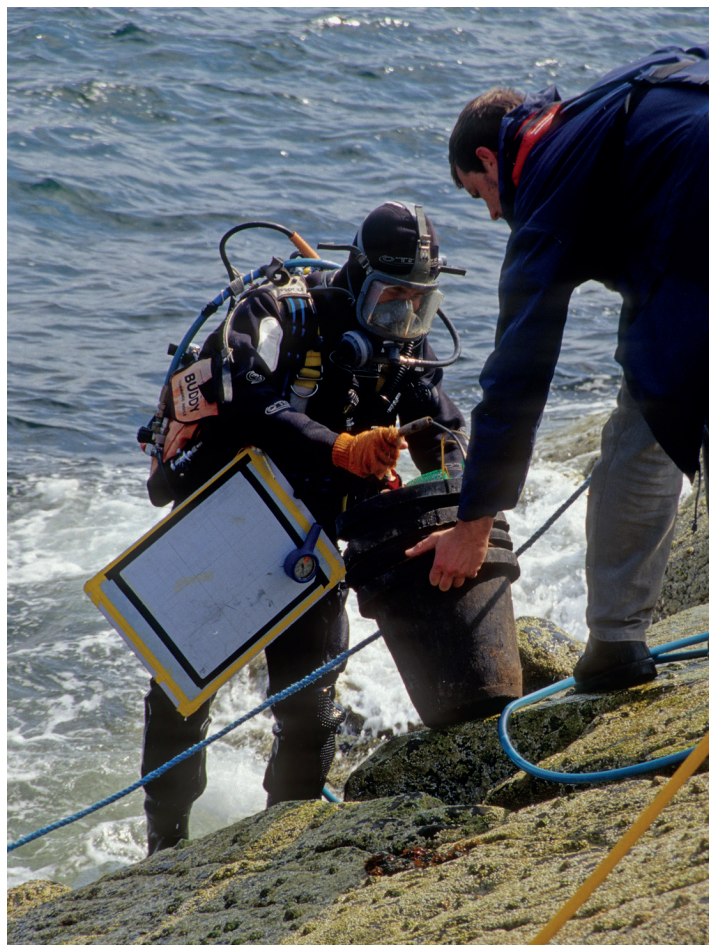
Illustration 25

An archaeologist with excavation tools and drawing-board about to enter the water, assisted by his tender (DP 173580)

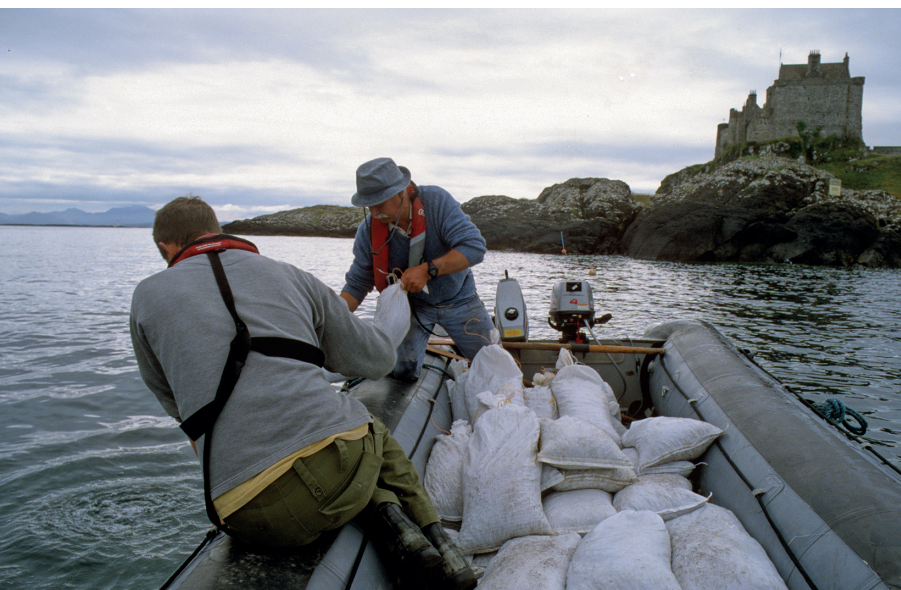
Illustration 26
Sandbags filled with gravel being delivered to the site (Edward Martin, DP 174780)

As explained above, the project's priority in 1993 was to stabilise erosion on the wreck, and this was achieved by placing a single layer of flat-weave polyester bags filled with gravel over the areas where the exposure of archaeological material had been observed (Illus 26–7). The bags were loosely filled with 20mm gravel, which it was felt would be less susceptible to transport by water-movement should the containers split or degrade. The loose fill ensured that the bag shapes would adapt to seabed irregularities, lock well together, and present a soft pliable interface against any archaeological material with which they might come into contact. Fifty-bag batches were transported to the site by inflatable boat and dropped in pre-selected dumps adjacent to the wreck but clear of archaeologically sensitive areas. They were moved around the site by divers who, having removed their fins, carried one in each hand and, thus weighted, could walk upright to where the bags were required, guided by a pre-laid line. Once each pair of bags had been set in position the diver, free of the weight, could lie horizontally and pull himself back along the line to the dump for another load. During the preliminary consolidation of the site 500 bags were laid, covering a total area of some 60m².

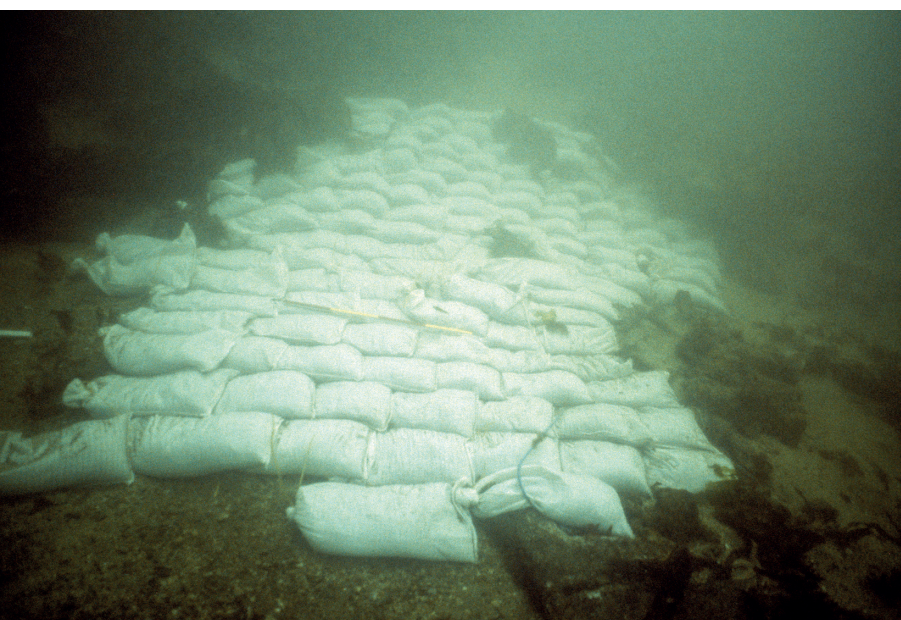
Illustration 27
Sandbags freshly laid over an exposed organic deposit (DP 174786)

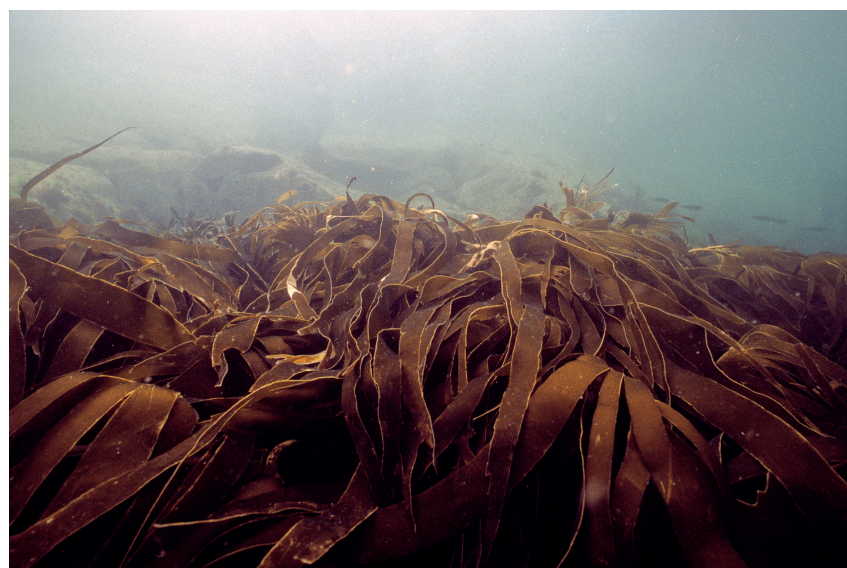
Illustration 28
Shallow-water algae cover most of the site, damping water-movement at sea-bed level to minimal velocities. This species, *Laminaria digitata*, covers the shallower and environmentally most dynamic parts of the wreck (DP 173716)

of large-fronded shallow-water *Laminaria* species which normally covers the site provides a boundary layer which reduces water-movement beneath it to negligible levels (Illus 28). Only when the *Laminaria* is removed can moving water make contact with the sea-floor at velocities sufficient to displace sediments. Sandbagging negates this effect, while the bags provide surfaces on which fresh *Laminaria* growth can establish itself and reach maturity, thus re-creating the protective boundary layer. Once this balance is achieved the bags become redundant and can be left to disintegrate, leaving the stable gravel to consolidate naturally.

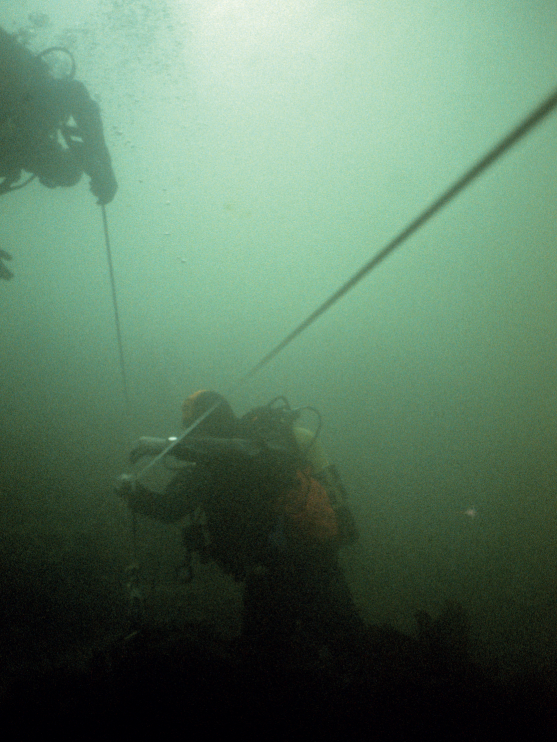
Illustration 29

A network of datum-points being established over the site by tape triangulation from a primary baseline

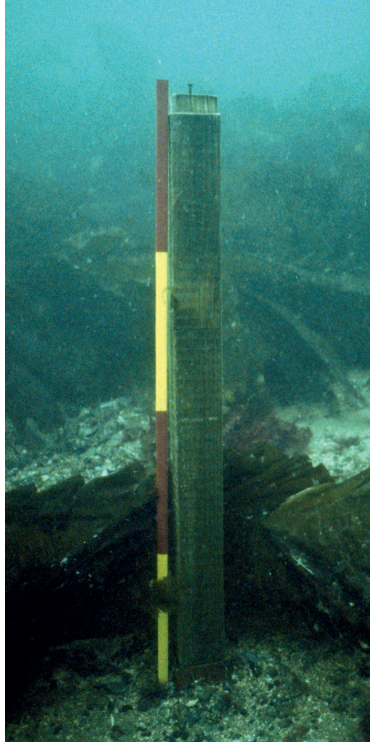
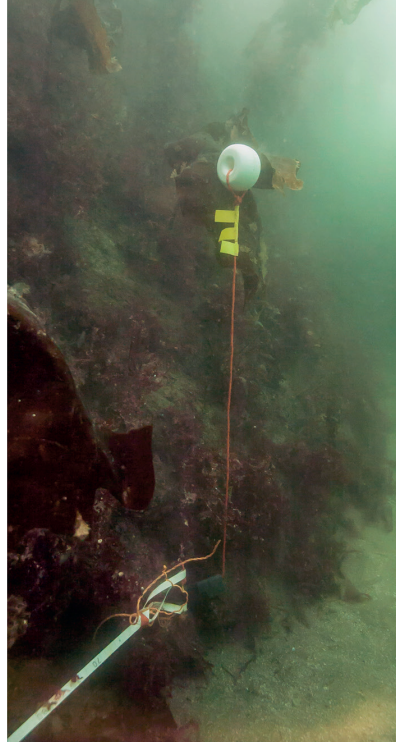
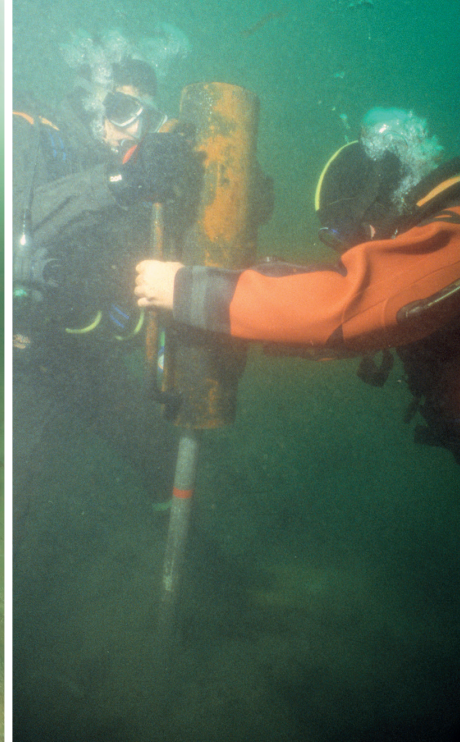
Illustration 30

Left: datum-post in position on site. Note the nail for securing the ends of measuring tapes. Centre: piton fixed near the base of the cliff, with identifying float (Edward Martin). Right: fence-post rammer being used to drive an aluminium scaffold-pole into sand as a temporary datum (DP 174362)

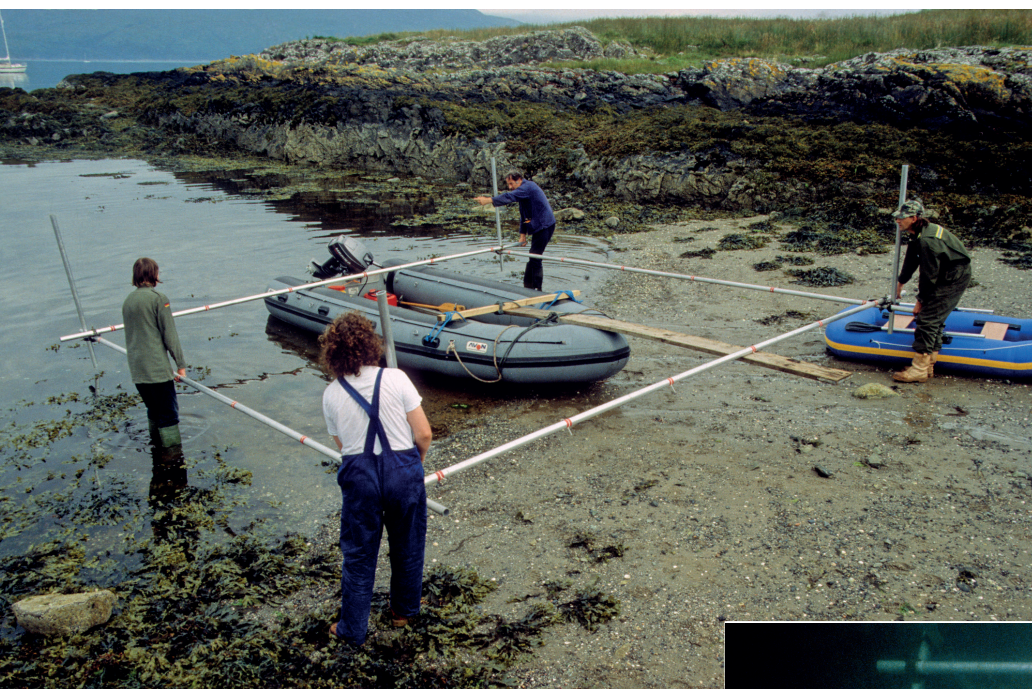
Illustration 31

Assembled 5m grid of aluminium scaffold-poles being secured to an inflatable boat for transport to the site (DP 174380)

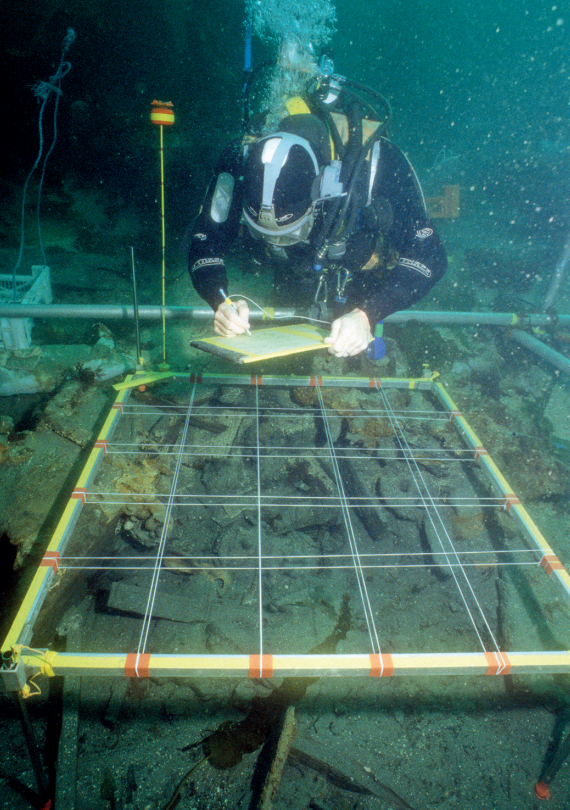
Illustration 33

A 1m drawing-frame, double-strung at 0.2m intervals, positioned and levelled with reference to a grid (DP 174407)

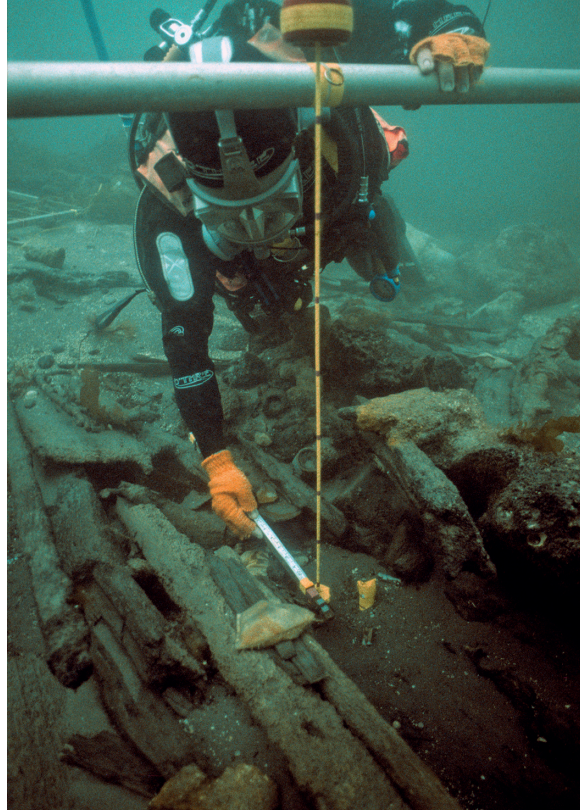
Illustration 34

The underwater equivalent of a plumb-bob is a scaled rod with a weighted bottom and a buoyant top which stands vertically in still water. A two-way spirit-level at the top allows it to be adjusted for accuracy (DP 174391)

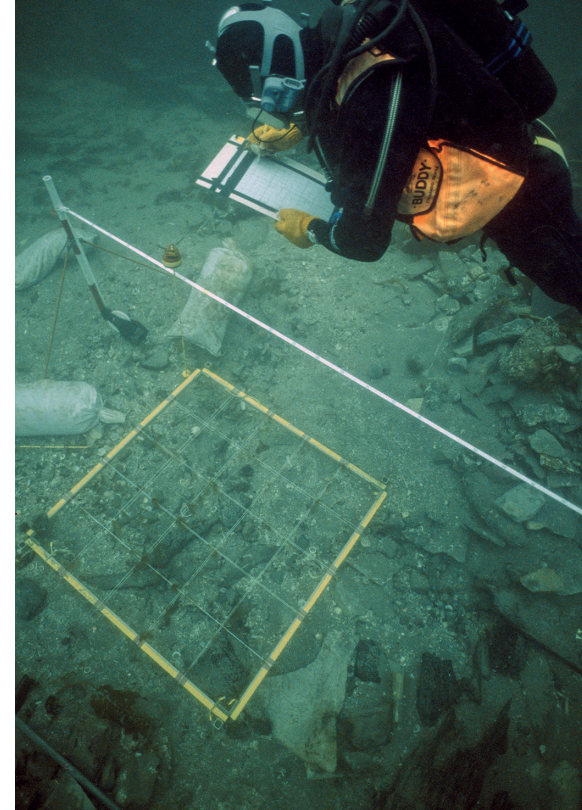
Illustration 35

Recording using a 1m drawing-frame positioned against a tape datum-line. A diver's ability to hover directly above the frame is a bonus of working under water (DP 174425)

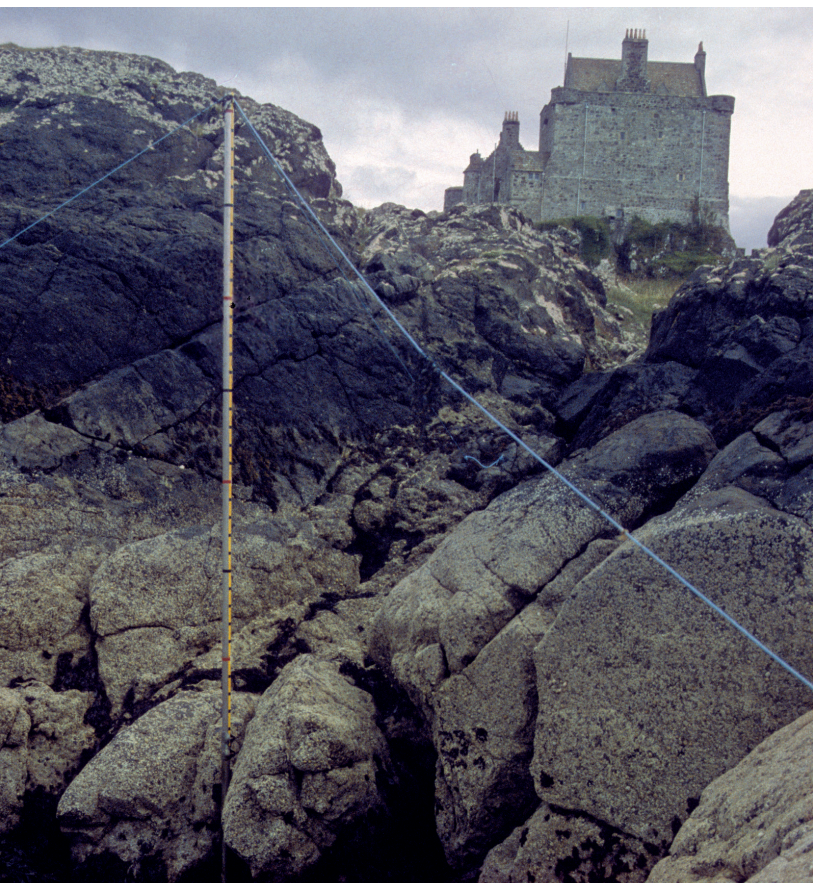
Illustration 37

The tide-gauge established at the shore/water interface adjacent to the wreck. Its foot is placed at the lowest identified tide level and it rises to a height of 4.5m, covering the full tidal range (DP 174404)

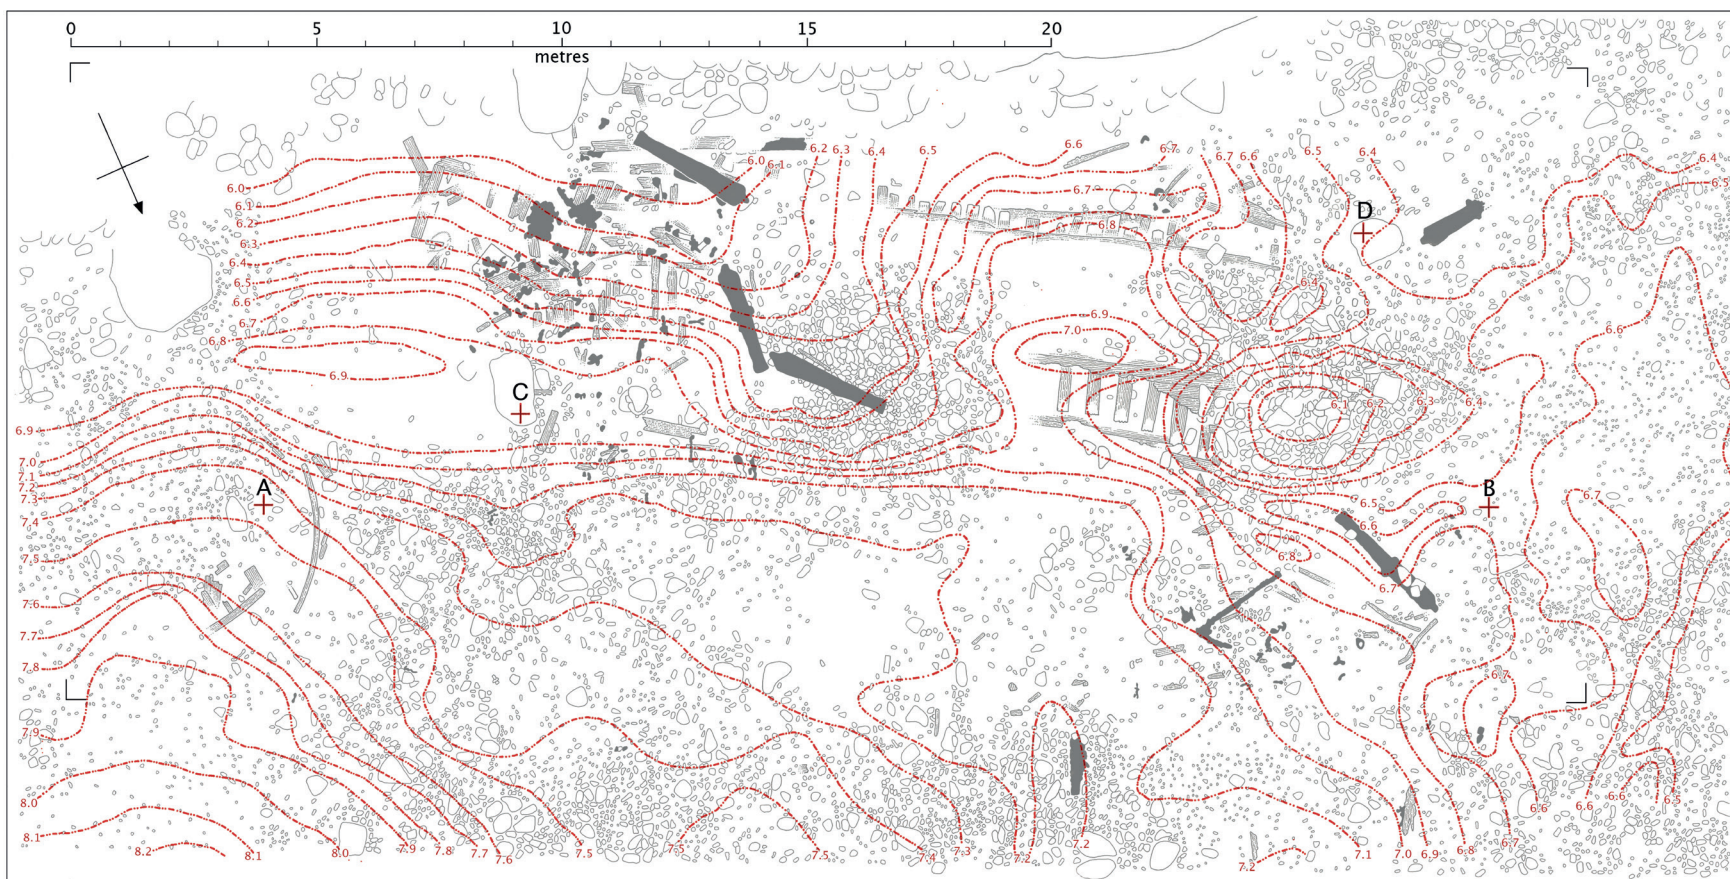
Illustration 39

Topographical survey of the wreck-site before excavation. Depths below the local site datum, which approximates with Mean Low Water Springs, are shown in red at 0.1m intervals. The primary horizontal datums, from which all subsequent survey has been derived, are indicated as A and B. Vertical datums C and D are also shown

In 1996 contours at 10cm intervals were superimposed on the two-dimensional survey. Trials aimed at determining the best method of doing this had been conducted during the previous season. These included a simple barometric device calibrated against a constant sea-bed datum to accommodate tidal changes (Martin 1983: 43), physical depth-measurements taken in flat-calm conditions from a tape attached to a surface buoy and time-co-ordinated with readings taken from a calibrated tide-gauge on the surface (Illus 37), and finally a digital depth-gauge constantly checked against the primary depth-datum C (Illus 38). Surprisingly, the last technique proved to be the simplest and most accurate. Readings were taken at 1m intervals along tape-lines set parallel with the site-datum A-B. Each series of readings was prefaced by a calibration reading at the primary depth-datum, which lay above the level of any of the contour points. The gauge, which recorded metric depths nominally to one decimal point, was then placed directly on the position to be recorded, and slowly raised up a short vertical scale until the decimal point moved to the next figure. The height at which the changeover occurred was added to the recorded depth, and the reading adjusted against a reading obtained by the same method at the primary depth-datum. It had been anticipated that the results would be accurate enough to permit the plotting of contours at 25cm intervals, but in the event a finer resolution was possible, and 10cm contouring was achieved across the site. Independent checks confirmed the general reliability of

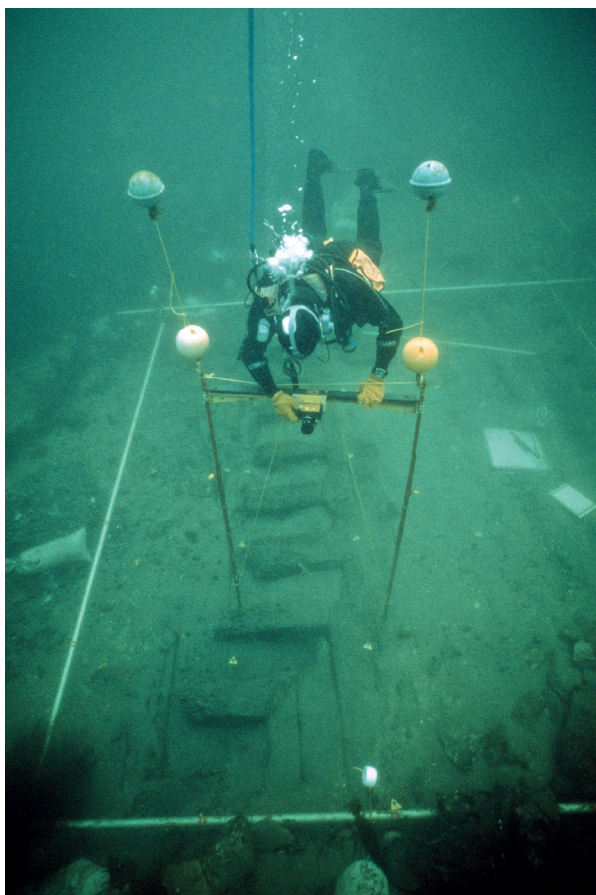
Illustration 42
Levelling the bipod photo-tower by means of a two-way spirit-level (DP 173135)

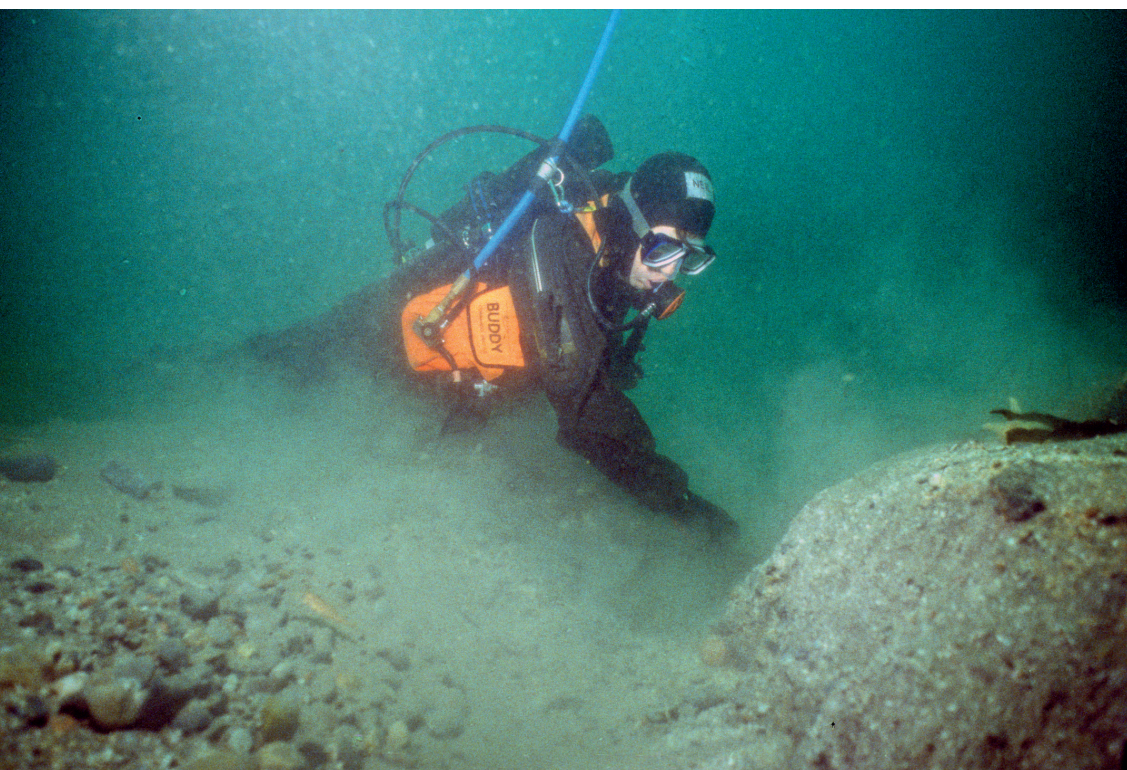
Illustration 43

The hand-fanning technique of area excavation (DP 174477)

Although the same principles of archaeological excavation on land can and should be followed under water (Bass 1966), there are some practical differences in applying them. On many sea-beds, including that at Duart Point, loose material at the sediment/water interface is generally in a semi-fluid state. Surface-levels are therefore prone to disturbance by water-movement, whether of natural or anthropogenic origin. However this characteristic can be exploited by the excavator, using a hand-fanning technique to displace the sedimentary matrix (Illus 43). Applied vigorously, this is akin to using a shovel to shift spoil on a terrestrial site, while a gentle

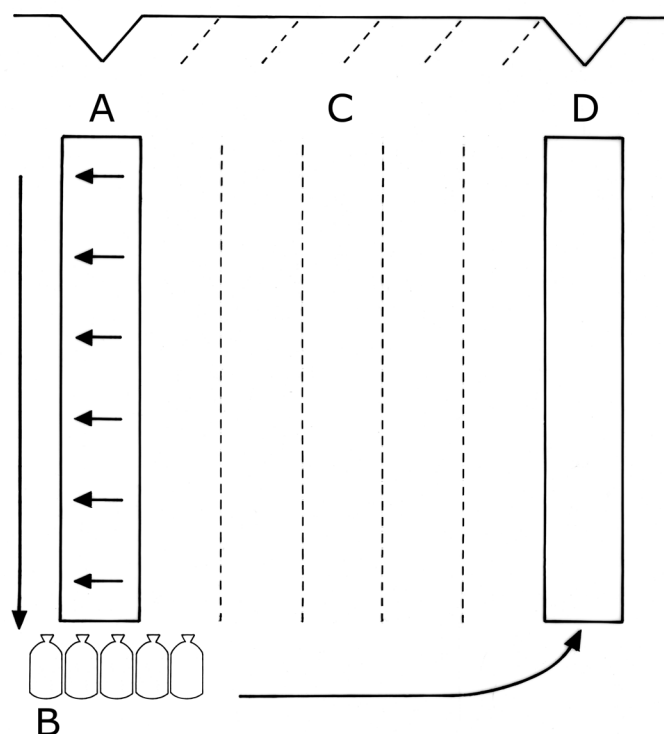
Illustration 44

Diagram explaining the 'advancing front' method of area excavation. Arrows indicate the transport of spoil. (A) is the initial trench; (B) the spoil from it; (C) the faces in which stratigraphy can be recorded; (D) the final trench, which can be filled with the bagged spoil (B)

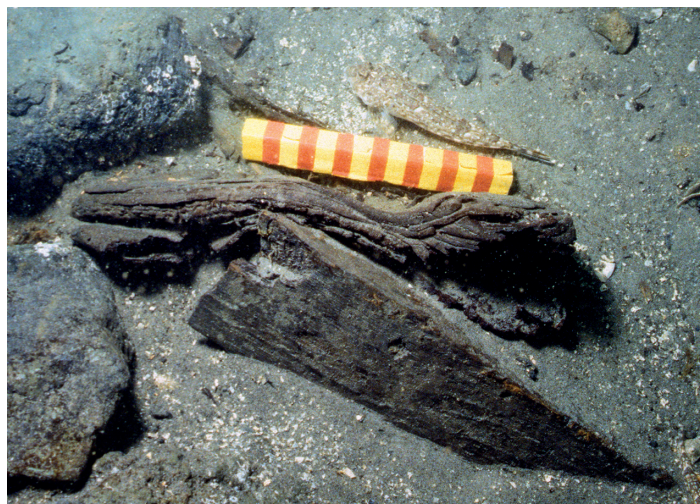
Illustration 46

A fragile leather shoe immediately after excavation. Scale 15 centimetres

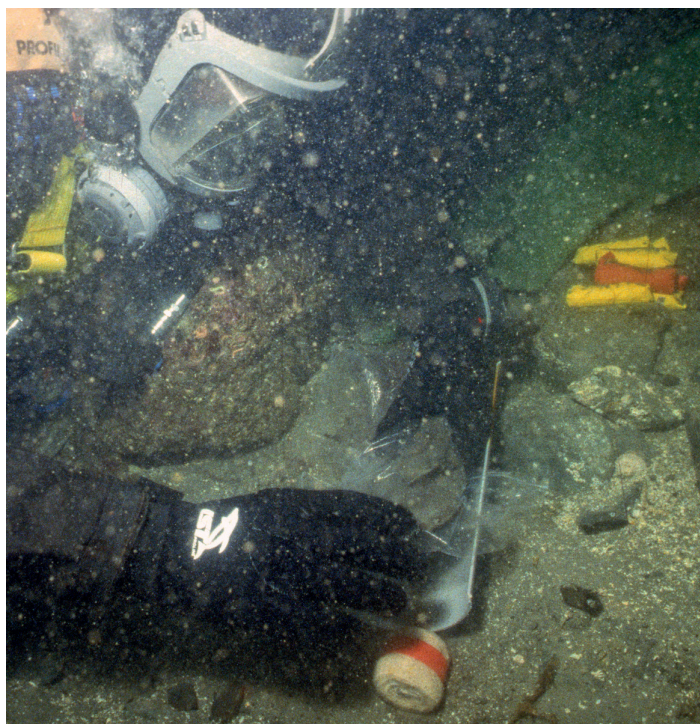
Illustration 47

The shoe, now in a polythene bag, is placed into a short length of plastic guttering before being secured with a bandage. The rolled bandage, with a lead weight at its inner end to ballast it and an easily detached wrapping of electrical tape, is placed close to hand (DP 174486)

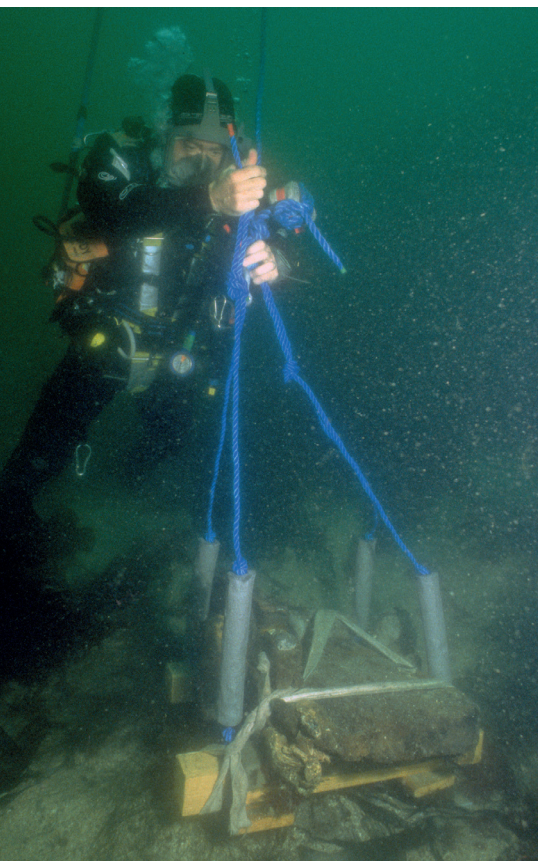
Illustration 48

Part of the wooden gun-carriage [83], secured to a supporting former with bandages, is prepared for lifting. The rope strops are surrounded by expanded polystyrene tubing to avoid damage to the wood (DP 174580)

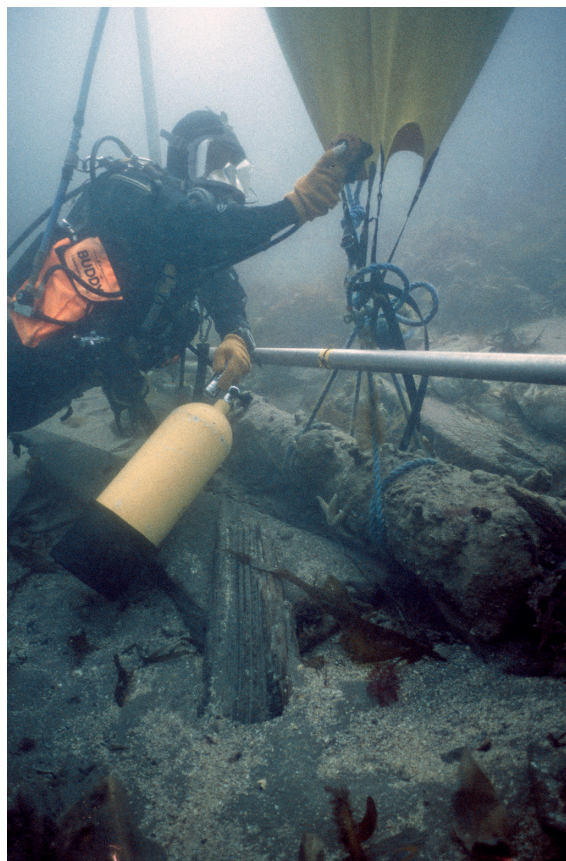
Illustration 49

Raising the concreted iron gun [82] by means of an air-bag, inflated from a high-pressure cylinder (DP 174543)

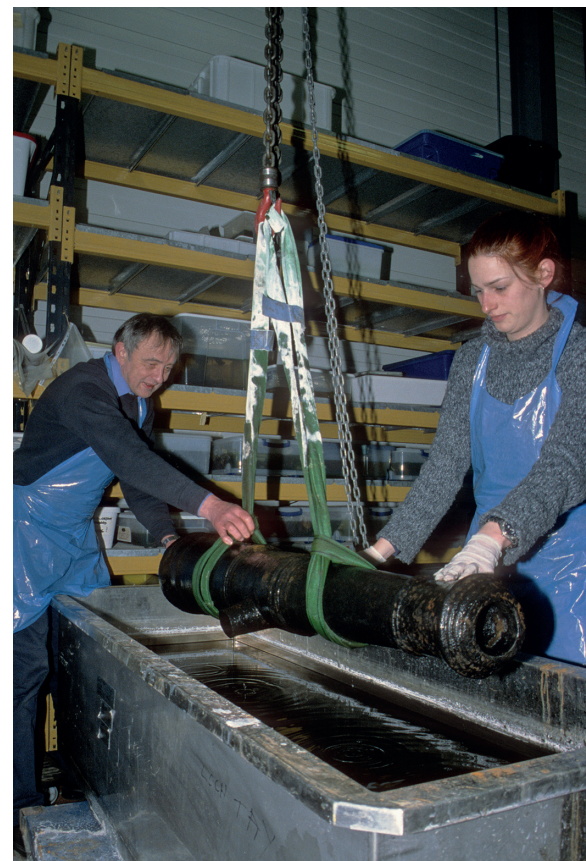
Illustration 50

The iron gun [82], its concretion removed, in the hands of conservators at National Museums Scotland (DP 174570)
