A Cromwellian Warship wrecked off Duart Castle, Mull, Scotland, in 1653

Colin Martin

Chapter 5

THE SHIP: STRUCTURE AND LAYOUT

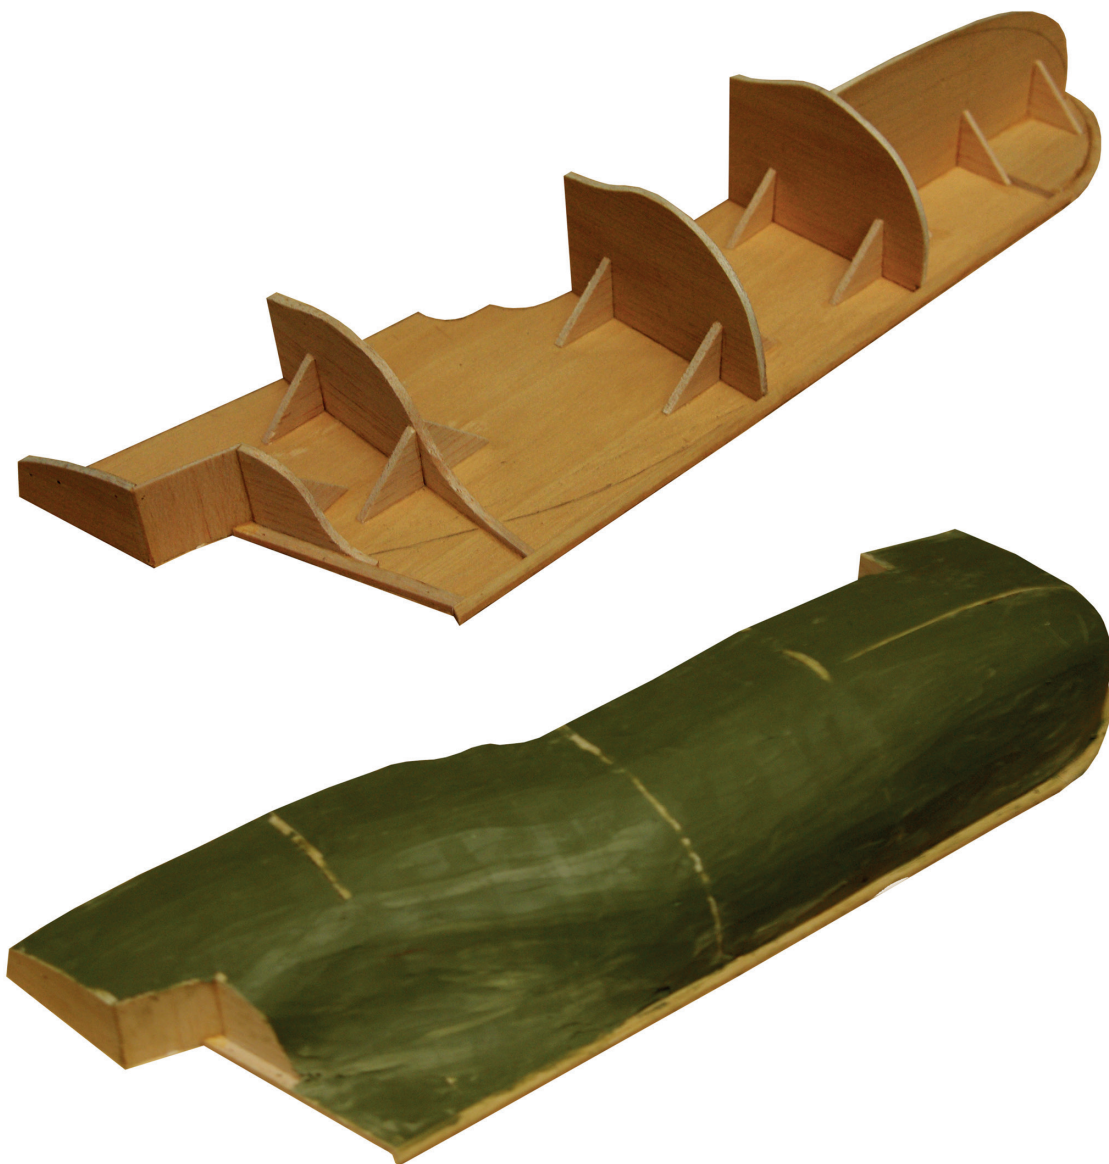
Illustration 132
Top: speculative framework of the hull based on recorded elements. Bottom: speculative half-model faired with modelling-compound

These data were extrapolated to create a best-fit framework for a skeletal half-model of the hull which incorporated all the known information and what could reasonably be deduced from it. The framework was faired with plasticine and the hull-lines lifted from it (Illus 132–3). Helpful references were provided by Howard (1979), Lavery (1988), Kirsch (1990), Steffey (1994) and Adams (2013). Kirsch includes as an appendix the invaluable *Treatise on Shipbuilding* of c 1620, edited by William Salisbury from a manuscript in the Admiralty Library, originally published by the Society for Nautical Research in 1958.

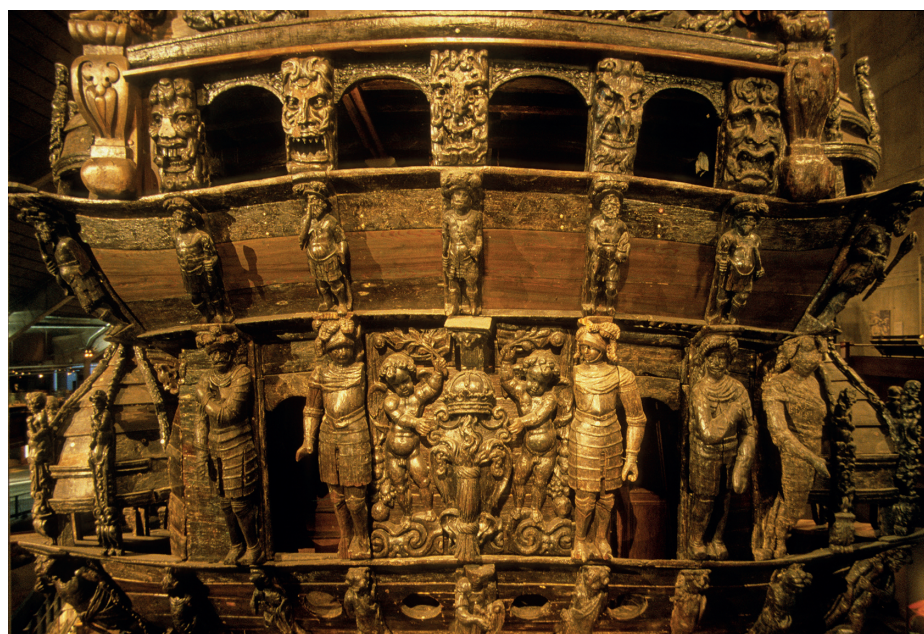
Illustration 141

Arched windows of the stern cabin of *Vasa*

A close parallel to this object is seen in the upper stern window range of *Vasa*, immediately above the royal arms (Illus 141), though in the case of *Vasa* these arches are embellished with relief carving. Their downwards angles are splayed to accommodate the flare and camber of the transom's geometry, echoing the deviation from the square noted on the Duart Point example. On these grounds, and the fact that the arc dimensions are virtually identical to the width of the Hope pediment, which it has been hypothesised was set in a central position immediately above the range of windows, it is concluded that this component is part of the top arch from one of the stern windows.

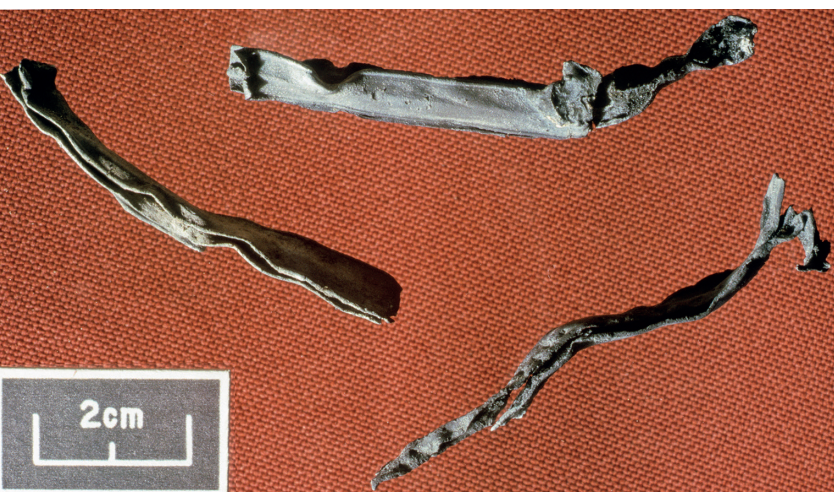
Illustration 143

H-sectioned window-glass joiners, or comes [16], found in the vicinity of Gun 8 (DP 174189)

- [16] DP00/018b, **087.109**, concreted to the oar-port lid attached to Gun 8, a 90mm square of window-glass, with its lead surround (Illus 81). Nearby three pieces of lead window-cames (grooved joining-bars) were found (DP99/070 and 102) (Illus 143). Another piece (DP99/117) was visible within a surface find of concretion. These elements undoubtedly come from the stern-cabin windows.

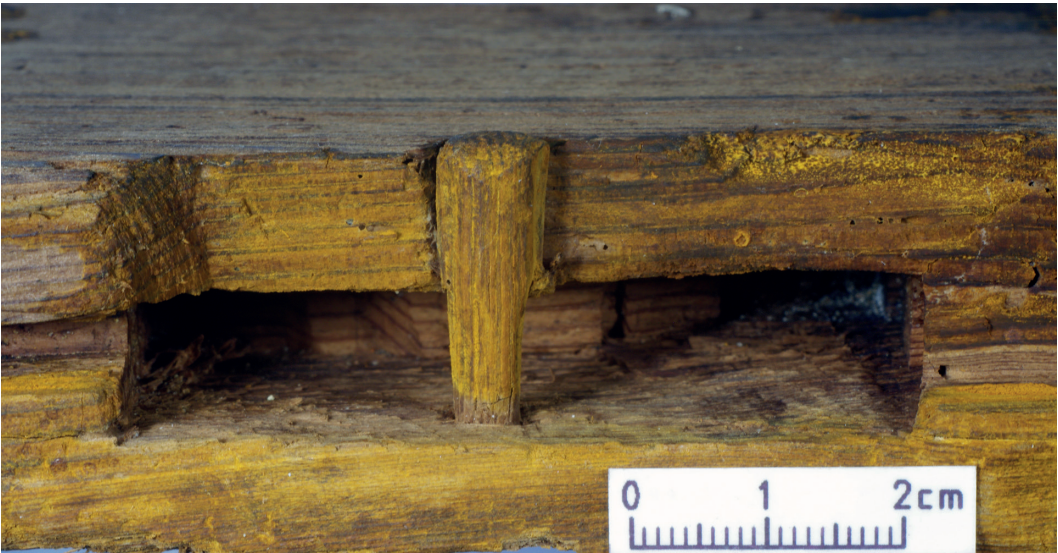
Illustration 153
Joint in moulded panel frame [26]
