A Cromwellian Warship wrecked off Duart Castle, Mull, Scotland, in 1653

Colin Martin

Chapter 6

THE SHIP: OPERATION AND MANAGEMENT

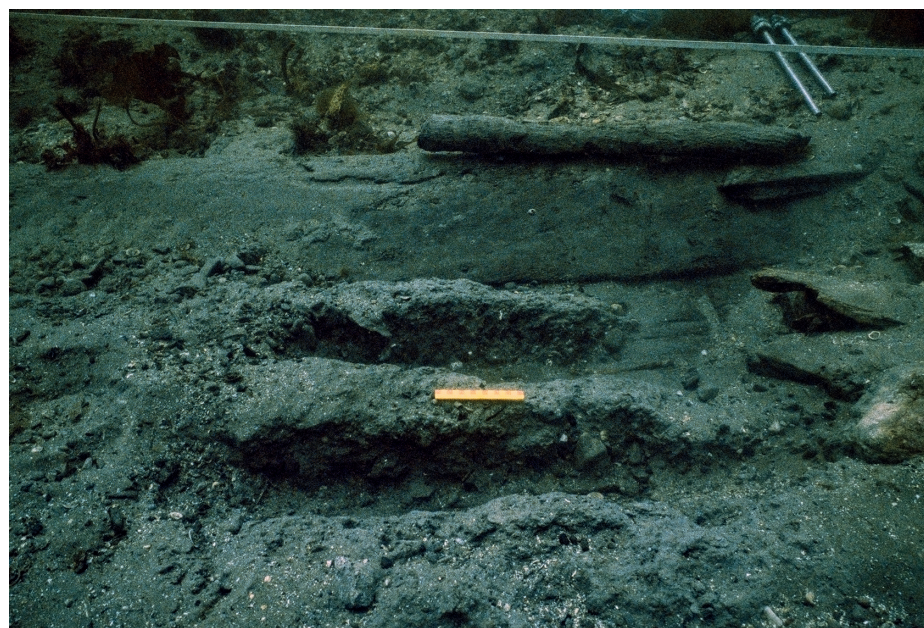
Illustration 164

Clay lining of the lower hold. The clay has been ribbed longitudinally down to the ceiling planking as it approaches the port bilge, presumably to stabilise the gravel laid above it. Three parallel channels are shown partly excavated here. Scale 15 centimetres (DP 173758)

Much of the partially eroded floor in the midships section between the two ballast-mounds, above the ceiling planking, had been lined with a creamy-coloured clay. Professor McManus's analysis shows that this material is probably

fireclay of the Carboniferous period. This is not common in Highland regions, but it could well have been derived from the west coast of central Scotland. Towards the port side of the hull, just before the upwards turn of the bilge, the clay lining is ribbed with three furrows up to 0.15m deep extending to the ceiling planks of the hull, exposing the longitudinal joints of the timbers (Illus 164). Above the clay is a layer of gravel distinctively different from the natural sea-bed shingle in this area, and this is also presumably ballast. The ribbing of the clay along the bilges may have been intended to stabilise the gravel against sideways movement when the ship rolled; alternatively, the furrows may have been settings for stabilising-boards, recalling Mainwaring's remarks on the securing of ballast, 'they make pouches, as they are called, that is bulkheads of boards, to keep it up fast that it do not run from one side to the other, as the ship doth heel upon a tack' (Manwaring & Perrin 1922: 93).

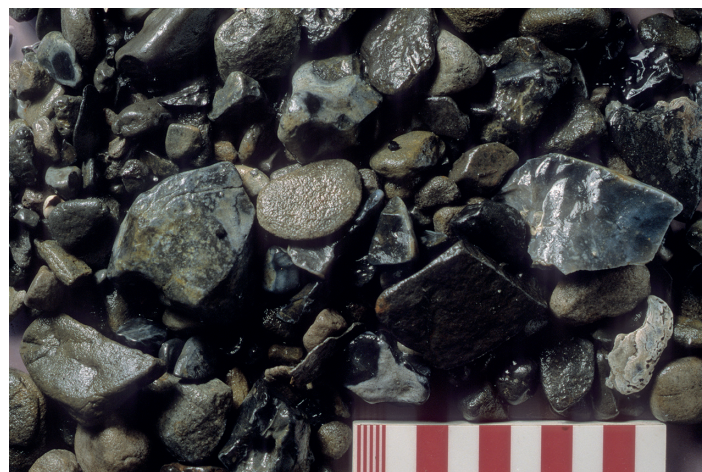
Illustration 165

Sample of gravel from the channels in the midships clay ballast. Scale in centimetres (DP 173762)

Samples of gravel were taken from the lower levels of the ribbed furrows to ensure that they were not contaminated with natural material (Illus 165). Professor McManus suggests that the ballast gravel may have come from the Inner Hebrides, but is unlikely to derive from mainland Argyll or the Outer Isles. Among the gravel ten water-abraded potsherds were identified (Illus 166). None of the fabrics matched ceramics found elsewhere on the wreck. The wares represented include olive jars from the region around Seville. One other sherd suggests a Spanish association while others, though not closely identified, appear to be of continental origin and possibly of significantly earlier date than pottery found elsewhere on the wreck (George Haggerty pers comm). The most probable explanation is that the gravel had been taken on board from a deposit somewhere in the Inner Hebrides or the adjacent mainland at which vessels with continental connections had discharged ballast. Because of the need to keep harbours

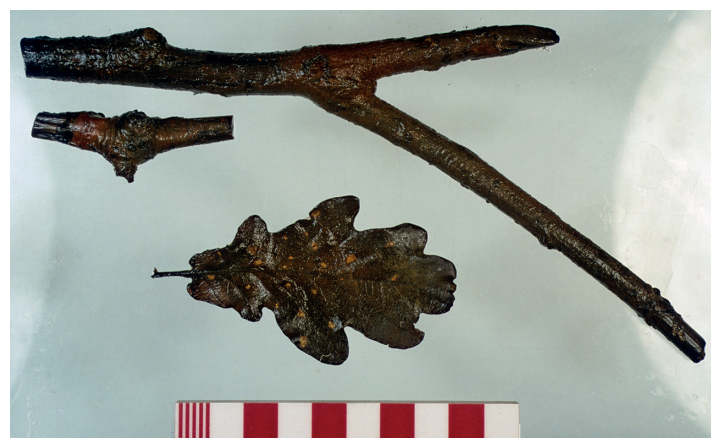
Illustration 167
Scraps of oak brushwood, which may have served as packing for stacked casks. Scale in centimetres (DP 174124)

Among the collapsed aft end of the wreck several oak twigs were found, some with leaves still attached (Illus 167). These may have been firewood, or dunnage associated with cargo stowage. In the latter case they might have been used as fuel once the cargo was consumed or discharged.

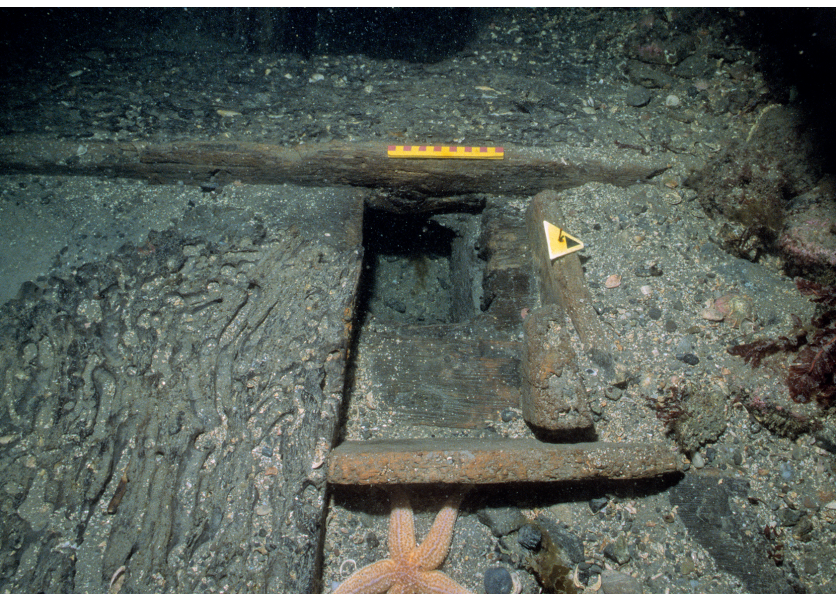
Illustration 178

The port-side pump-sump and box. The abraded keelson is at the top (with 15cm scale) while the remains of the transverse mainmast-step (eroded almost to extinction) are on the left (DP 173785)

Immediately aft of the transverse mainmast-step, on the line of the limber planking and hard against the keelson on the port side at **188.074**, is a small box-like structure measuring 0.3m × 0.2m (1ft × 8in) (Illus 178) (see Chapter 3.2 area 6). Its forward edge is formed by the side of the transverse mast-step, its starboard edge by the keelson, the port by a short plank fastened to the forward side of Frame 3.6A, and the aft by another short, slightly angled plank. At the forward port-side corner of the box a rectangular hole measuring 200mm × 150mm (8in × 6in) has been cut through the limber-

These features were undoubtedly sumps for the port and starboard pump-tubes. Some form of filtration is likely to have been provided at the base of the suction-tube to prevent the pumps from blocking, and while no evidence of this was found, the relatively clean state of the bilges, gaps between the frames, limber-holes and pump-sumps suggest that there was a regular and significant flow of water through the ship's natural drainage-courses. This, as pointed out at the end of the previous chapter, is a symptom of a leaky ship.

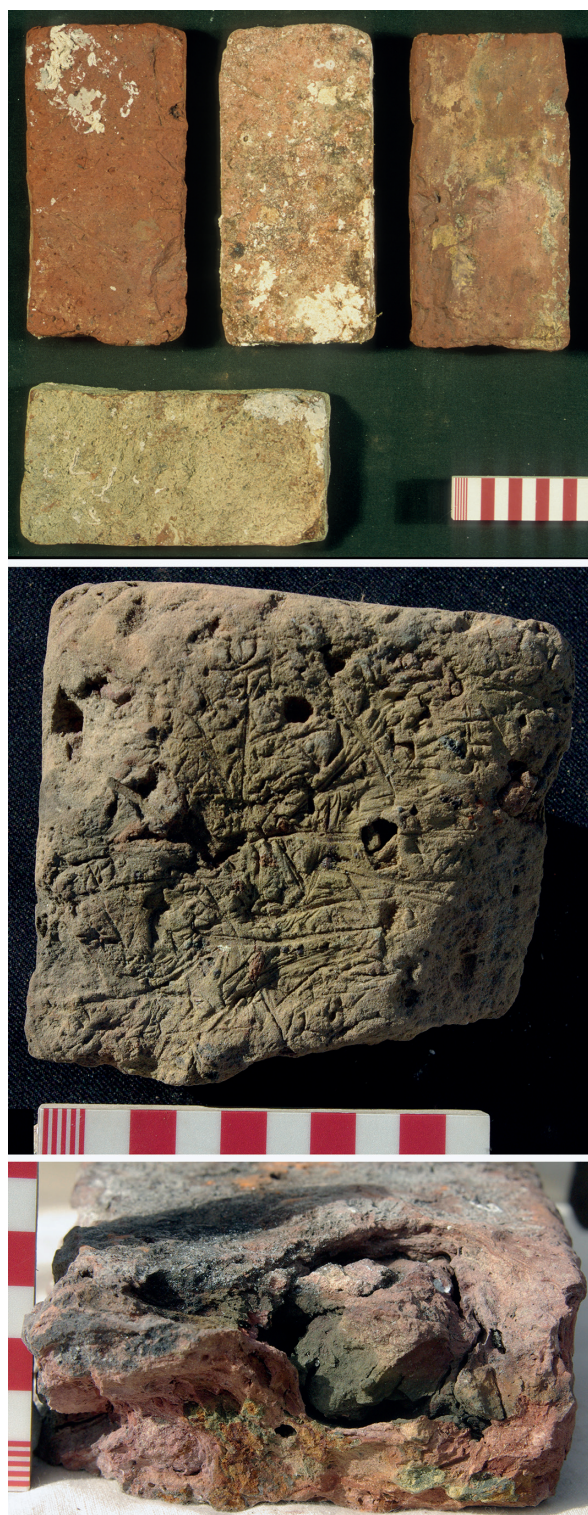
Illustration 179

Top: bricks [59] from the galley area showing the four fabric types (DP 174195). Middle: brick showing marks of the grass on which it was laid while still soft. Scale 10 centimetres. Bottom: the interior of a Type 3 brick revealed by breakage, showing poorly mixed clays and brick inclusions

[59] DP96/015, DP00/133, DP01/066, 110, DP02/019 (4 whole, 2 half), DP03/015 (the majority), from around the port-side edge of the forward ballast-mound, 17 complete bricks, two broken ones and a few fragments (Illus 179).

- Type 1. Light purplish fabric, few inclusions (eight examples).
- Type 2. Pinkish-red fabric, no visible inclusions (four examples).
- Type 3. Dark buff fabric with a dark-grey core and large inclusions of broken red brick (three examples, all broken). Straw impressions on the face of one example.
- Type 4. Refractory bricks. Light buff fabric with crushed brick inclusions (four examples).

Between them they show evidence of a smoothed upper face, marks on the upper face indicating that they were scraped lengthwise with a board, and an underside texture that suggests that while wet they had lain on a straw-covered surface. A Proclamation of 1625 specified 9in × 4½in × 2¼in (229mm × 113mm × 57mm) as the minimum size of bricks sold in London, though this was by no means universal (Lloyd 1925: 12). The graph (Illus 180) shows median values quite close to this standard, although there are discrepancies of up to 15mm on some bricks. Most of the discrepancies fall below the prescribed standard.

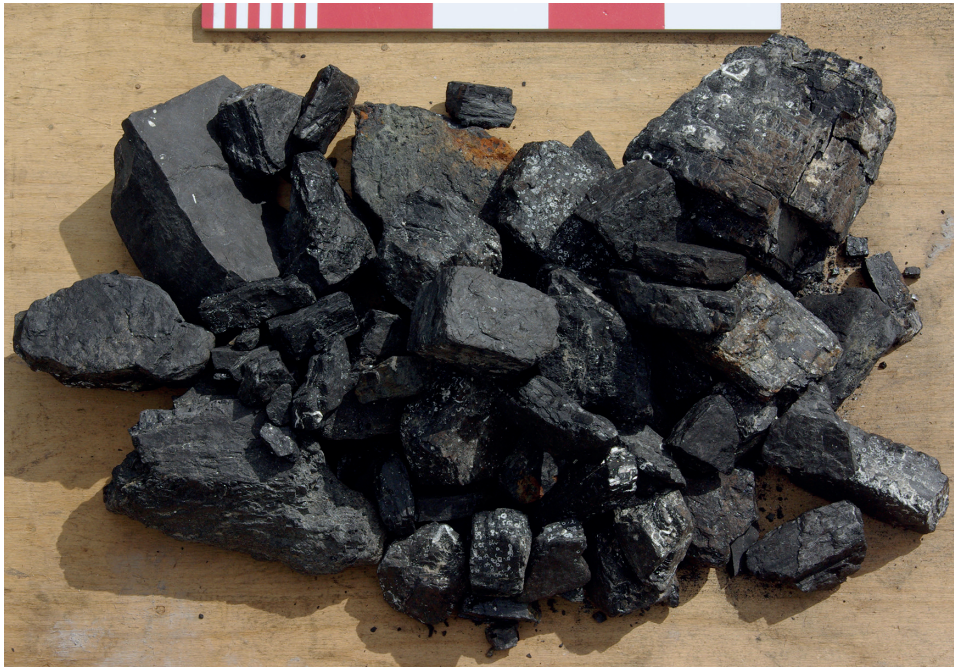
Illustration 182
Coal from the area of the collapsed galley. Scale 50 centimetres

Small fragments of coal were found scattered across the site, with concentrations of larger pieces in the area of bricks, tiles, and other material among the collapsed galley around grid square **28.07** (Illus 182) and in the adjacent area under the ballast in the vicinity of grid square **27.06**. A total of 8.5kg was recovered. Coal was evidently the main cooking fuel in Cobbett's fleet. The nature of the coal does not allow close geological provenancing (John McManus pers comm) but is typical of the Central Scottish coal measures which extend from the Fife to the Clyde coasts (Unstead 1964: 214), and may well have been taken aboard at Ayr. Its distribution on the wreck suggests that it was stowed close to the bow, no doubt immediately above the ballast.

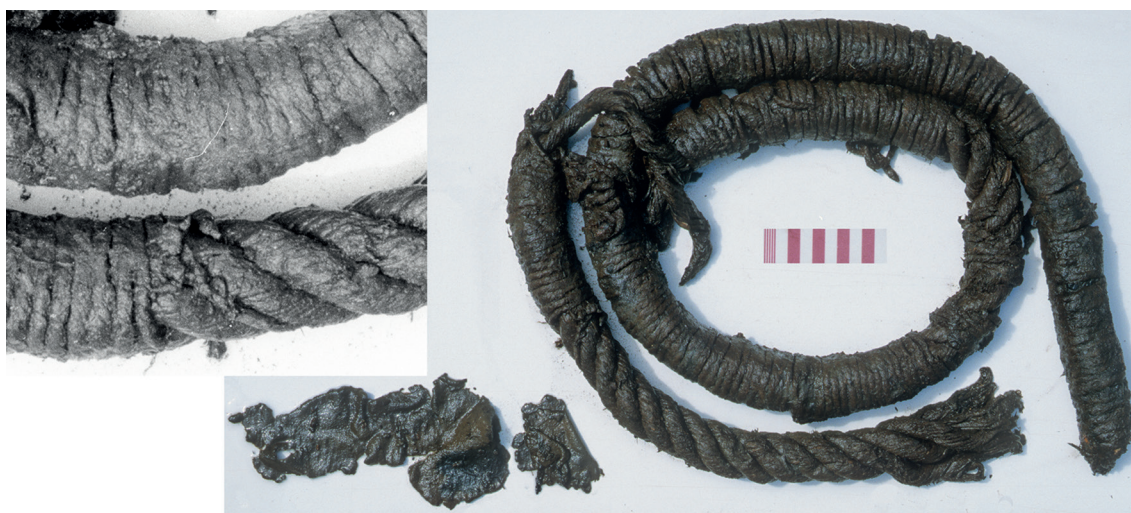
Illustration 193

Rope [80], wormed, served and parcelled (DP 173271); top left: detail of rope showing the partial unwrapping of its outer worming and serving. Scale 10 centimetres (DP 174087)

[80] DP97/A015, **079.092**, the longest example, three-strand Z-laid hawser of 38mm diameter (1½in) 1.6m long, disposed in one-and-a-half coiled loops (Illus 193). At one point a single lie of spun-yarn worming is evident, though this has been lost from all other spaces between the hawser strands which have lost their servings. Along most of its length it is served with a continuous binding of 2.5mm spun yarn which increases the diameter to 43mm (1¾in). Pieces of its leather parcelling are shown on the left. This is part of a group of cordage found in Excavation Area 5, in a deposit largely filled with organic material. It consists of three main elements of probably conjoining hemp cordage and two associated leather items, and appears to derive from a single length of hemp hawser which has been wormed, served, and parcelled with leather. Such protective treatment, which rendered the rope at least partly waterproof, was generally reserved for standing rigging (Stopford 1953: 40–1. Procedures for dressing rope in this way are described in the *Admiralty Manual of Seamanship* vol 1 1972: 188–90).
