# A Cromwellian Warship wrecked off Duart Castle, Mull, Scotland, in 1653

Colin Martin

Martin, C J M 2017 *A Cromwellian Warship wrecked off Duart Castle, Mull, Scotland, in 1653*. Edinburgh: Society of Antiquaries of Scotland.  
<https://doi.org/10.9750/9781908332189>

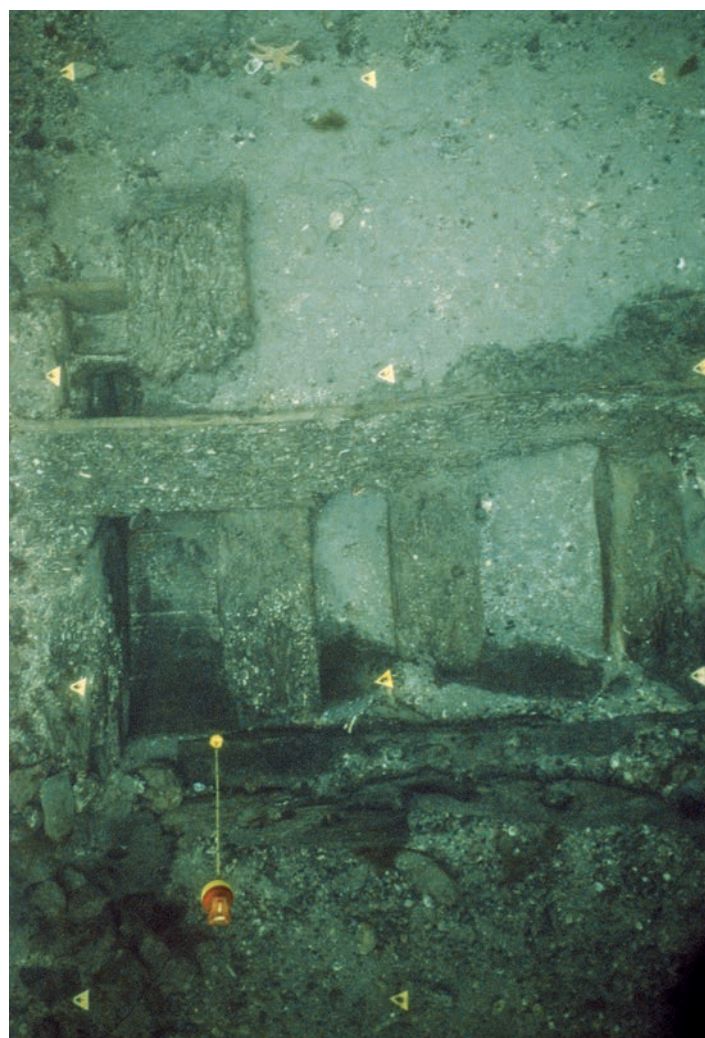
Illustration 101  
Detail of the central midships area showing (from bottom) fragmentary starboard-side planking, starboard-side floor-timbers, the abraded keelson, the port-side pump-sump and box (top left), and the abraded remnants of the transverse mainmast-step to its right. The yellow triangular targets are at 1m intervals (DP 173806)

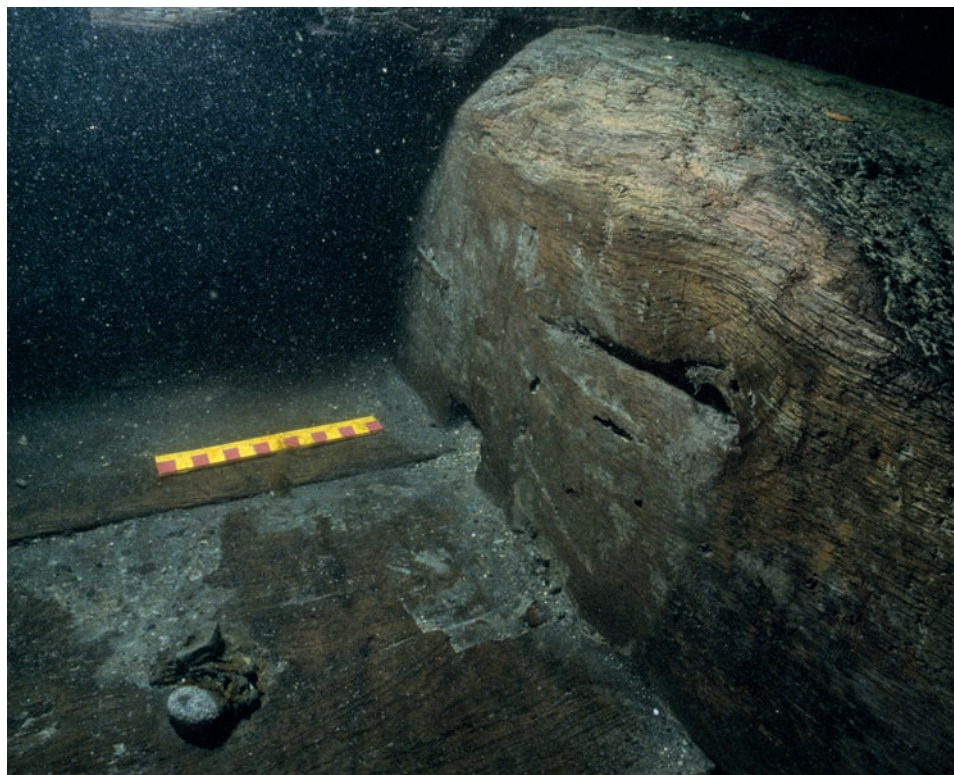
*Illustration 105*

Oblique view of the pump-sump and mast-step complex looking to port. The abraded and shipworm-damaged surface of the keelson (across bottom of picture) and transverse mast-step (top right) are clear. Scale 15 centimetres (DP 173777)

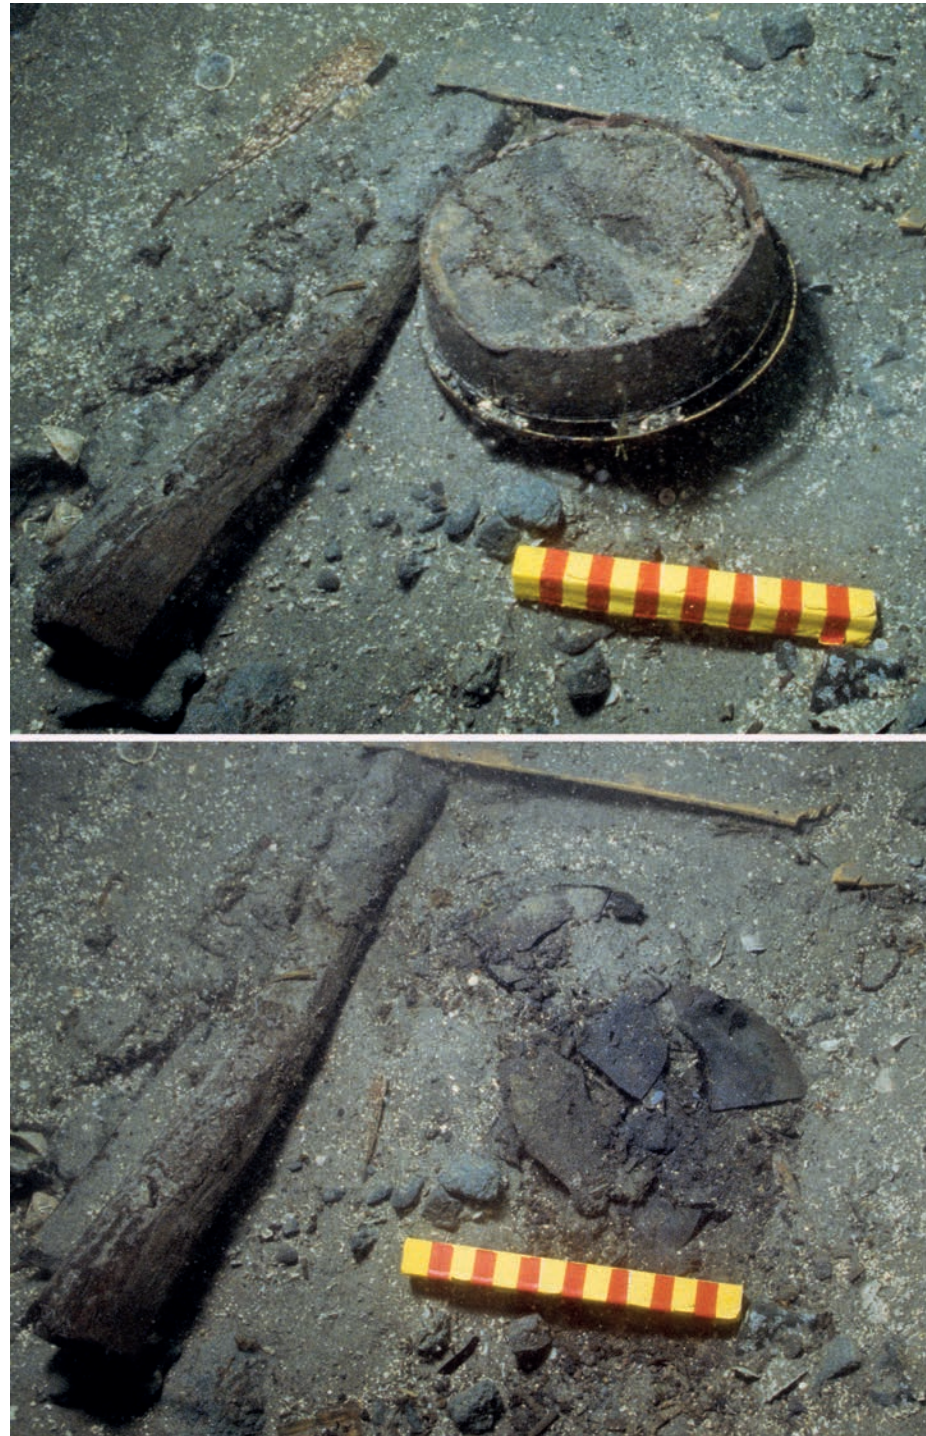
Illustration 120

Top: inverted mariner's compass [91], in situ after excavation. Its base is cracked and imploded (DP 174253). Bottom: shattered glass face of the compass after removal of the bowl. That it retains its circular shape indicates that it broke when the compass reached the sea-bed, and that neither object has moved since. Scale 15 centimetres (DP 174255)
