# The Archaeology of Finlaggan, Islay

David Caldwell

# THE LOCH-SIDE, EILEAN MÓR AND EILEAN NA COMHAIRLE

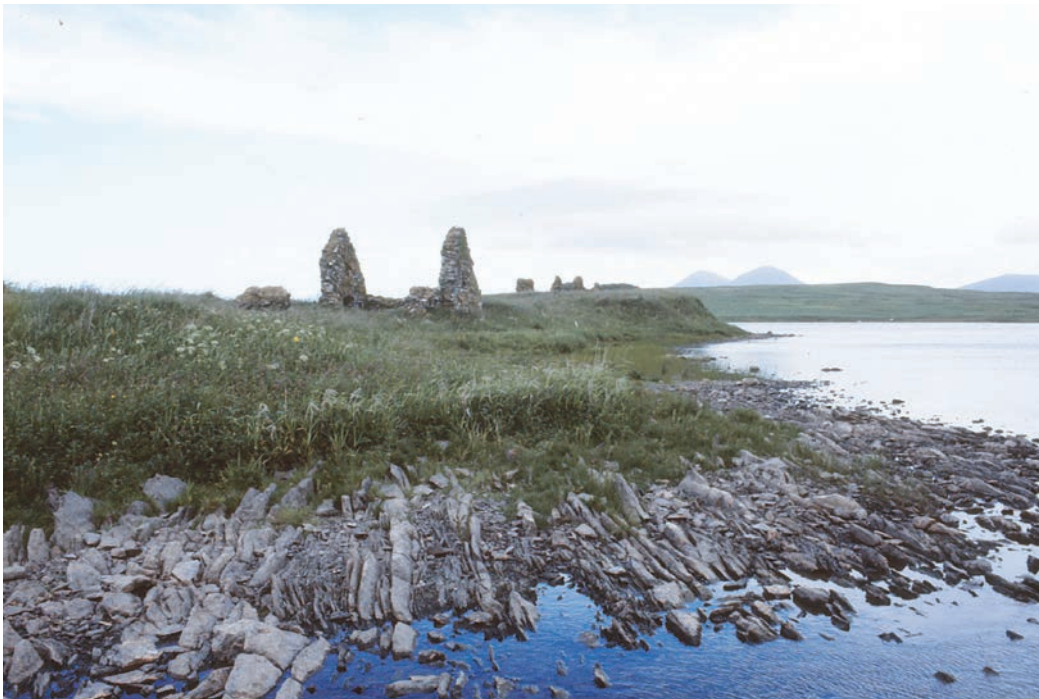
Illustration 6.2

The west shore of Eilean Mór in spring 1988 with beds of limestone and phyllite exposed as a result of erosion

grey-blue phyllites that contain cubes of iron pyrites (Illus 6.2). These phyllites appear to be highly cleaved, while the more massive limestone exhibits tension cracks filled with calcite. The cliff face to the south-east of the chapel represents the largest exposure of phyllite on the island. The dip of these flaggy limestones and shales is almost vertical and the beds are often very contorted.

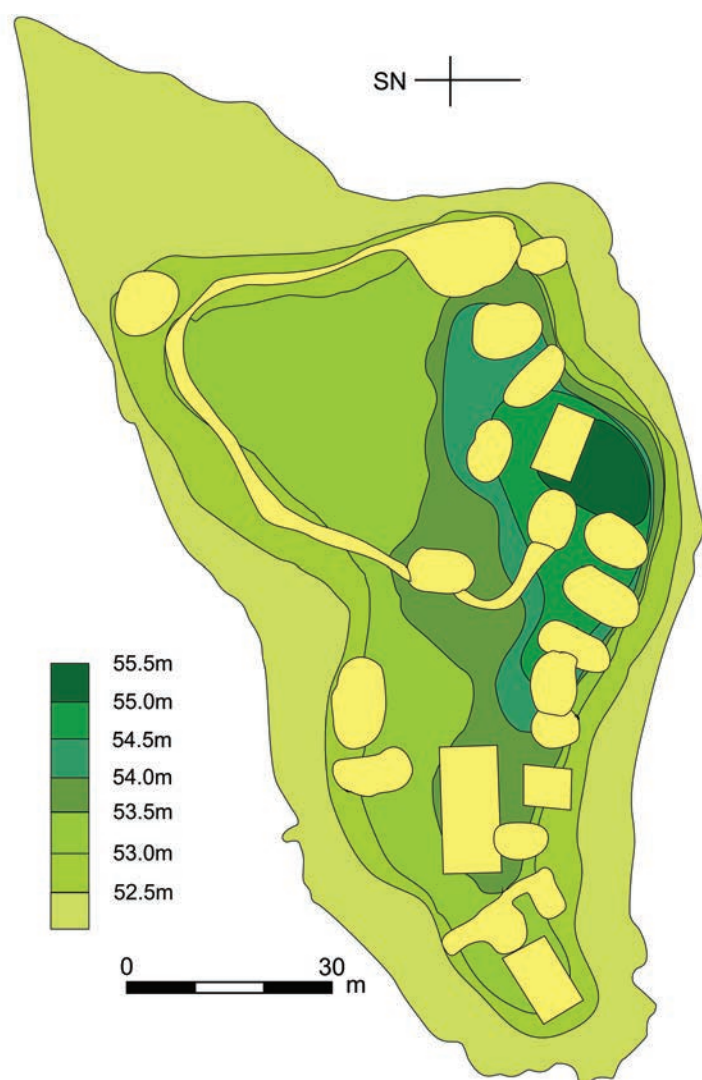
Illustration 6.5

Map of Eilean Mór with contours (excluding upstanding human remains) at half-metre intervals. The water level is as at November 1989. The value of the contour lines is relative to the temporary site benchmark

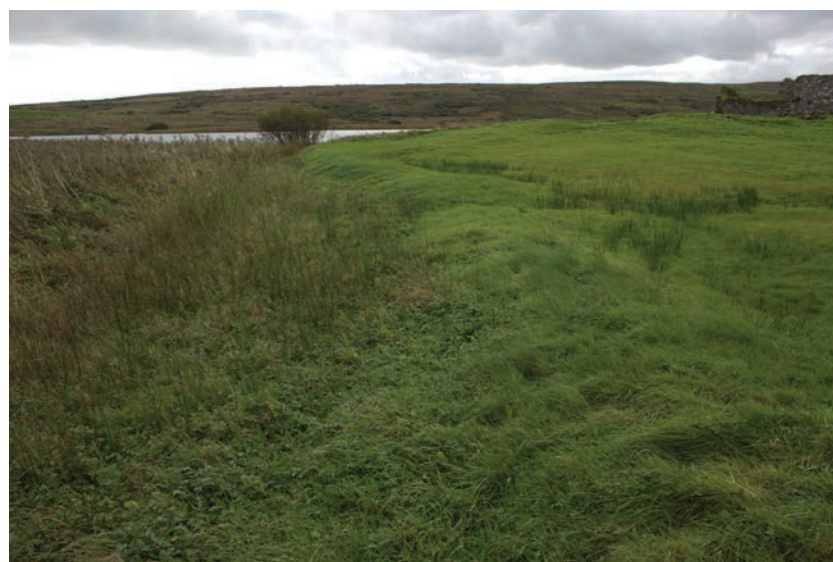
Illustration 6.6

The bank defining the edge of Eilean Mór proper. To the left is the alluvial tail; to the right lazy beds and the chapel

From the tip of the alluvial tail another wooden walkway crosses the marsh to the firmer ground of the island proper, separated by a turf-covered bank, actually the remains of a post-medieval fortification (Illus 6.6). Just outside the turf bank, where it bends from the north-west shore of the island across the base of the alluvial tail, is a low mound which excavation shows is the stub of a gate-tower (Illus 6.7). An earlier means of access is indicated by the remains of a stone causeway visible in the water off the north edge of the alluvial tail. From the end of the wooden walkway a modern path crosses an undulating area of old lazy beds before bifurcating, the left fork climbing to the chapel on the highest part of the island, the right extending down the length of the island to the tip opposite Eilean na Comhairle.

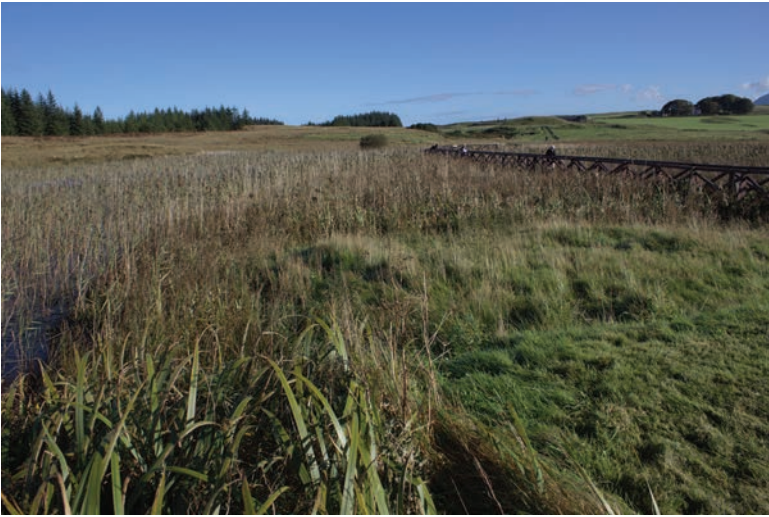
Illustration 6.7

The low mound at the tip of Eilean Mór, representing the remains of a gatehouse; view from within bank across the alluvial tail

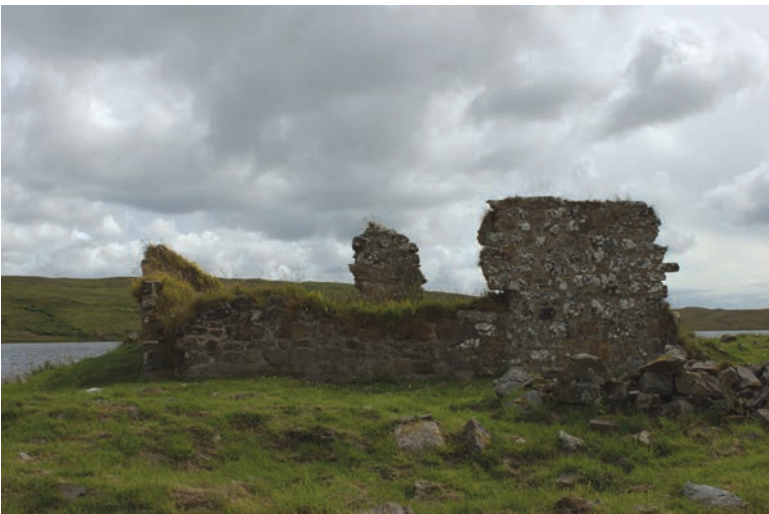
Illustration 6.8

The ruins of the chapel on Eilean Mór (September 2016, after conservation), looking towards its north wall

oriented approximately true east–west (Illus 6.8). It is rectangular, 10.1 by 6.1m, with lime-mortared walls, and is one of only two upstanding ruined buildings on the island. Adjacent to it on the highest part of the island is a level, clear area, readily identified as a burial ground with a square stone base (R), which excavation in trench 1 has shown to be the plinth for a cross. On the sloping ground between the chapel and the lazy beds are the turf-covered ruins of three buildings (T, U and V). Houses T and U have stone walls. House T is oval, about 9 by 6m overall, with its entrance facing downslope. The remains of house U show as a two-roomed structure about 15 by 5.5m. Structure V appears as an embanked hollow, 11 by 7m (Illus 6.9).

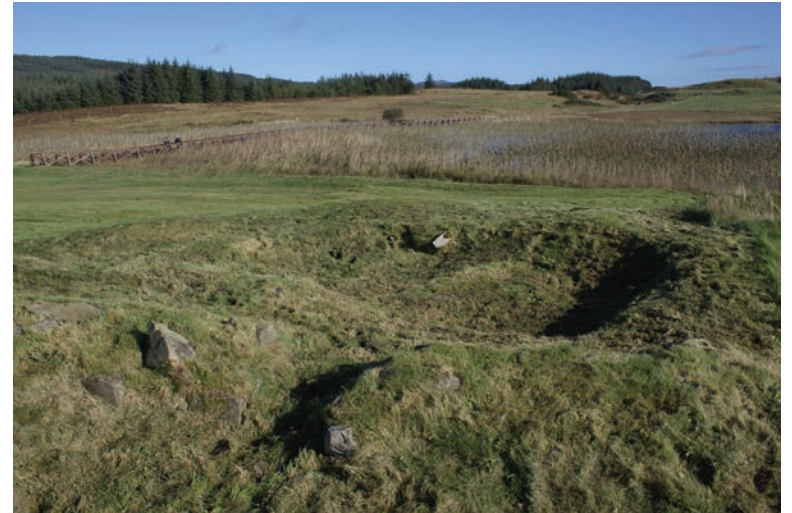
Illustration 6.9

House V with an entrance in house U in the foreground

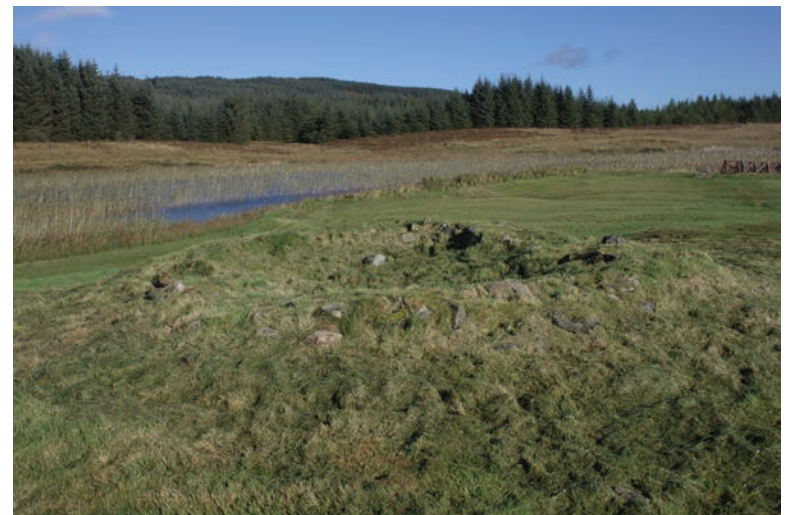
Illustration 6.10

House Y with lazy beds in the background

Sitting over the top of the turf bank defining the west side of the enclosure are the turf-covered ruins of a rectangular stone building (Y), 9 by 6.5m (Illus 6.10), and adjacent to it outside the enclosure, Y1, which appeared to RCAHMS to be a small yard with a dyke enclosing it to the west.

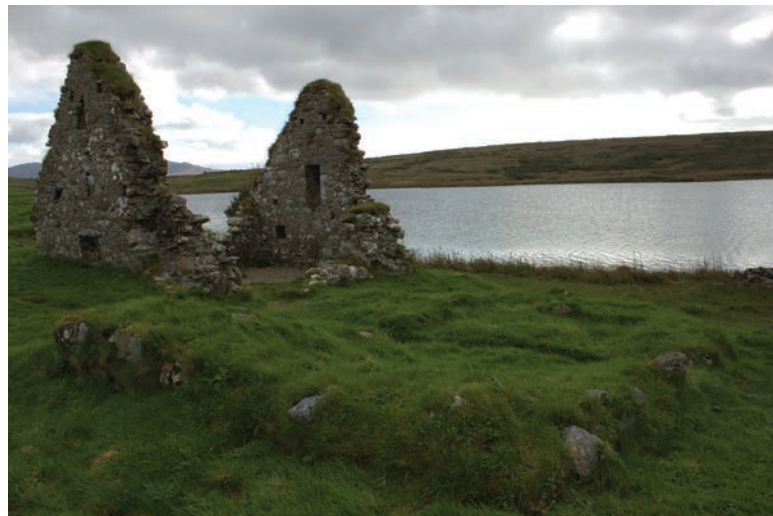
Illustration 6.11

The upstanding gables of house C, with the ruins of house B in the foreground

From the chapel a ridge of relatively high ground extends westwards along the southern edge of the island to the other upstanding ruin, structure C, 7.3 by 6.4m, which appears as two gable ends of lime-mortared masonry (Illus 6.11). Between the chapel and building C is a group of turf-covered ruins, most prominently house F, 10.5 by 7m, with opposed entrances in its long sides (Illus 6.12). Adjacent to F and probably contemporary with it is a small circular stone feature (G), which we now know overlies a medieval cobbled road. It is a kiln, diameter 4m, perhaps for burning lime for building operations rather than for drying corn. Perhaps also of similar date is house S next to the chapel, of similar form to F, 8.5 by 6m.

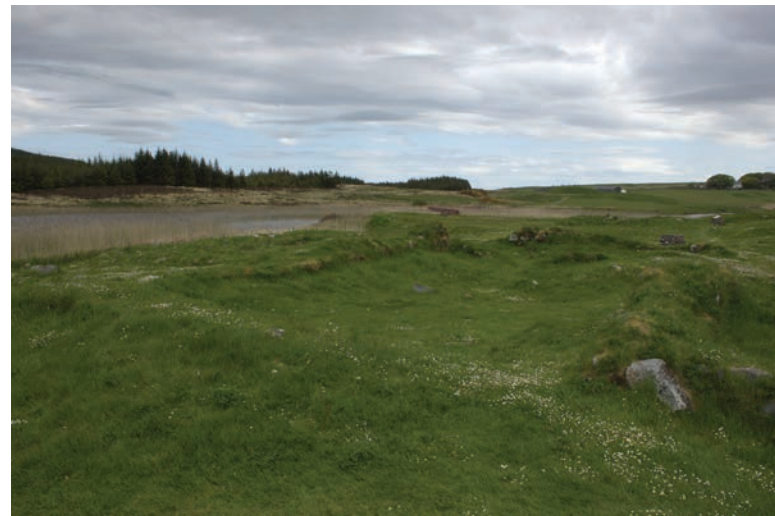
Illustration 6.13

House A, the great hall, with the screens area at the far end

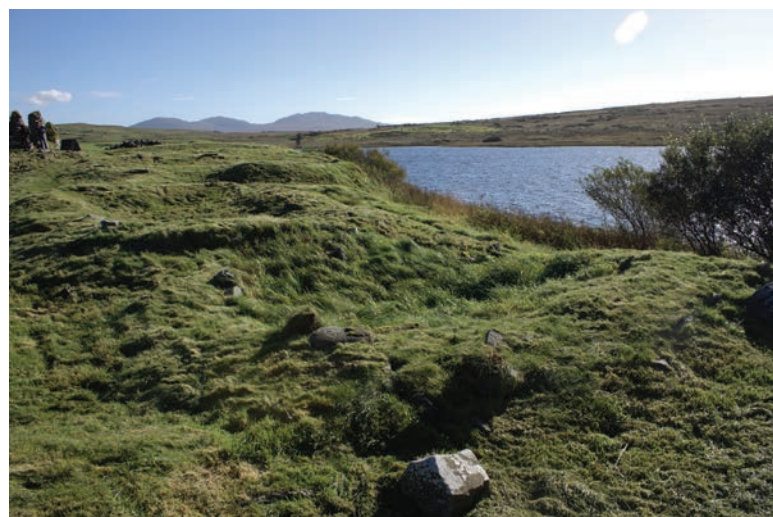
Illustration 6.12

Houses on the ridge of Eilean Mór. The hollow in the foreground is building E; beyond it is house F, sitting over building E, and behind that can be seen a bank topped by house H

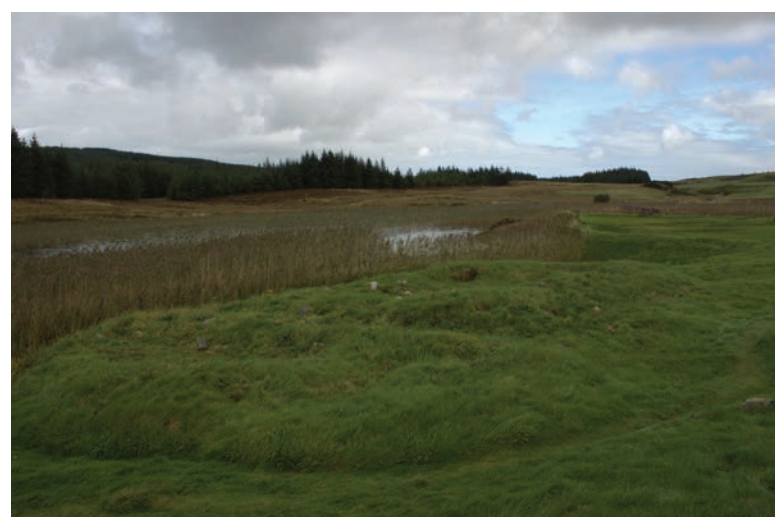
Illustration 6.14

House L with house K behind it

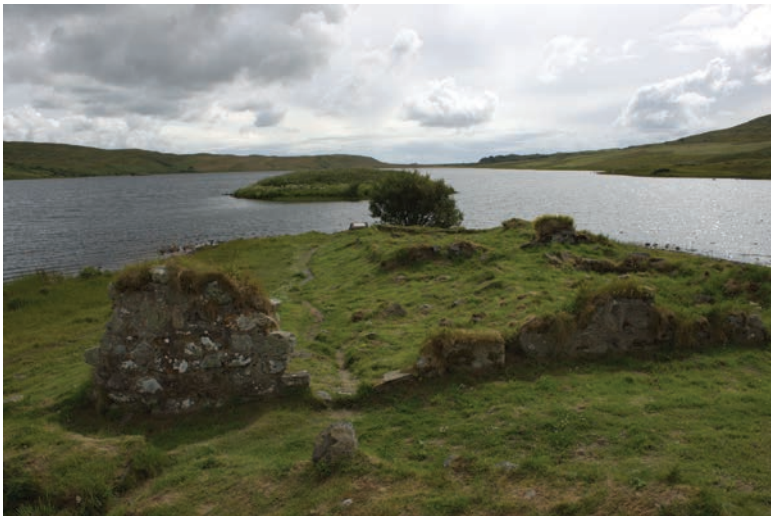
Illustration 6.15  
The cross-wall partitioning off the end of Eilean Mór nearest Eilean na Comhairle, with house P beyond

The end of the island to the west of the great hall is partitioned off by a lime-mortared wall, still partially standing several courses high (Illus 6.15). It shelters a complex of buildings identified by the Royal Commission as the probable residential quarters of the lords of the Isles. The main structure is P, the foundations of a rectangular lime-mortared building with an overall size of 11.5 by 6.8m (Illus 6.15). The construction of two later drystone houses, P.1 and P.2, within its ruins obscured the fact that it was another hall. There are only vestigial remains of structures M and N, two rectangular houses built on to the back of the partition wall. The partition wall extended northwards on to the shore to form a narrow chamber (M.1, Illus 6.16), and another wall also

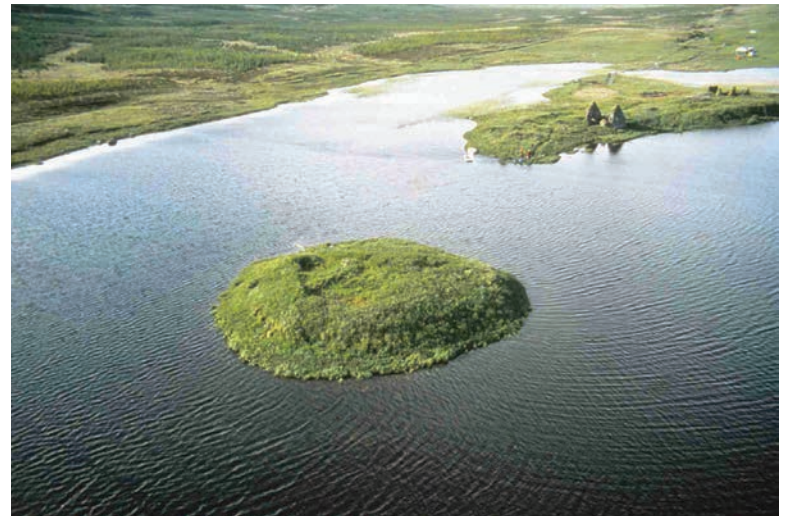
Illustration 6.17  
Aerial view of Eilean na Comhairle

Eilean na Comhairle (English, 'the council island') is circular, 25m in diameter, rising to a height of less than 3m above water level, and lies some 45m to the south-west of Eilean Mór (Illus 6.17, 6.18). Because it is not normally accessible it is in summer clothed with a dense crop of long grass, nettles, thistles, etc, masking the ruins of three structures on its summit. The remains of a stone causeway connecting the two islands lie under the water. There is a 6m length mid-channel resting on a bare rock

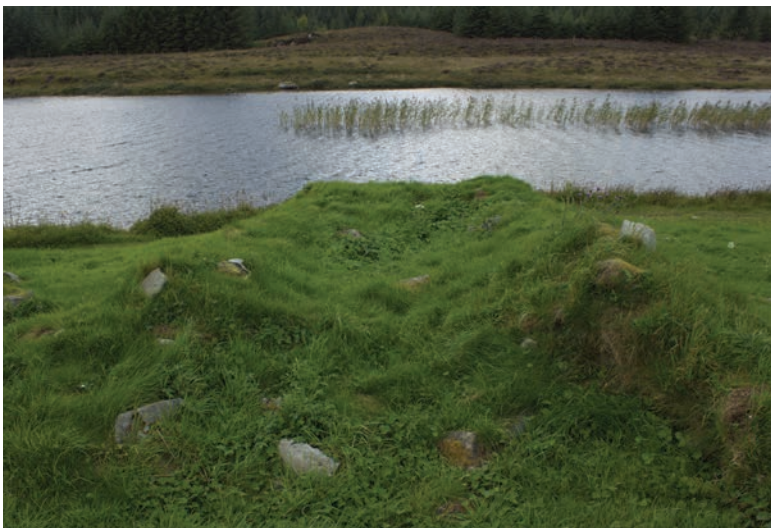
Illustration 6.16  
Structure M.1

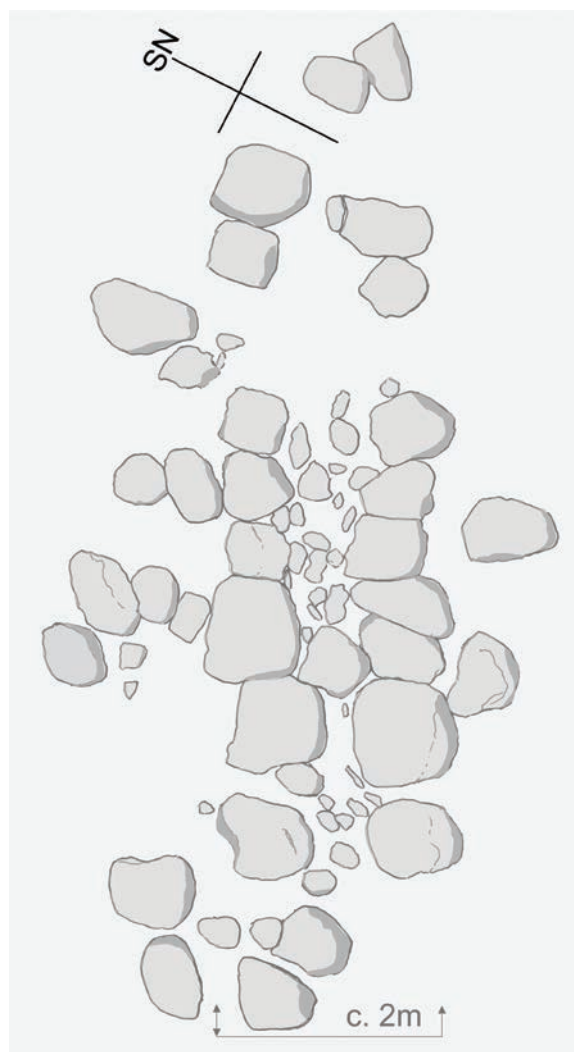
Illustration 6.19

Surviving underwater stretch of the causeway between Eilean na Comhairle and Eilean Mór, drawn from an image taken from a drone; scale approximate

platform, with some of its stones scattered on either side. It is about 2m wide and is composed of large sub-rounded boulders, defining the two sides, with smaller stones packed in the narrow space up the middle (Illus 6.19). Only one course is evident but to have been an effective means of crossing the water dry-shod there may have been at least one other, and in places more courses.

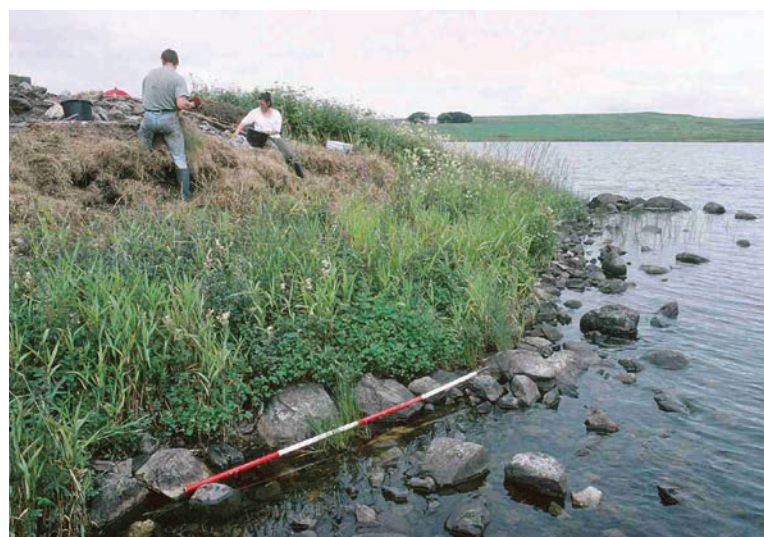
Illustration 6.20

Eilean na Comhairle, boulders round edge. Work in trench 23 in the background

The perimeter of Eilean na Comhairle from the jetty on its northern edge round anticlockwise to the jetty on its southern margin is composed of boulders and blocks of stone, some laid, some collapsed, but all the result of human activity (Illus 6.20). The remaining segment of shoreline adjacent to Eilean Mór is composed of silts and gravels. They form an apron extending underwater for a distance of about 6m before slipping down more steeply into a weedy channel with a silty floor. On this apron the depth of water is normally not any more than half a metre, with the channel reaching a depth of 1.5m (Illus 6.18). The apron appears to result from two processes, the natural creation of an alluvial tail in the lee of the island and the accumulation of midden material dumped here by the occupants in the past.

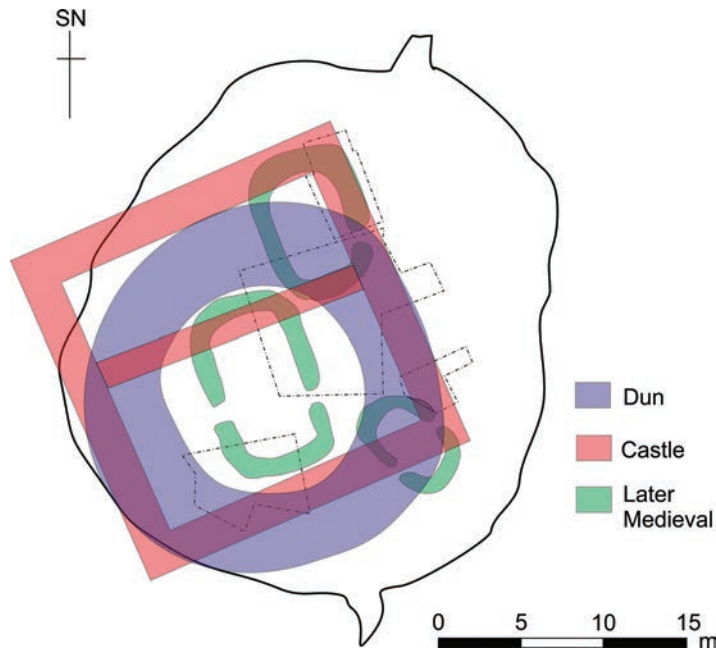
Illustration 6.22  
Eilean na Comhairle, composite interpretative plan

It was only as a result of our excavations that it became clear that much of the island consists of the ruins of a dun with massive drystone walls. Although only a very small part of this was exposed in our excavations, essentially in trench 23, it was possible to use this information, along with other observations of the island surfaces, both on the ground and from examination of aerial photographs, to interpret a circular fort with an overall diameter of about 20m. Its walls seem to survive for a height of up to 2m around much of the island. The dun was levelled and infilled with rubble in order to act as a platform for the castle, the presence of which had also been unsuspected. It in turn was flattened, but some of its walls remained in a reduced state to support houses (a) and (b).
