The Archaeology of Finlaggan, Islay

The Archaeology of Finlaggan, Islay: Excavations at the Centre of the Lordship of the Isles, 1989–1998

By David H Caldwell

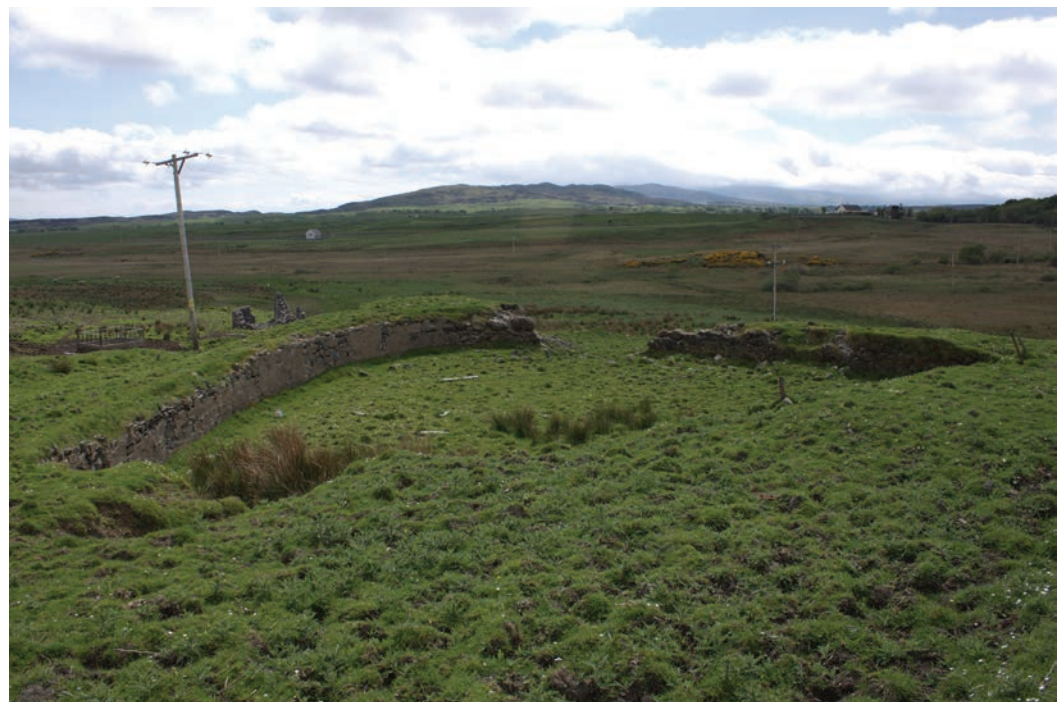
Illustration 4.14
The reservoir for storing water, at the washings, Mulreesh

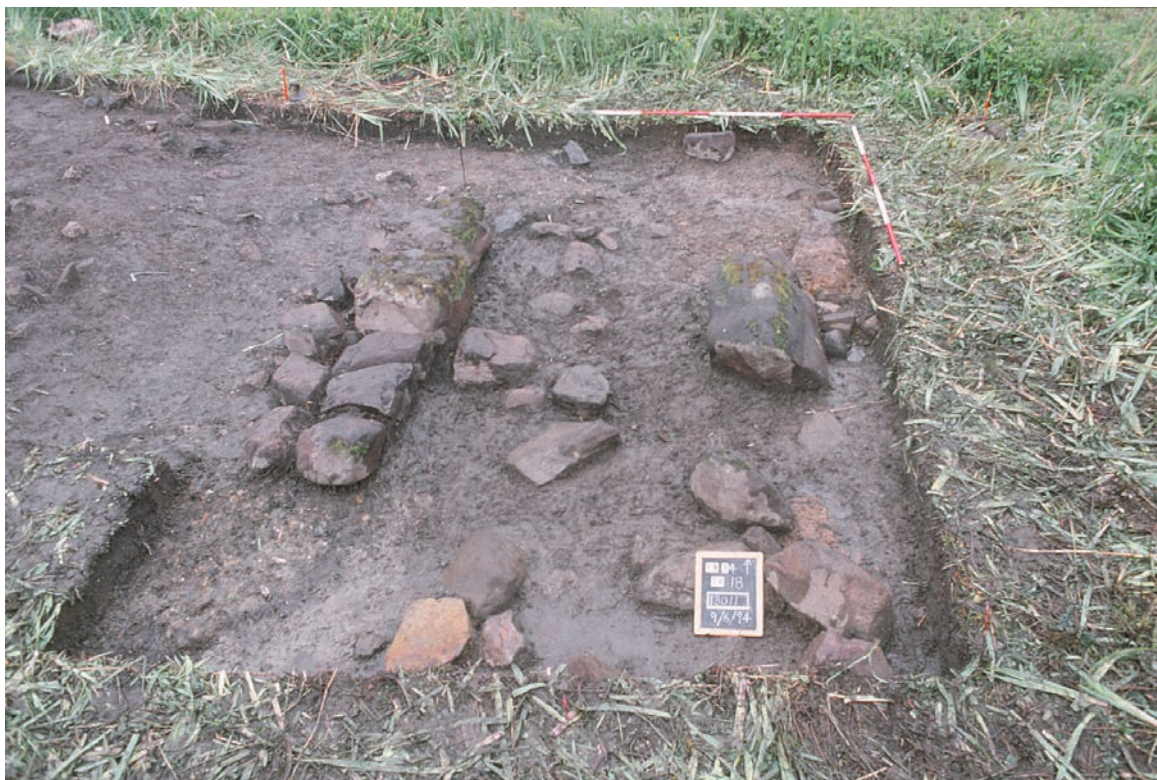
Trench 18, view of the two stone supports for a bridge providing access to the gatehouse

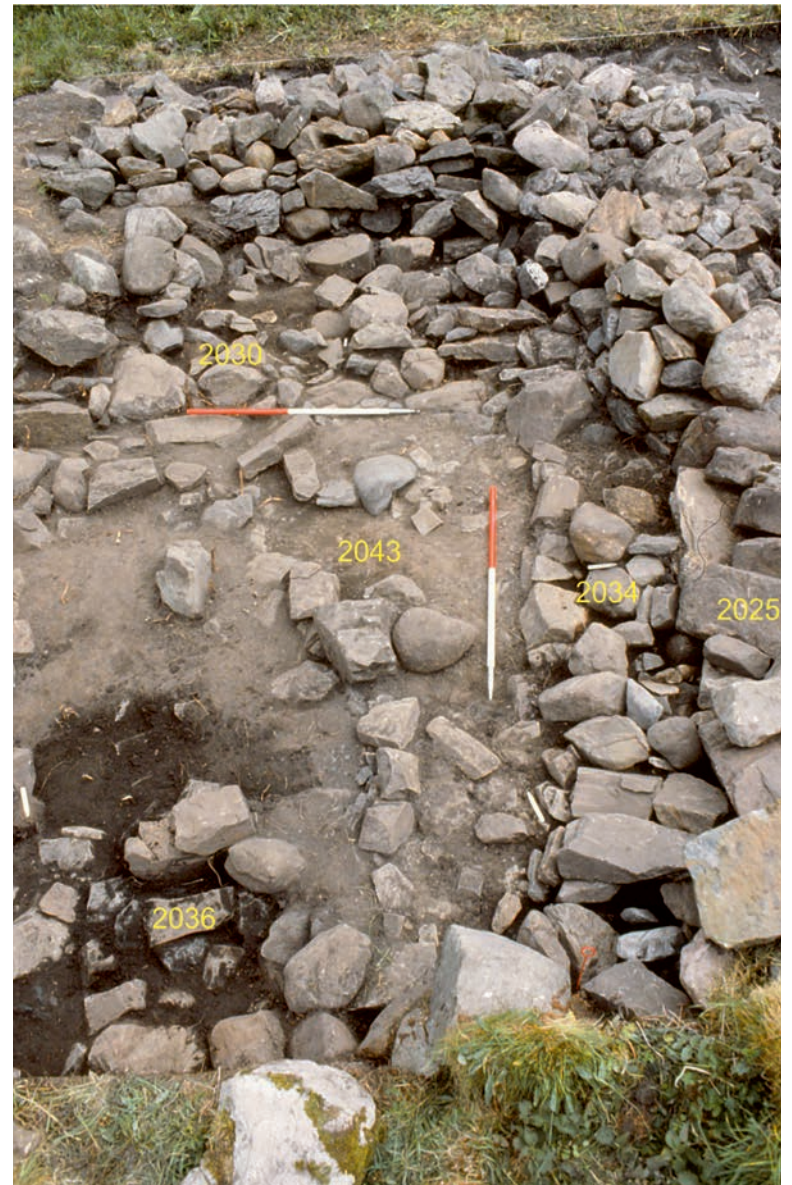
Illustration 12.15
Trench 2, looking east. The ranging rods are positioned in front of the faces of walls 2030 and 2034 of structure K.1. Later and earlier features are also visible in this view

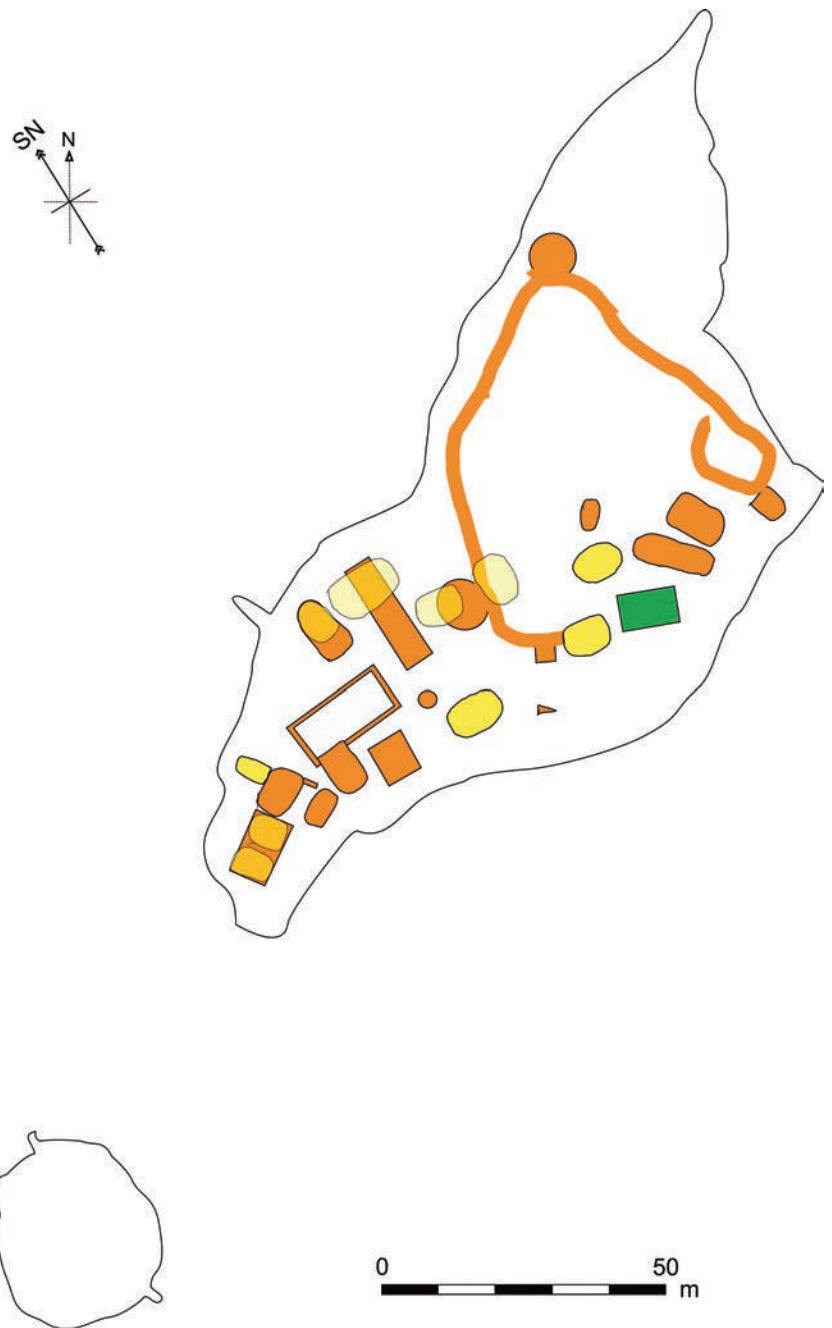
Illustration 14.13
Composite interpretative plan of post-medieval structures on Eilean Mór
