Bearsden

A Roman Fort on the Antonine Wall

David J Breeze

THE EXCAVATIONS

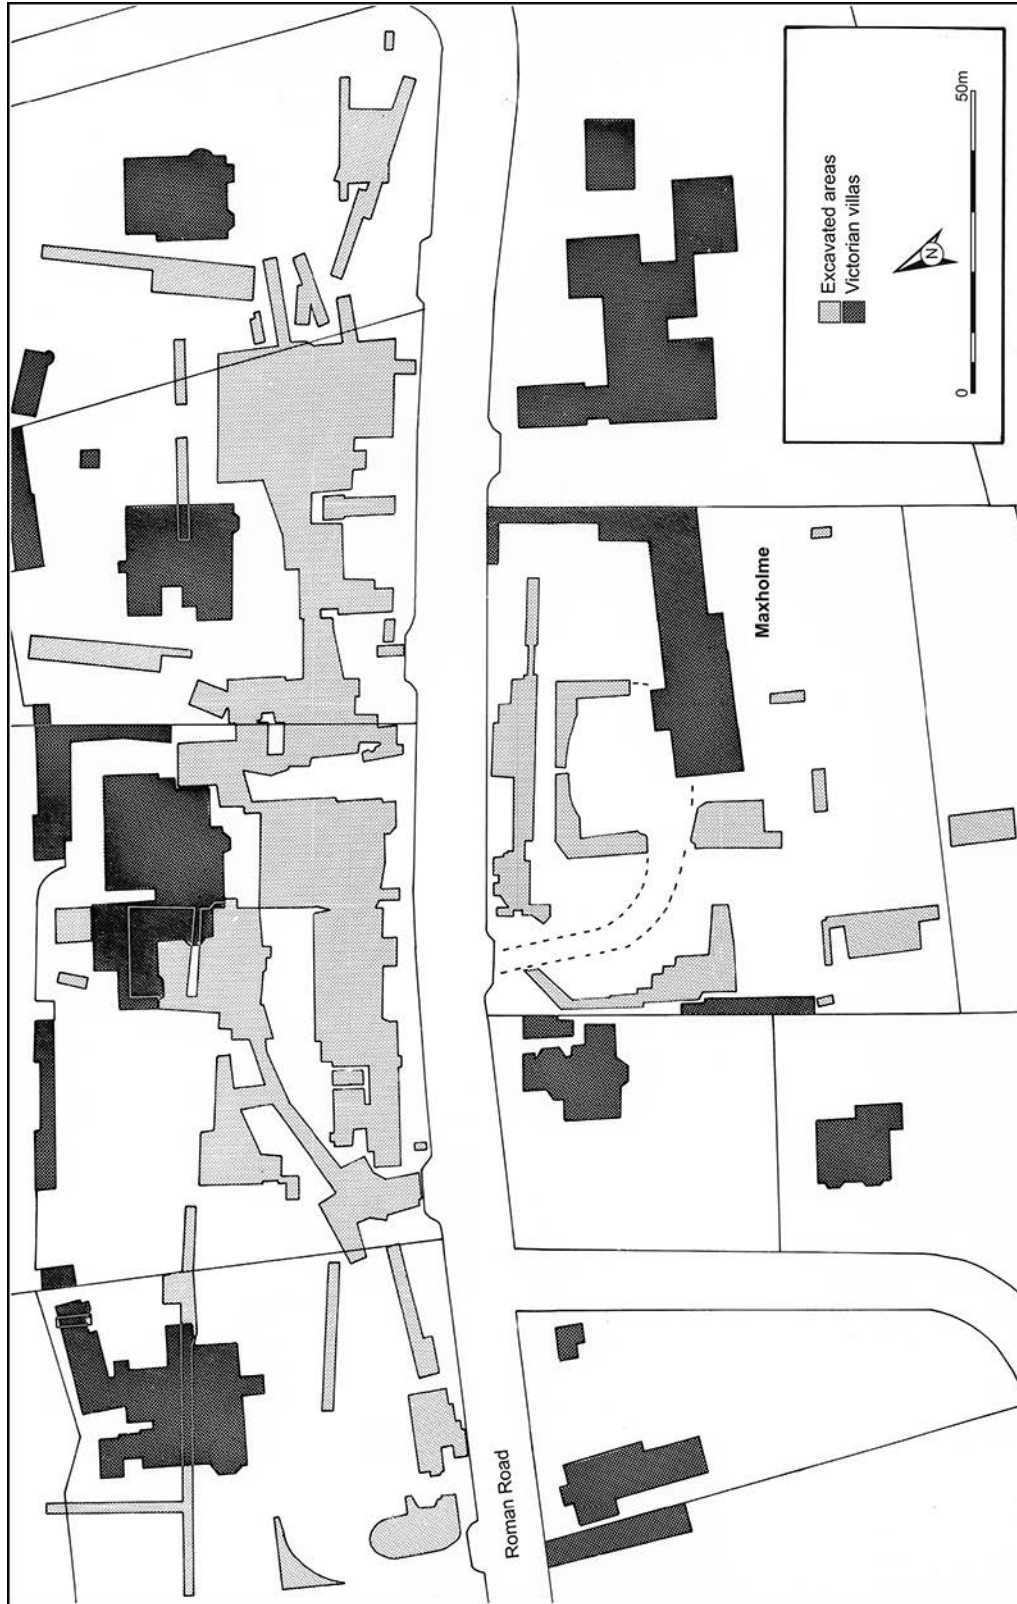
Illustration 3.0.1
The excavated areas in relation to the features existing in 1973.

A total of 5,000m² (0.5 ha = 1.25 acres) of the fort, the annexe and areas outside the defences were subjected to archaeological investigation over the ten seasons, 1973–82 (illus 3.0.1). The area of the fort and annexe as measured over the rampart is 16,000m², and over the ditches 17,680m², so the area excavated represents the equivalent of rather less than one-third of the military enclosure. The main areas unexamined were the south-western part of the fort and the southern half of the annexe. Subsequently, evaluations and rescue excavations took place in the latter area; the work usefully provided an additional line for the rampart between the fort and the annexe but otherwise reported only insubstantial remains (Duncan & Leslie 2003; Will & Sneddon 2010; Becket 2012).

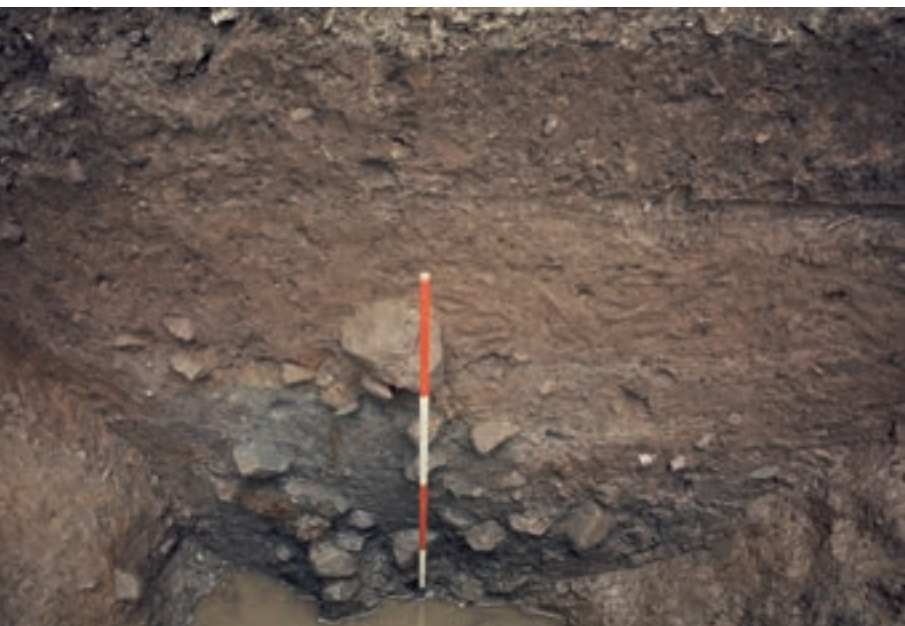
Illustration 3.2.2
The north ditch section looking west.

wide (illus 3.2.2 and 3.2.7). Opposite the east rampart of the fort it had widened to 7.2m (section F-F), and north of the east annexe ditches to 8.3m (illus 3.2.7). The profile revealed an irregular slope of about 45° on the south, with a rather steeper slope to the north; the ditch was a little over 2.5m deep. At the bottom of section E-E lay a deposit of 'organic' material (illus 3.2.2 and 3.2.7). Elsewhere this overlay a deposit of fine grey silt. It seems possible that the position was the same in this trench, but here the silt was not recognised owing to the difficulty of distinguishing it from the natural clay into which the ditch had been excavated and from which it had come. The u-shaped profile may therefore be false: it is possible that the profile should be V-shaped, as in section D-D. Over the 'organic' deposit lay silt of varying colours and consistencies, generally coarser than the fine silt usually accumulated in the bottom of the ditches. The silt merged into brown loam, and over this lay Victorian infill.

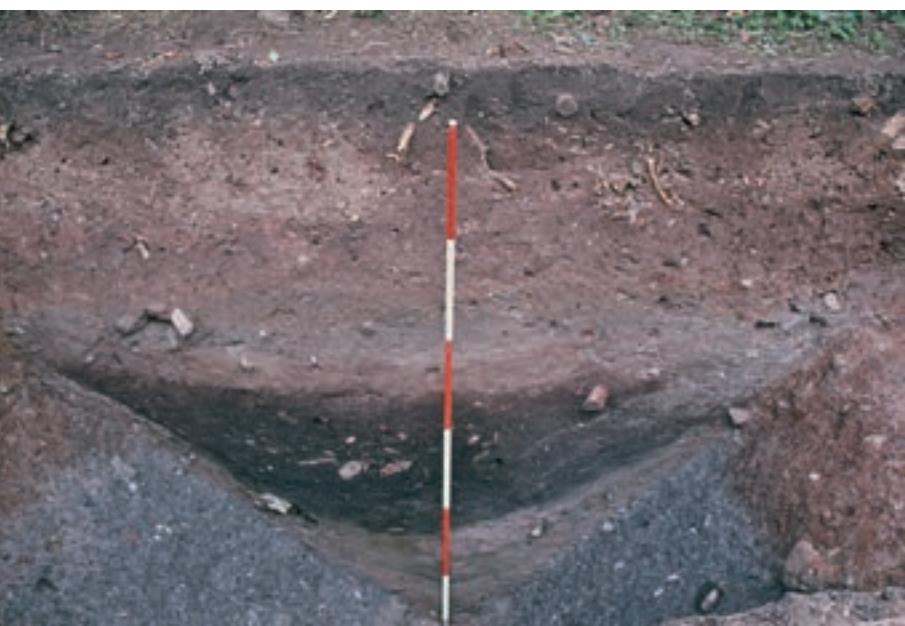
Illustration 3.2.3
The outer west ditch looking south.

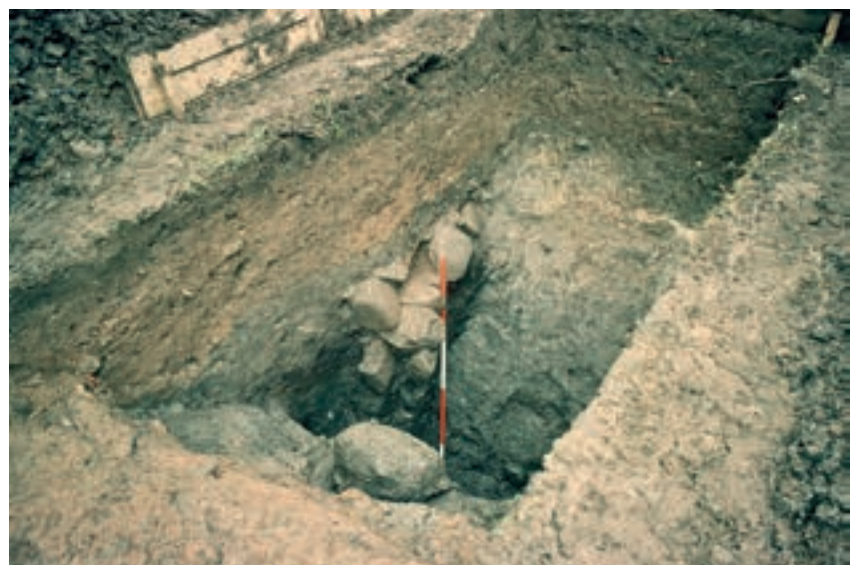
Illustration 3.2.4
The outer annexe ditch looking south.

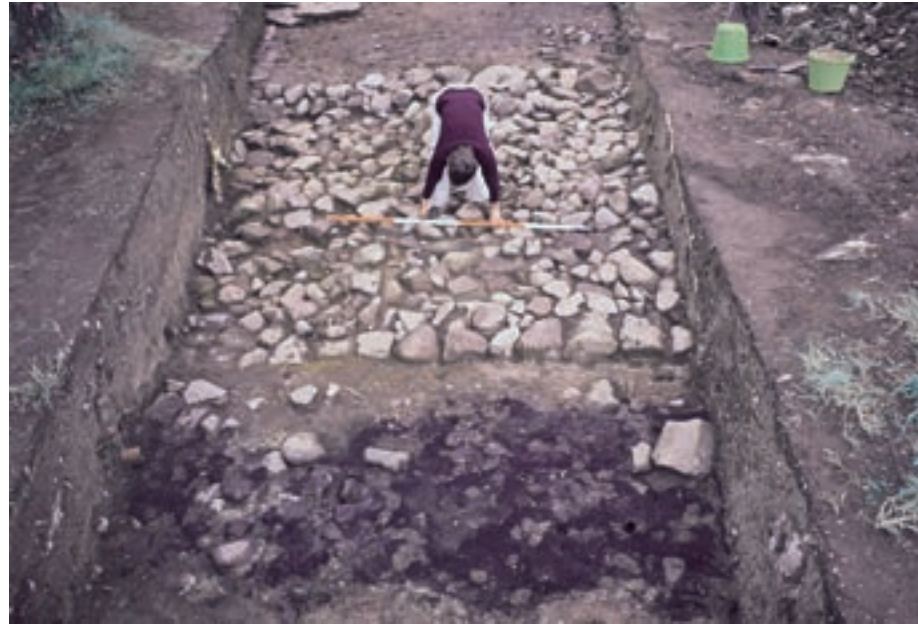
Illustration 3.2.15

The rampart base between the fort and annexe north of Roman Road with the area of burning to the east, looking west.

rampart. It was up to 120mm thick and about 1.5m wide (illus 3.2.15 and 3.2.16). Analysis of this material demonstrated that it contained willow, alder and hazel branches, 10mm to 15mm in diameter (13.8). A small amount of fallen turfwork overlay the burning. At one point, immediately north of Roman Road, a fragment of wood lay parallel to the rampart, but it was very soft and proved impossible to lift (3.2.17).

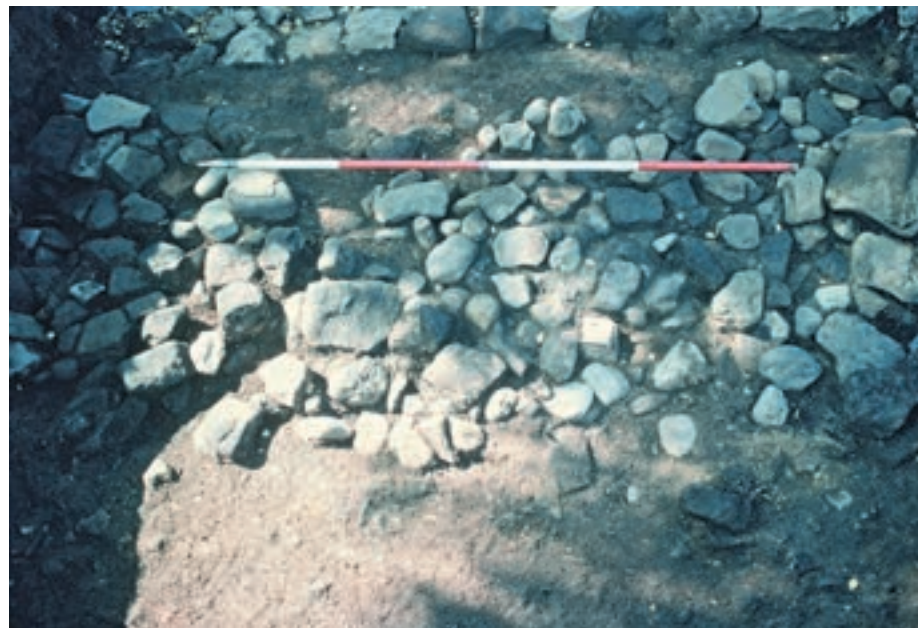
Illustration 3.2.16

The cobbling under the burning north of Roman Road.

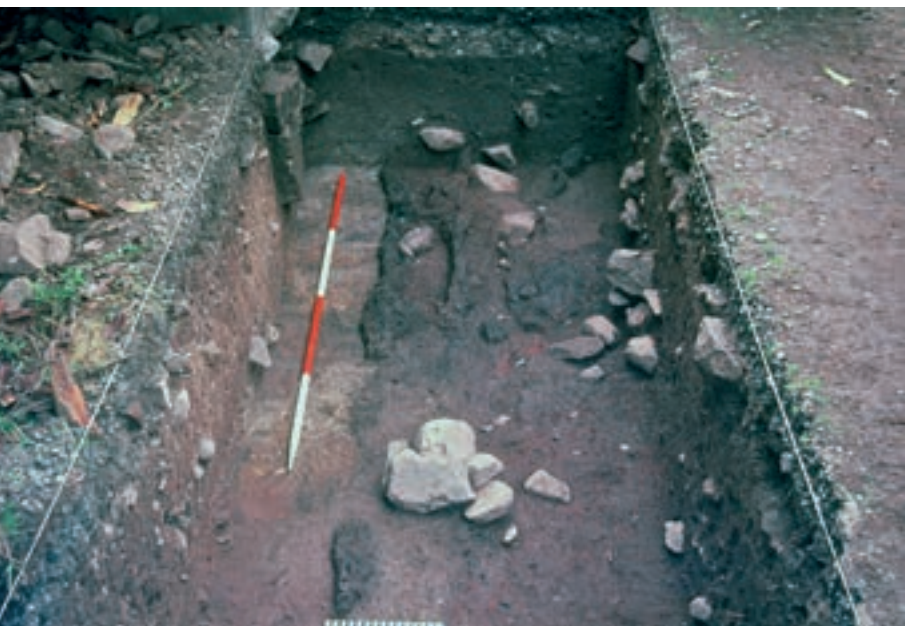
Illustration 3.2.17
Turf and wood of the fort/annexe rampart.

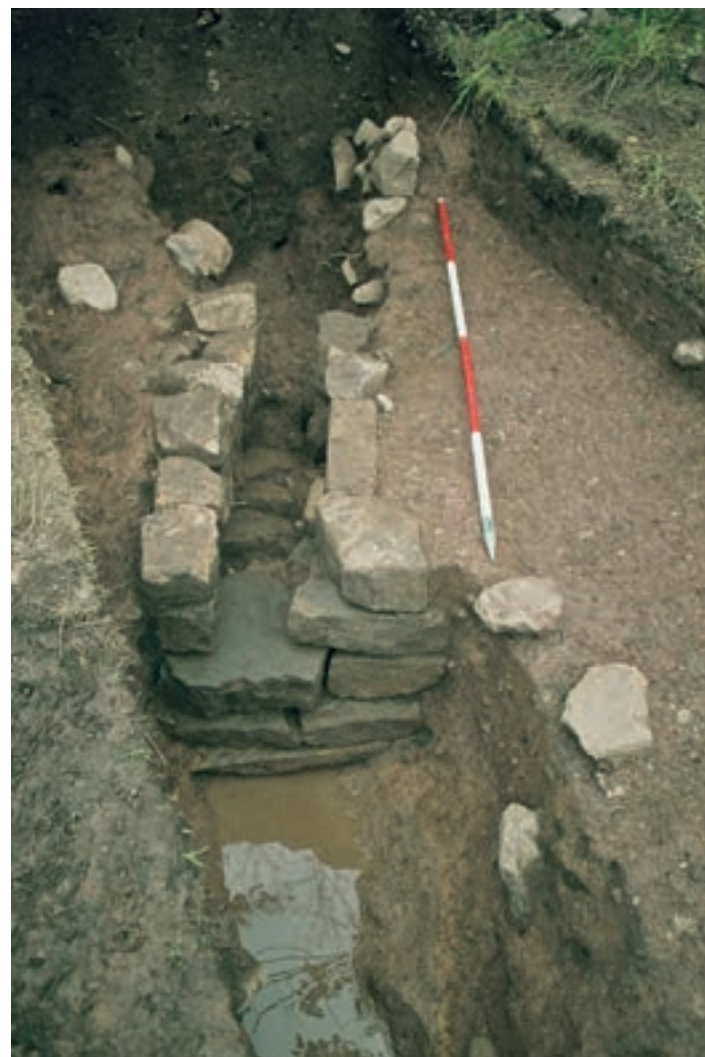
Illustration 3.2.18
The outfall of the drain through the east annexe rampart east of the primary bath-house.

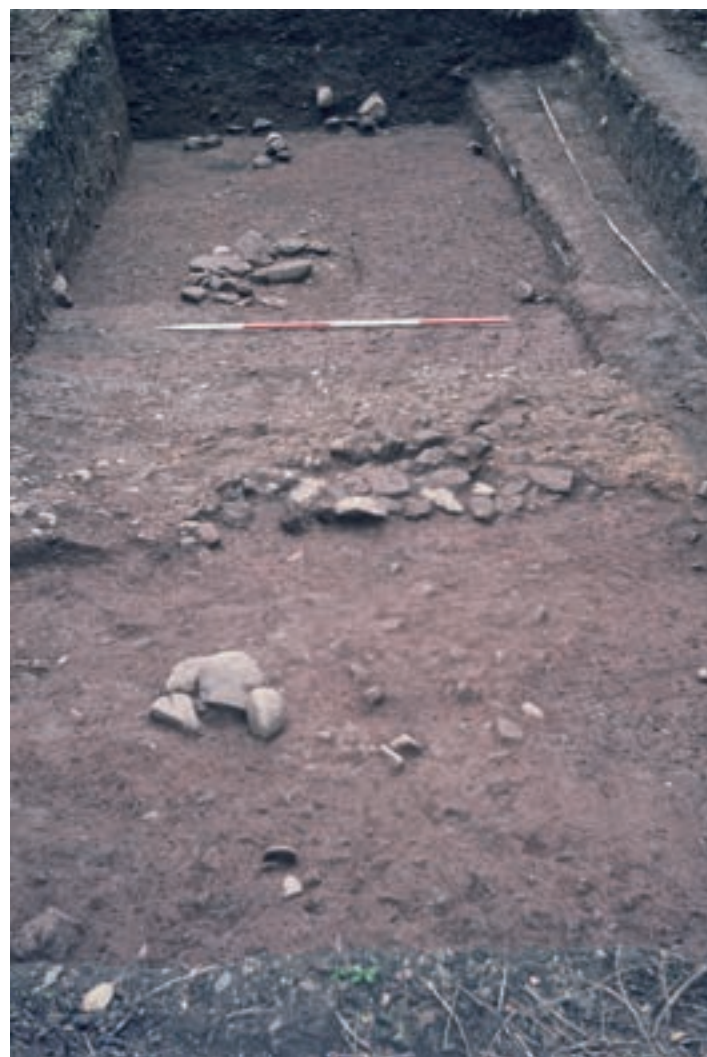
Illustration 3.2.25
The path between buildings 6 and 7 looking south.

Minor roads, or paths, were noted between several buildings. One left the intervallum road approximately at a right angle to pass between buildings 6 and 7 (illus 3.2.21; 25). It was traced for 11m, and was up to 1.7m wide. Another lay along the south side of building 7, and was also about 1.7m wide. A third lay between buildings 3 and 4, and consisted of a lightly metalled path up to 2m wide.

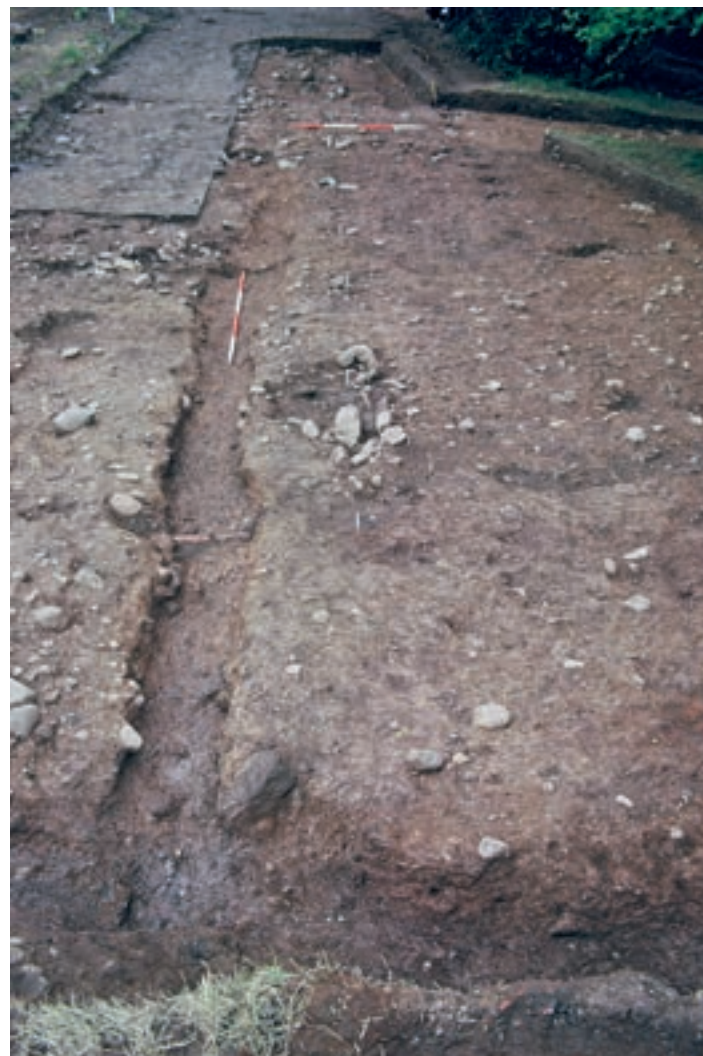
Illustration 3.2.29
The west end of building 1 looking east.

A timber building measuring externally 36.2m × 4.4m, except for the east wall which could be no longer than 4.05m (illus 3.2.27; 3.2.28 and 3.2.29). The posts were from 1.7 to 2.3m (average 1.9m) apart, and with no internal partitions found in spite of a considerable part of the building being examined. No internal floor survived. A gully, probably always open, ran along the north side of the building, and flowed westwards into another gully passing down the west side of buildings 1 and 2. Fragments of a drop hinge were recovered from the gully (11.3.3.100). A coin of Trajan was found at the western end of the building (12.3).

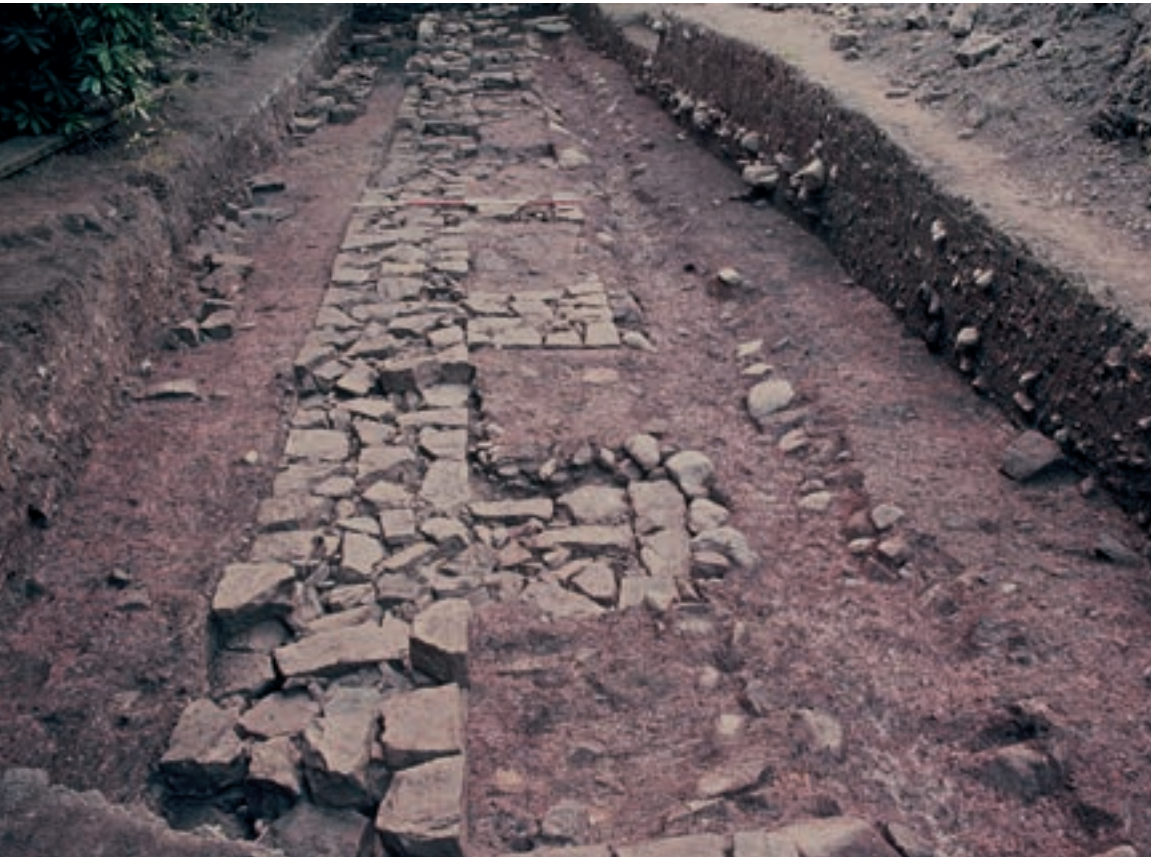
Illustration 3.2.34
The north wall of the north granary looking west.

The buttresses, placed at intervals varying from 1.3m to 1.65m along the north wall, ranged in width from 880mm to 1m and in length from 780mm to 1m. In the three spaces between the four western buttresses were vents through the wall (illus 3.2.36). These vents, 100mm–140mm wide, started above the second course up and were at least three courses high. Both walls and buttresses were placed on clay and cobble foundations. The foundations of the walls were two cobbles deep, bonded with soft grey clay, while the foundations of the buttresses were three cobbles deep (about 200mm and 350mm respectively). Masons' chippings, mixed with soft grey clay, extended halfway up the second course above the foundations both inside and outside the building, and over this lay a layer of hard reddish-brown clay approximately 100mm thick.

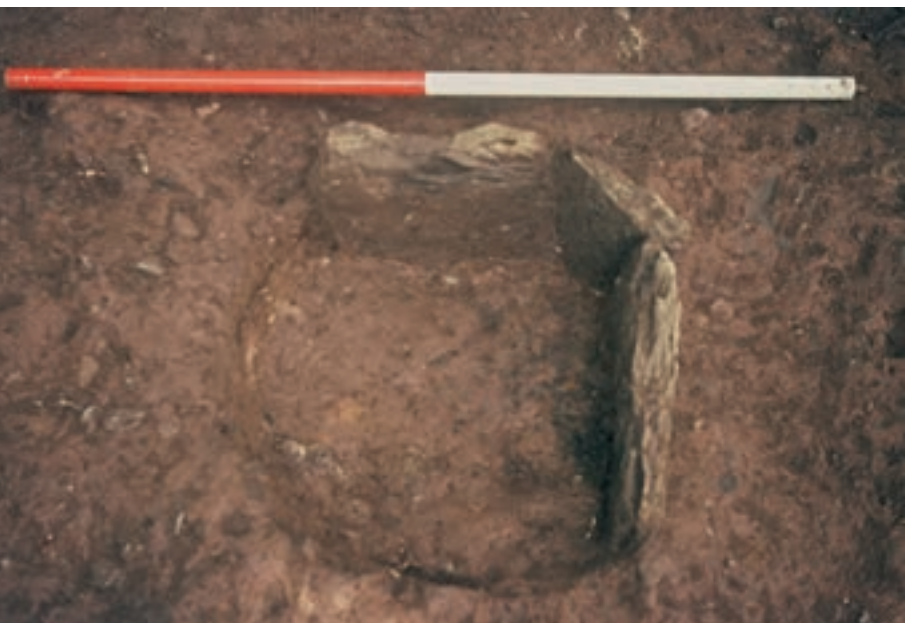
Illustration 3.2.39
The hearth at the east end of building 5.

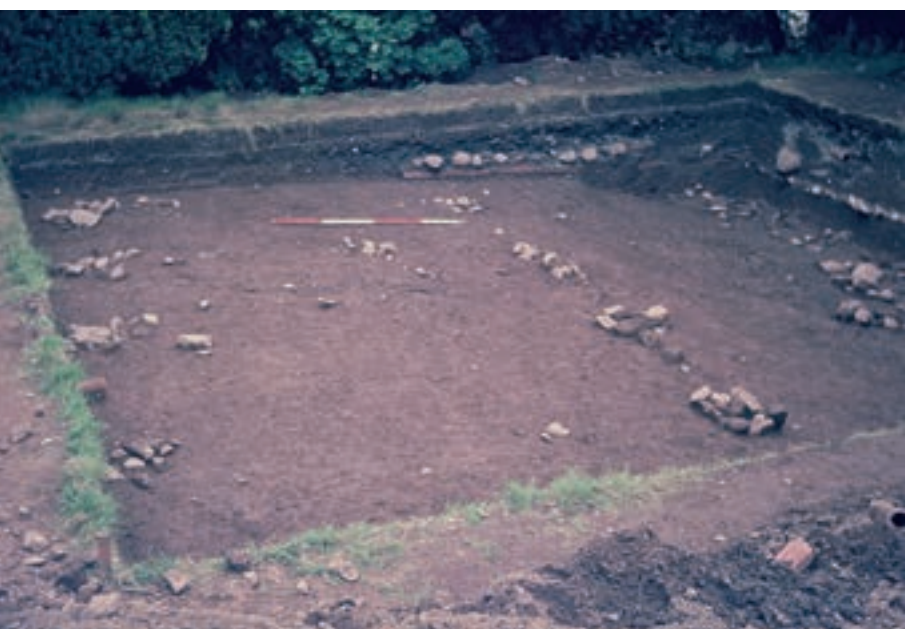
Illustration 3.2.40
Part of building 7 looking south-west.

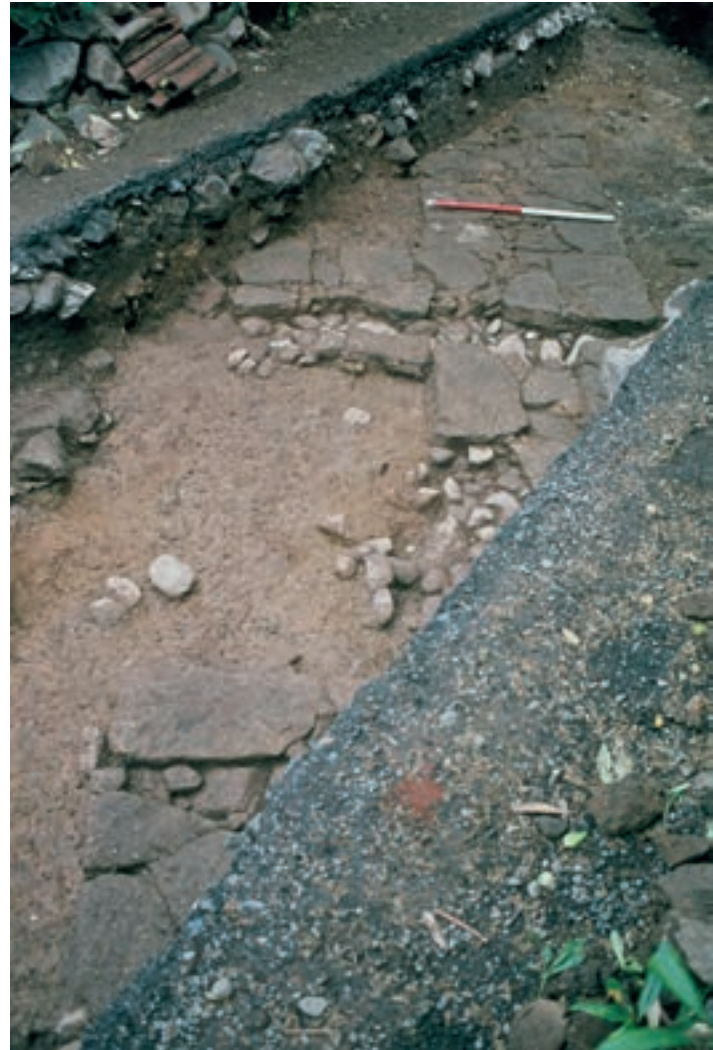
Illustration 3.2.41
The south granary looking south.

A stone building, only partially examined, and calculated as measuring 22m north-south by 5.5m east-west, excluding the buttresses (illus 3.2.42). The building was only located at two points, the south-east corner and the middle of the east side, in both places a buttress being revealed (illus 3.2.41). The east

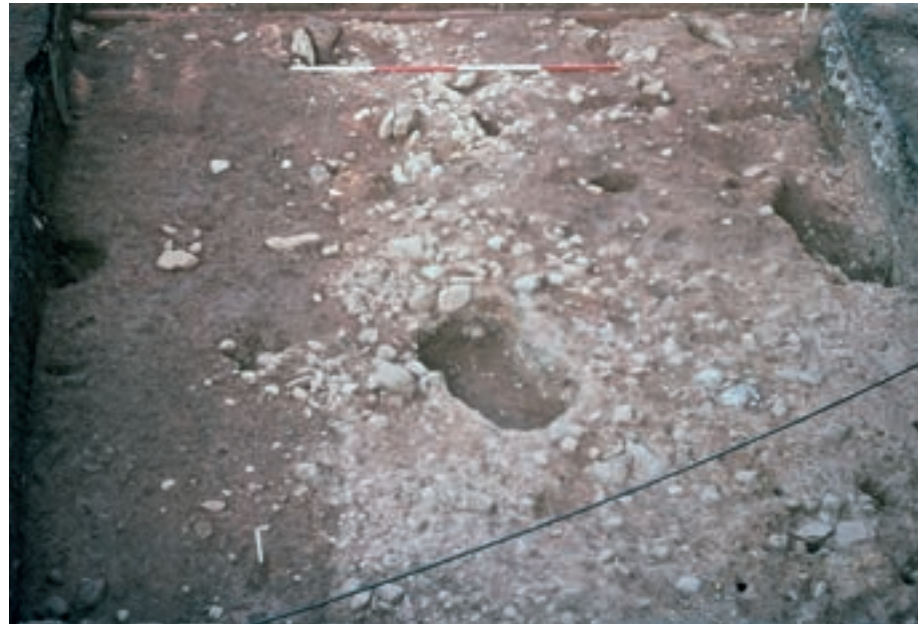
Illustration 3.2.47

The *via decumana*, following the removal of the burning, with the post-holes of building 14 beyond, looking west.

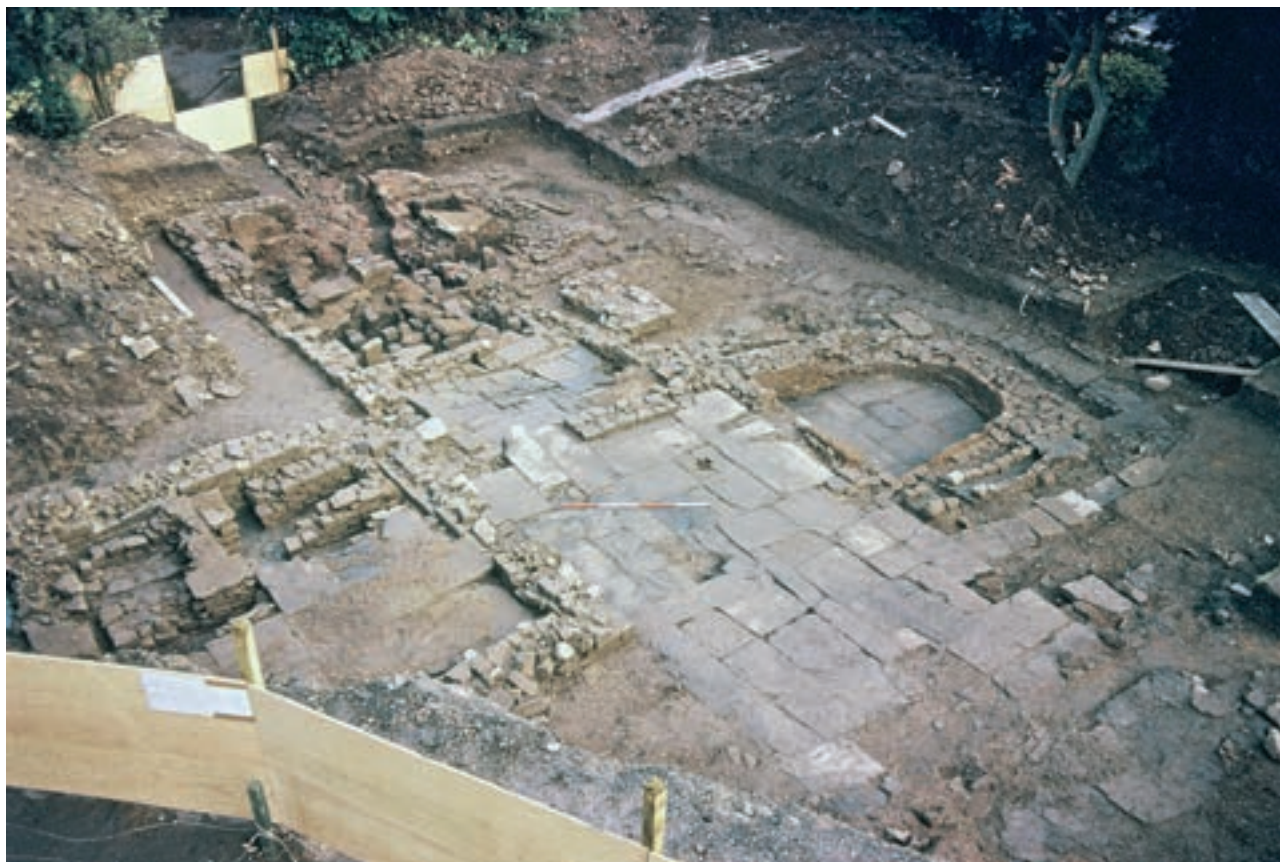
Illustration 3.3.1
A general view of the bath-house in 1973 looking south-east.

This lay north of the cold room. It was almost square, measuring internally 4.75m × 4.25m (illus 3.3.1, 3.3.48 and 3.3.49). The walls

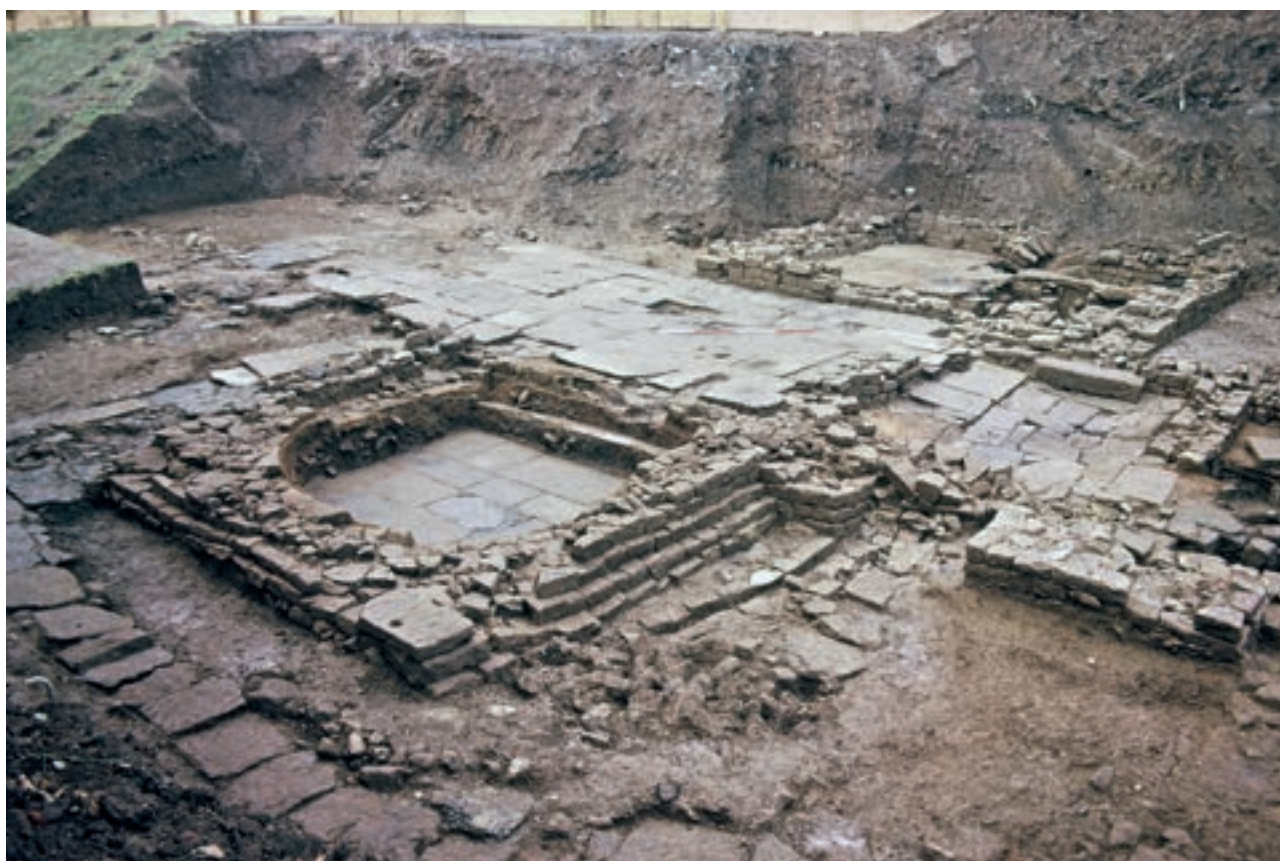
Illustration 3.3.2
A general view of the bath-house in 1973 looking north-west.

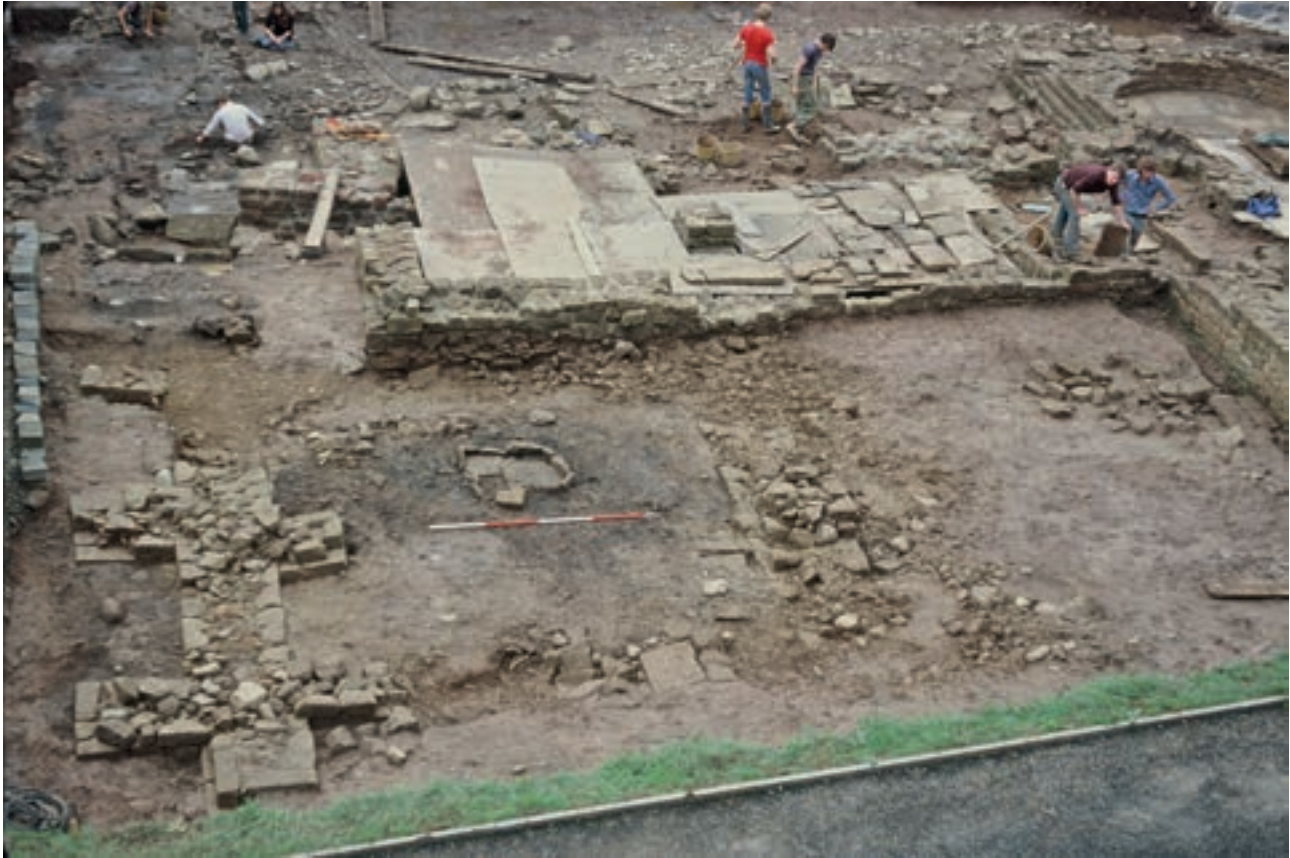
Illustration 3.3.10

The primary bath-house looking south showing the burning around the hearth.

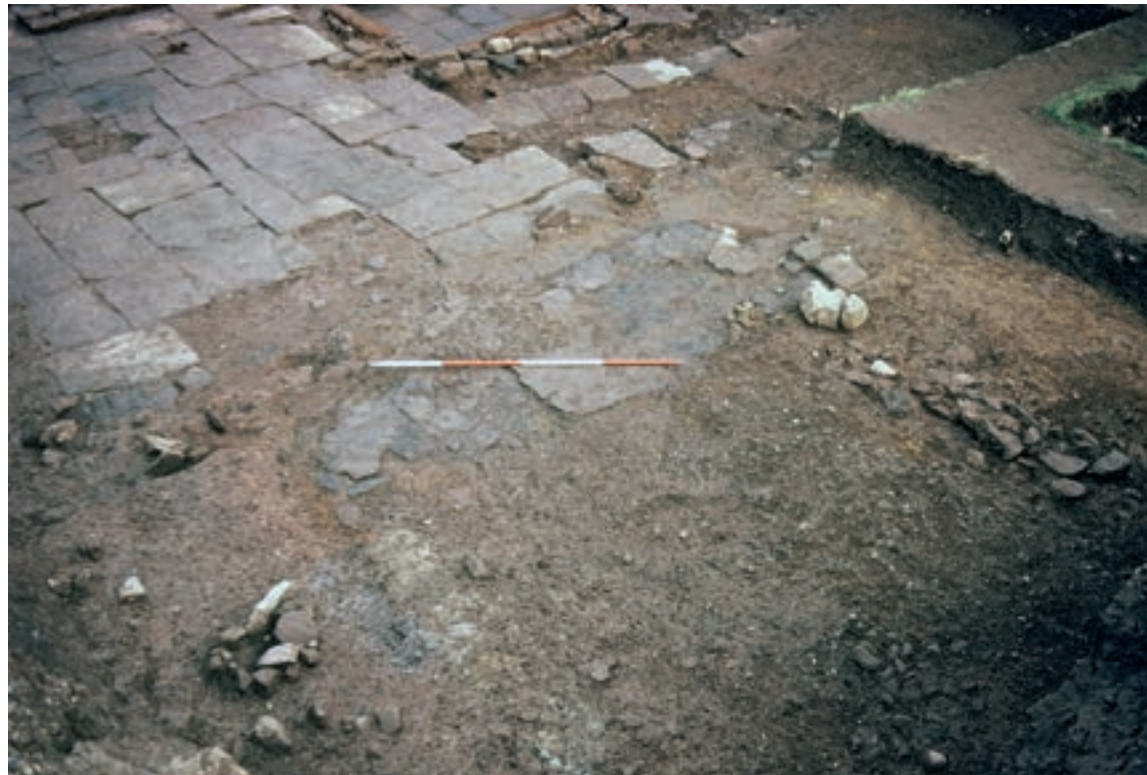
Illustration 3.3.12

The changing room in 1973 with the flags beside its eastern wall, and the flags of the cold room beyond.

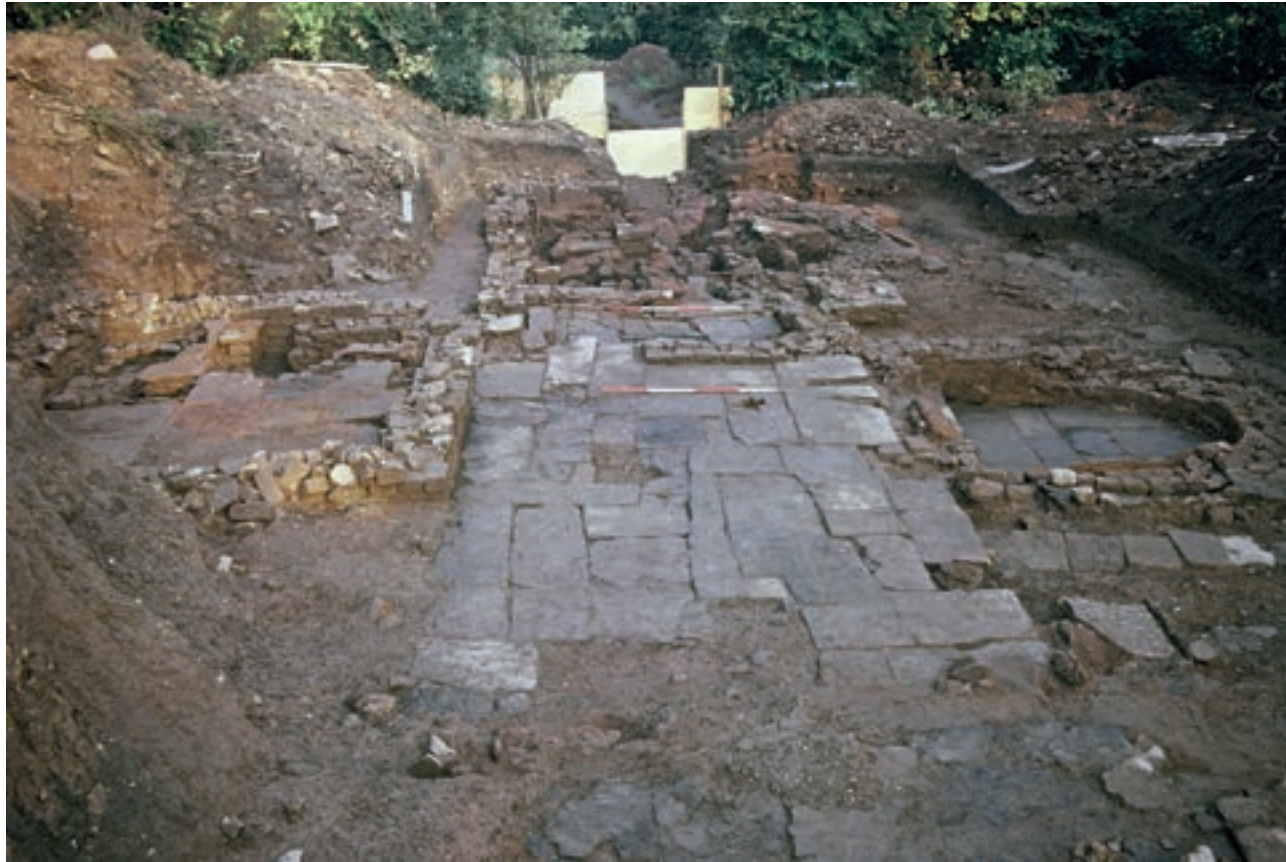
Illustration 3.3.15
The west end of the bath-house in 1973 looking north-west showing the changing room, cold room, cold bath and hot dry room.

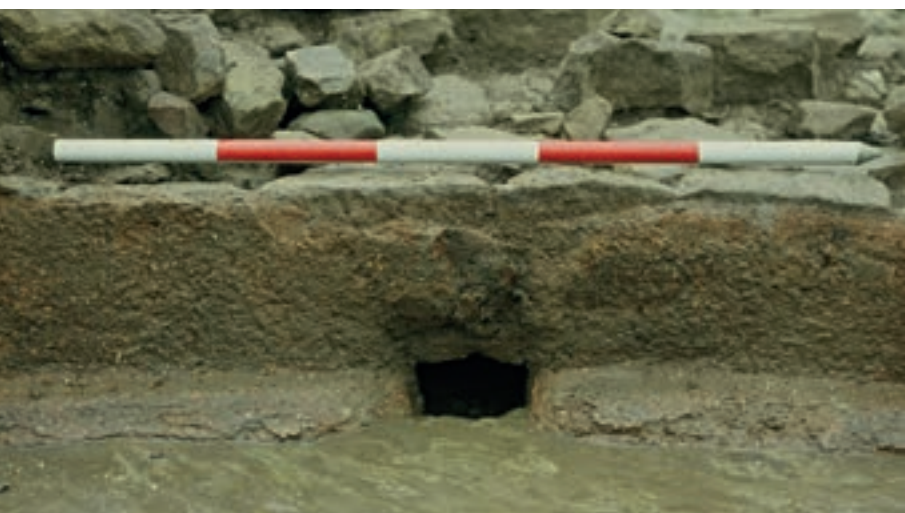
Illustration 3.3.23
The cold bath in 1980, detail of the outlet.

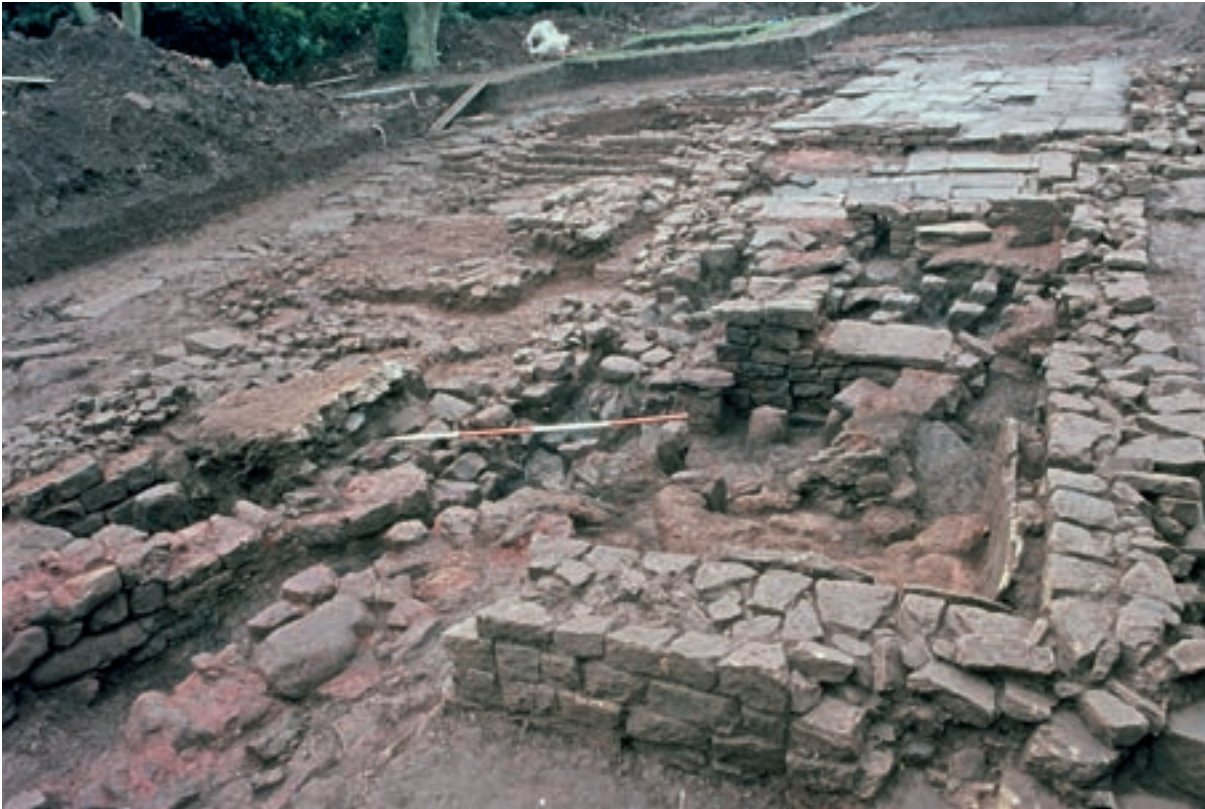
Illustration 3.3.24

The heated range in 1973 looking west with the hot room in the foreground with its furnace to the left, the two warm rooms, cold room and cold bath (far left) beyond. The wall-jacketing is in position in the hot room while a bench end stands in the second warm room with the seat lying beside it.

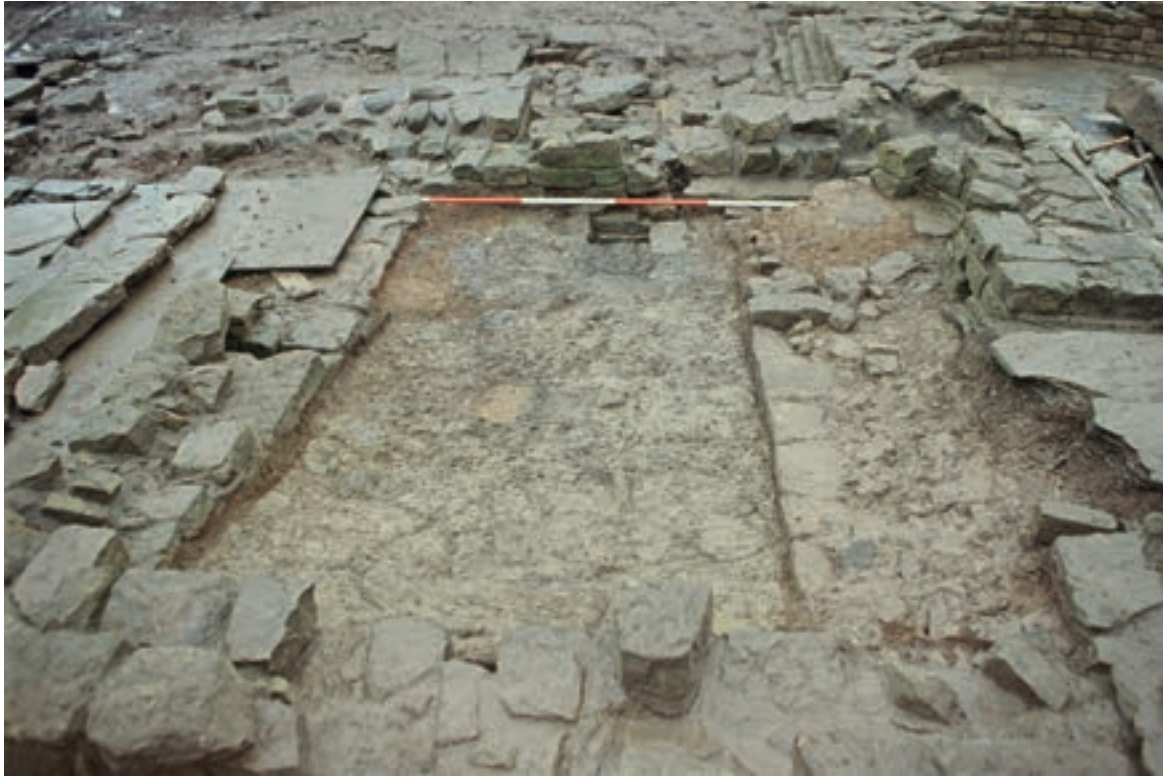
Illustration 3.3.31

The first warm room following lifting of the flag floors showing the clay fill looking south.

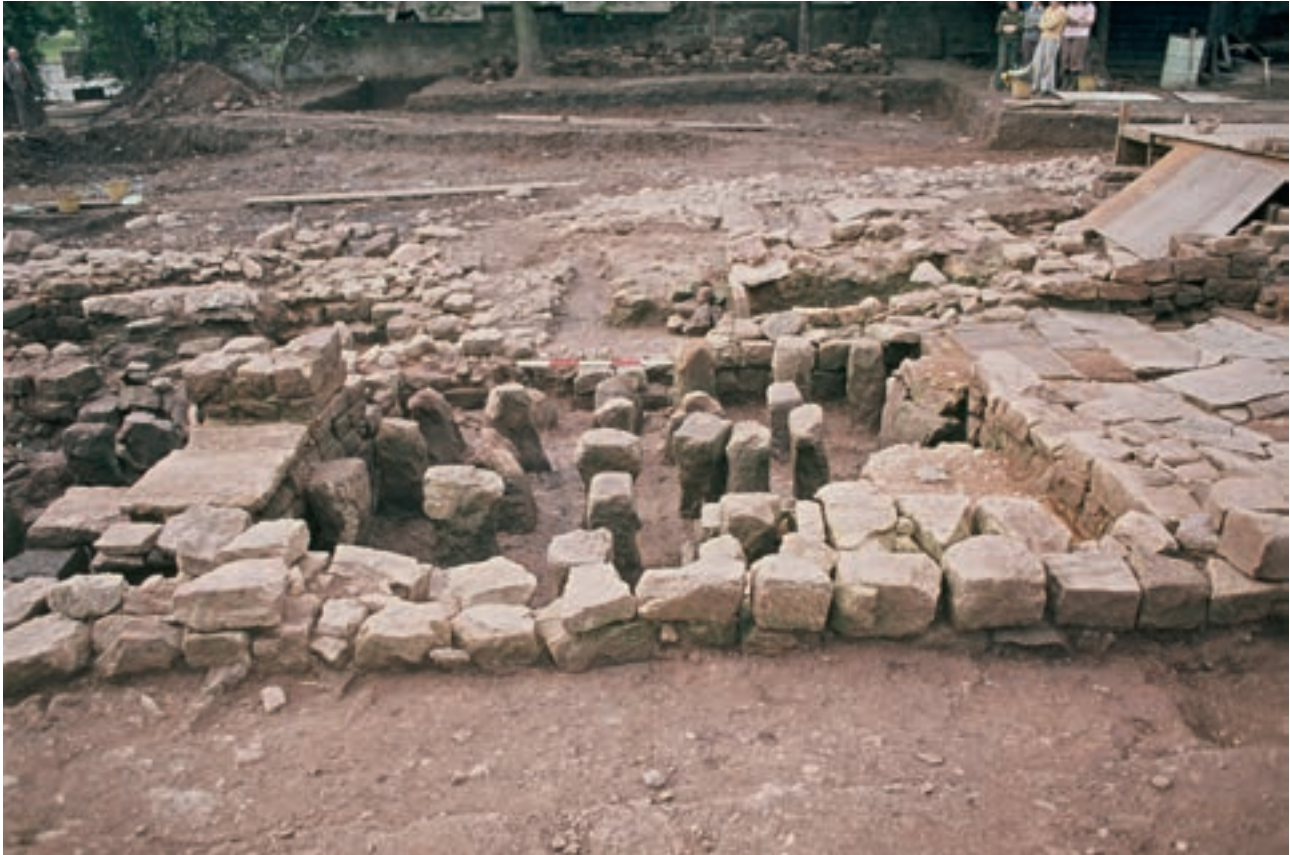
Illustration 3.3.41
The second warm room looking south.

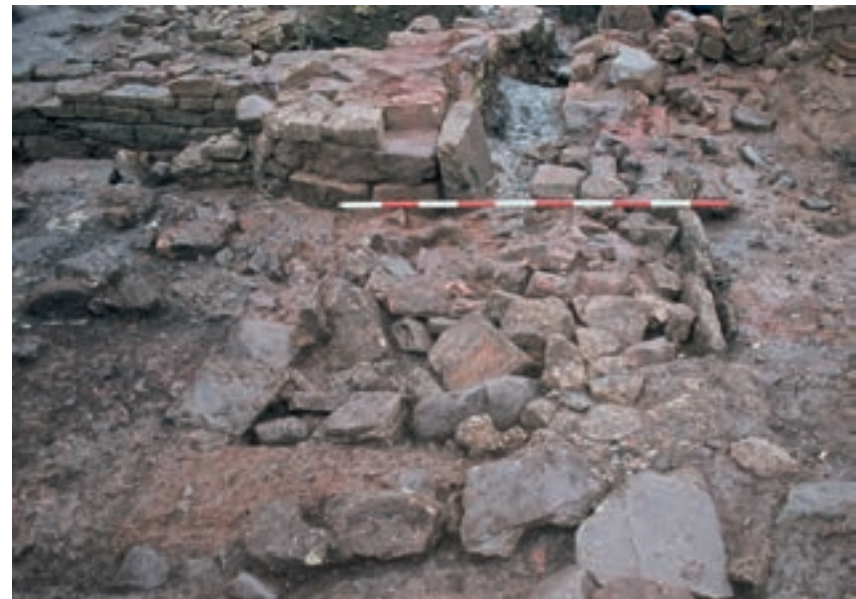
Illustration 3.3.46

The furnace chamber in 1973 looking west.

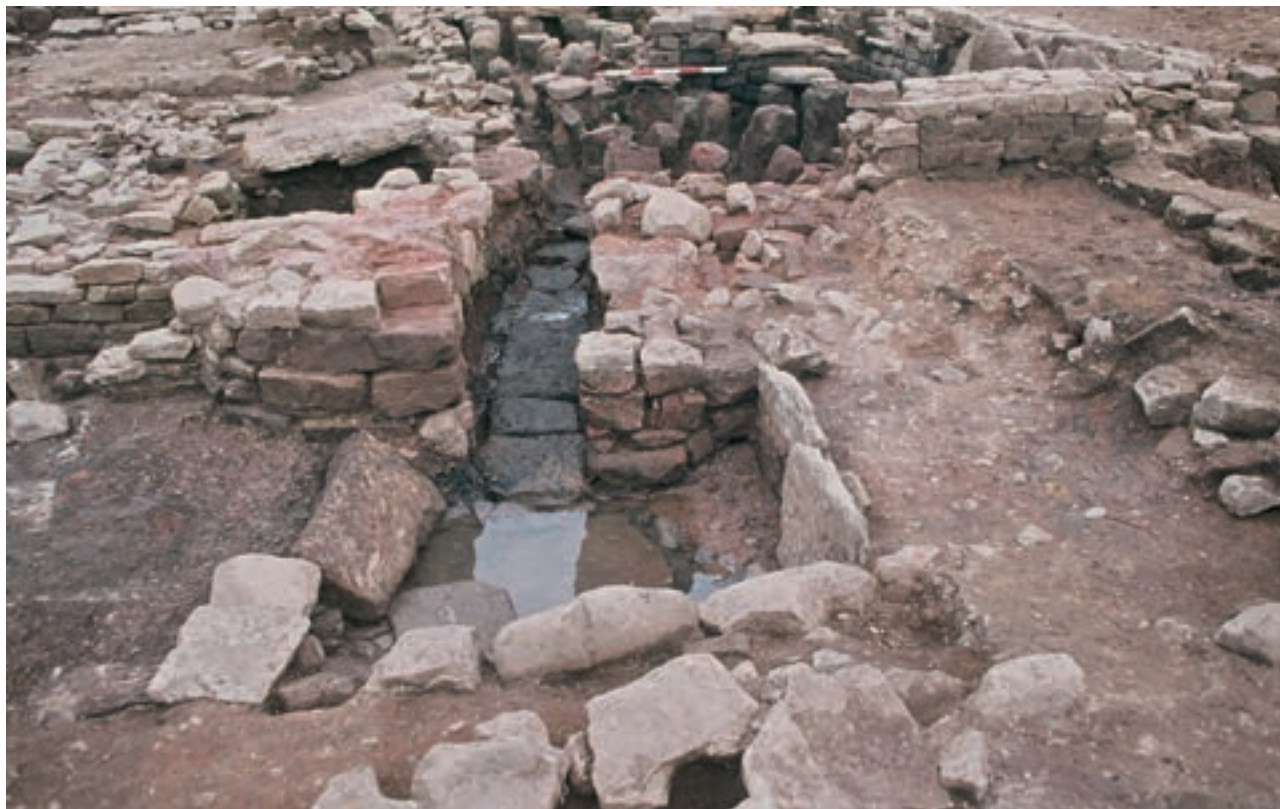
Illustration 3.3.47
The furnace chamber after excavation.
