Bearsden

A Roman Fort on the Antonine Wall

David J Breeze

THE EXCAVATIONS

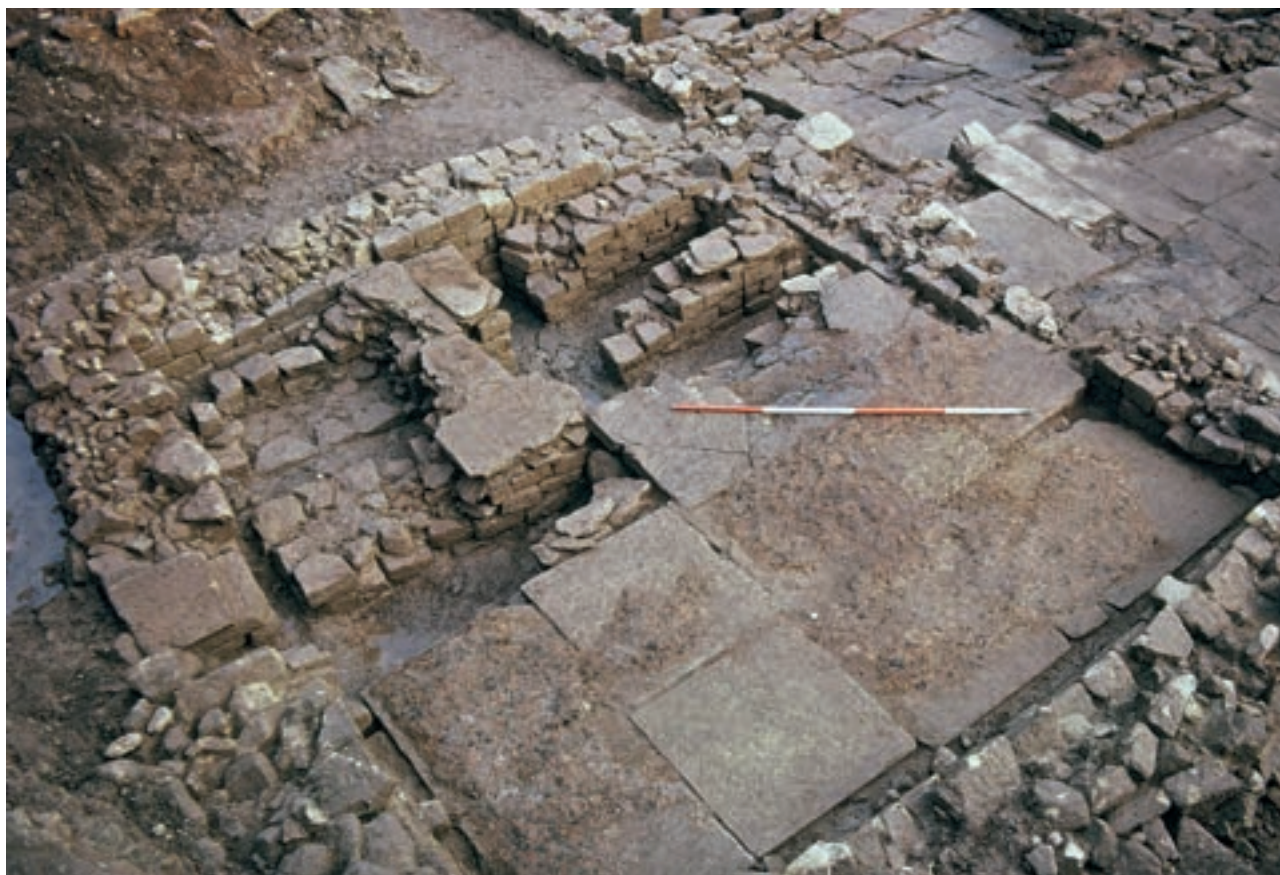
Illustration 3.3.48
The hot dry room in 1973. Note that the flags do not reach the walls, nor the plaster the edge of the flags; the projecting stones to hold out the wall-jacketing are also visible.

This lay north of the cold room. It was almost square, measuring internally 4.75m × 4.25m (illus 3.3.1, 3.3.48 and 3.3.49). The walls

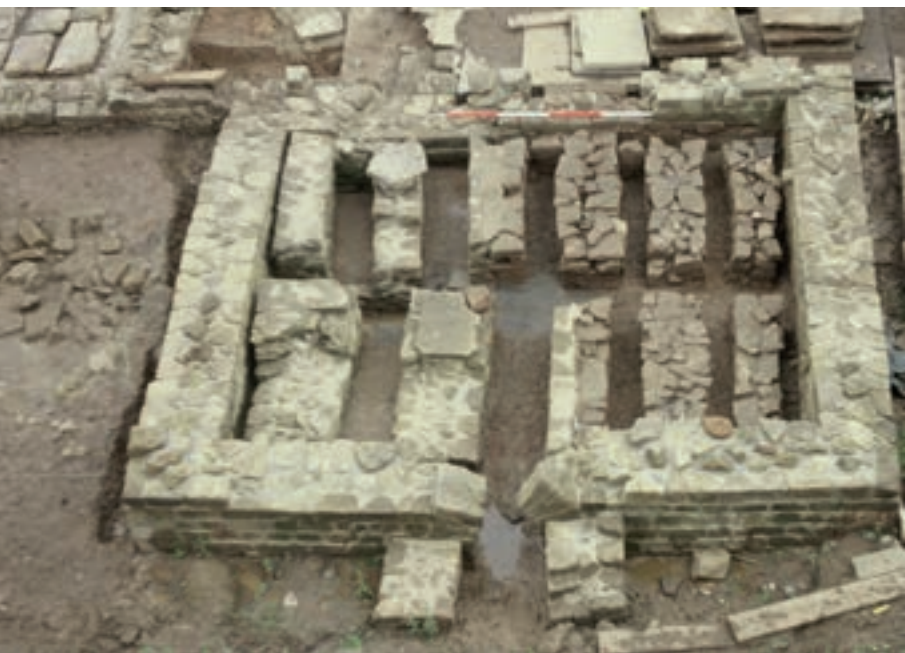
Illustration 3.3.51
The hot dry room looking south during consolidation.

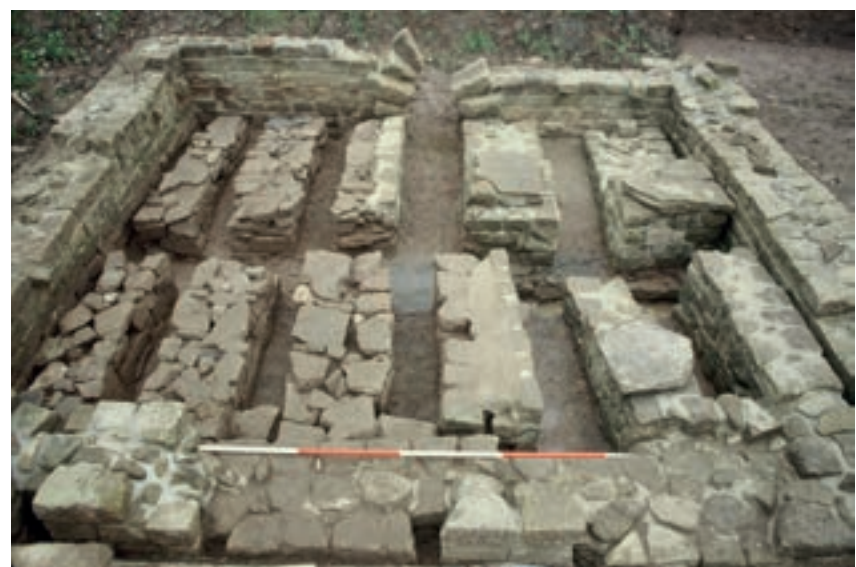
Illustration 3.3.50
The hot dry room looking north during consolidation with the floor removed to show the arrangement of the dwarf walls below. The sockets for the timber uprights along the south face of the south walls are visible in the foreground.

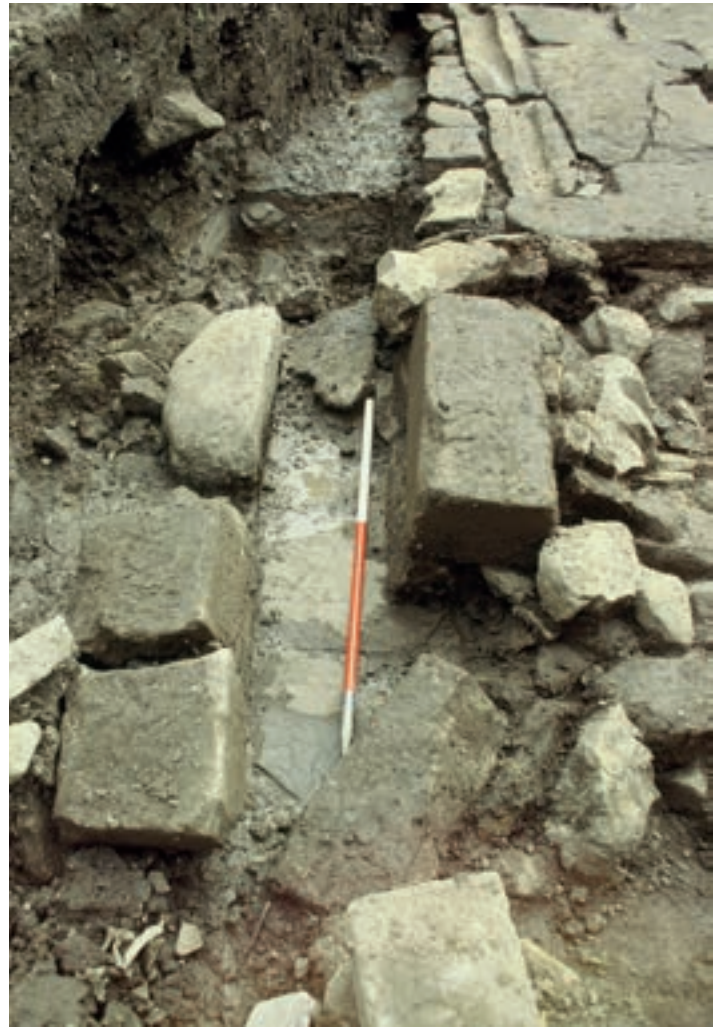
Illustration 3.3.61
The drain through the annexe rampart which carried the sewage into the ditches.

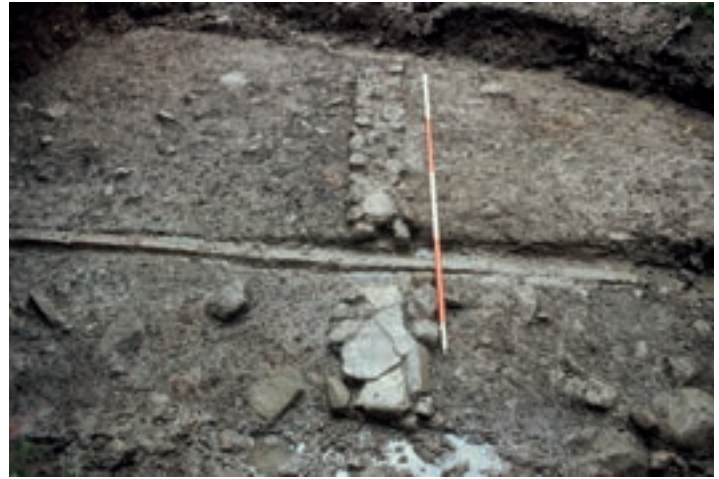
Illustration 3.3.66
The cobble foundation to the west of the latrine looking north.

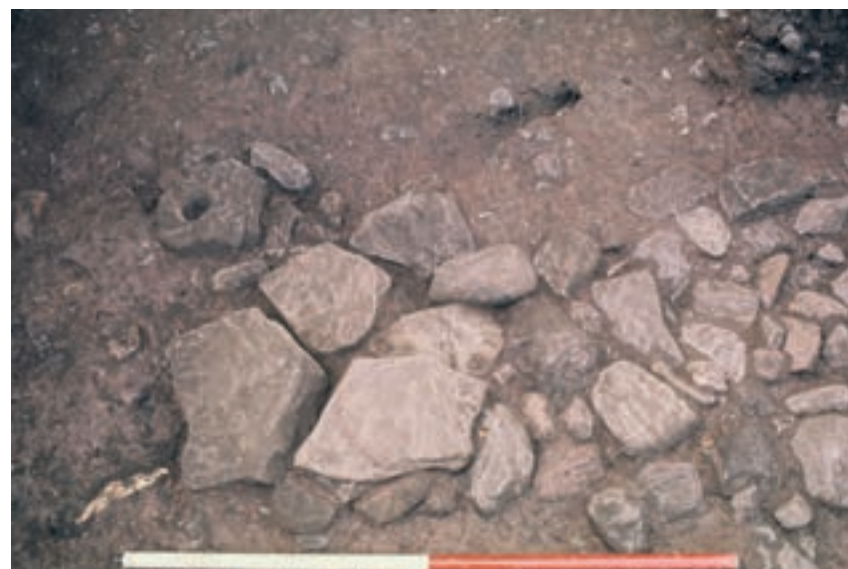
Illustration 3.4.3

The pivot stone in the clay and cobble foundation.
