Bearsden

A Roman Fort on the Antonine Wall

Chapter 6

BRICK AND TILE

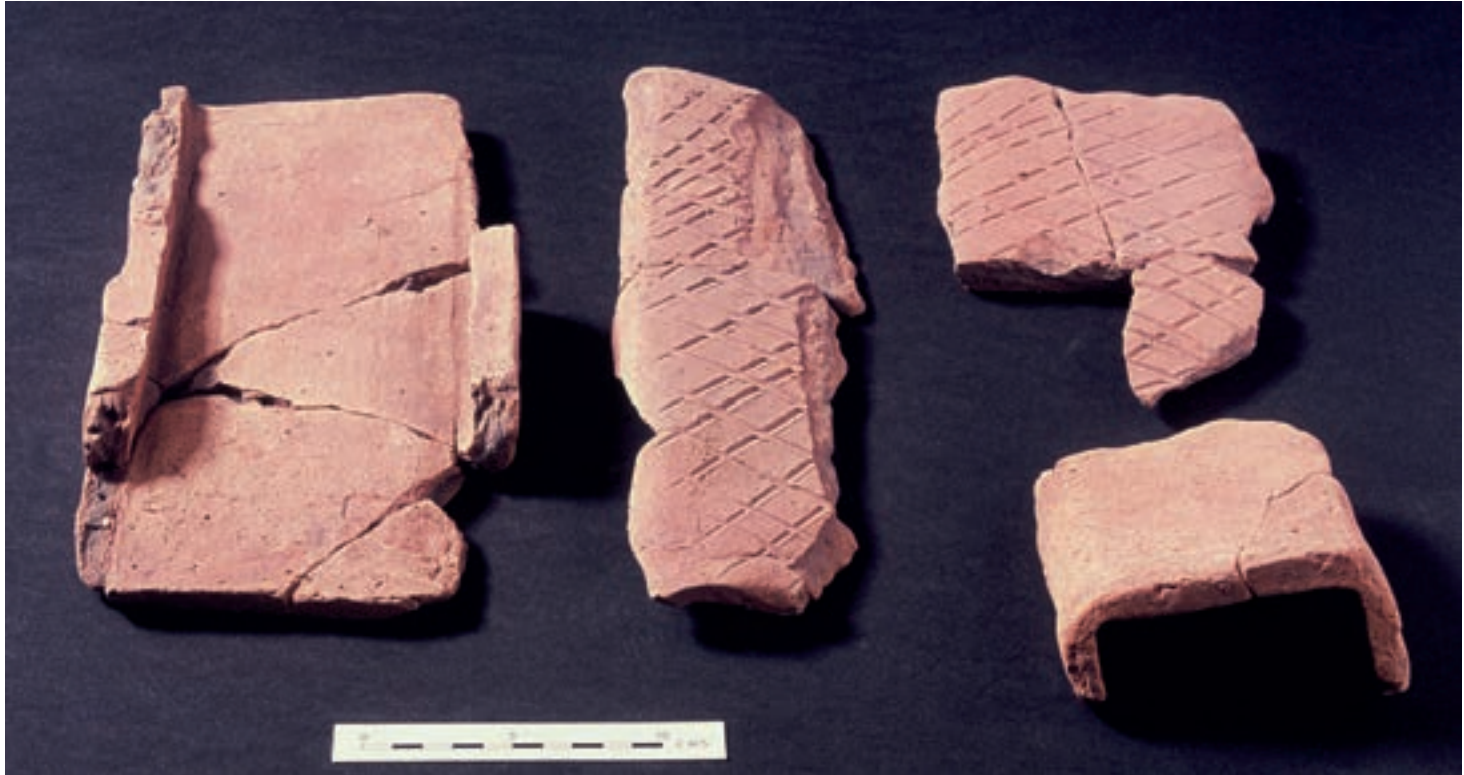
Illustration 6.1
Photograph of box tiles.

About 350 fragments of box flue were recovered, with the exception of five, all from the bath-house area (illus 6.1). Restored fragments indicated a length of 302mm. Widths varied between 132 and 145mm at the front, and back and 104 and 111mm at the sides. The average thickness of the fabric was 12mm. Many fragments were incised with a lattice pattern, to provide a key for mortar. This keying was mostly produced in a series of single lines, using with a narrow implement such as a stick. Another method involved the use of a comb; three and four-toothed combs are recorded.

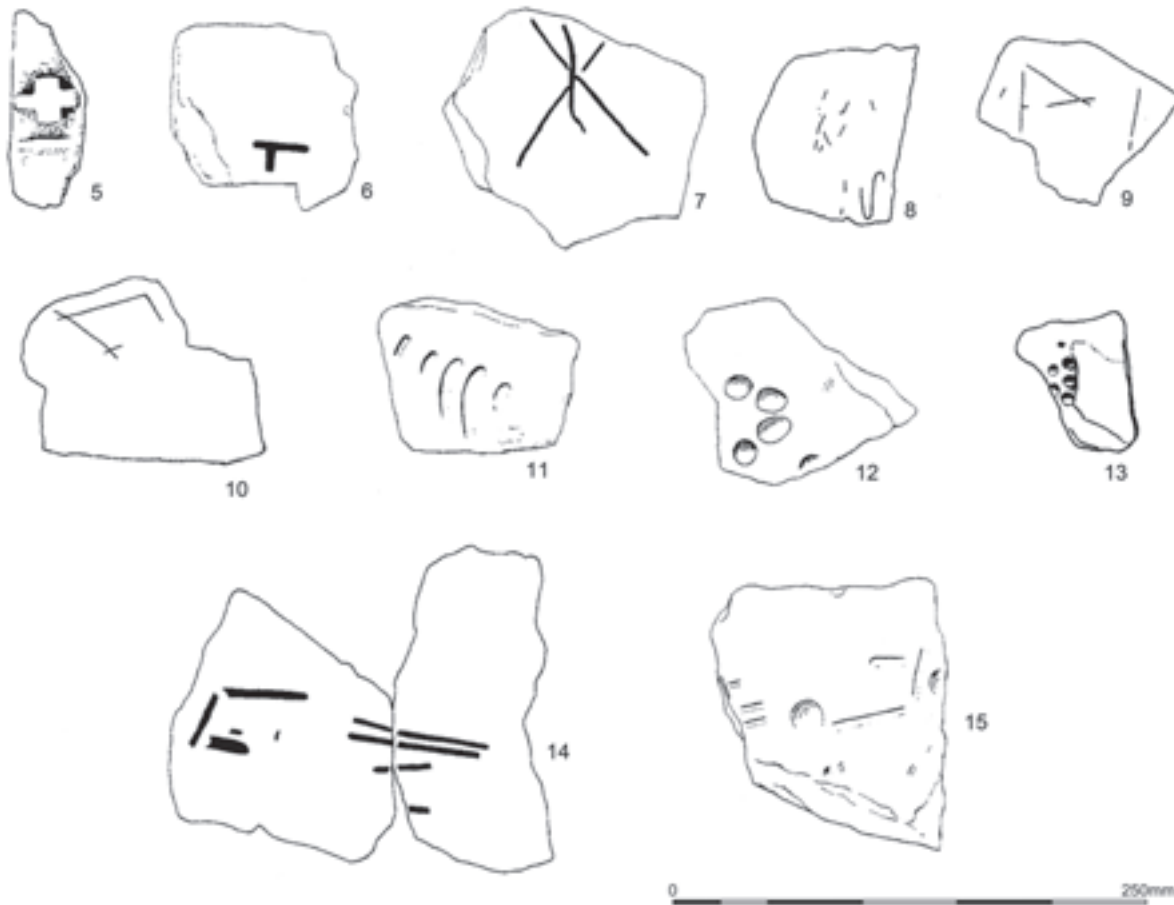
Illustration 6.4
Marks on tiles.

Two stamped tiles were found. One was a fragment of a *tegula* stamped on the edge with a cross motif (illus 6.4.5). The other was a fragment of a box flue with a T-shape impression near its vent (illus 6.4.6). It had a maximum thickness 12mm. It was a deep, sharply defined impression, possibly made by a metal instrument; a letter y was noted in a similar position on a box tile from Beaufort Park, Sussex (Brodrribb 1979b: 149–50).

A fragment of a box tile was incised with a cross composed of three strokes (illus 6.4.7). This signature is identical to that incised on a stone voussoir from the bath-house (5.2.4.76).

There were several examples of deliberate graffiti. These included a fragment of a *tegula* lightly incised with a letter S (illus 6.4.8), with a maximum thickness of 30mm; a *tegula* fragment with a lightly incised triangular mark, possibly a letter A (illus 6.4.10); and a fragment of a *tegula* lightly incised possibly with the letters TI (illus 6.4.9). There were examples of concentric grooving with fingers on a *tegula*, possibly a personal mark by the potter (ills 6.4.11); this form of concentric marking is very common on British *tegulae* (Brodrribb 1979a: 215–16).

Faunal impressions included part of a shoe print, with hobnails (NK73CO; annexe, south-west of the bath-house) (illus 6.4.13). The dense nail pattern is typical of military footwear, as seen in the shoe fragments from the site (19.1). There was one example of a dog pawprint (NK73CN; bath-house, unstratified) (illus 6.4.12).
