# Anatomy of an Iron Age Roundhouse

The Cnip Wheelhouse Excavations, Lewis

Ian Armit

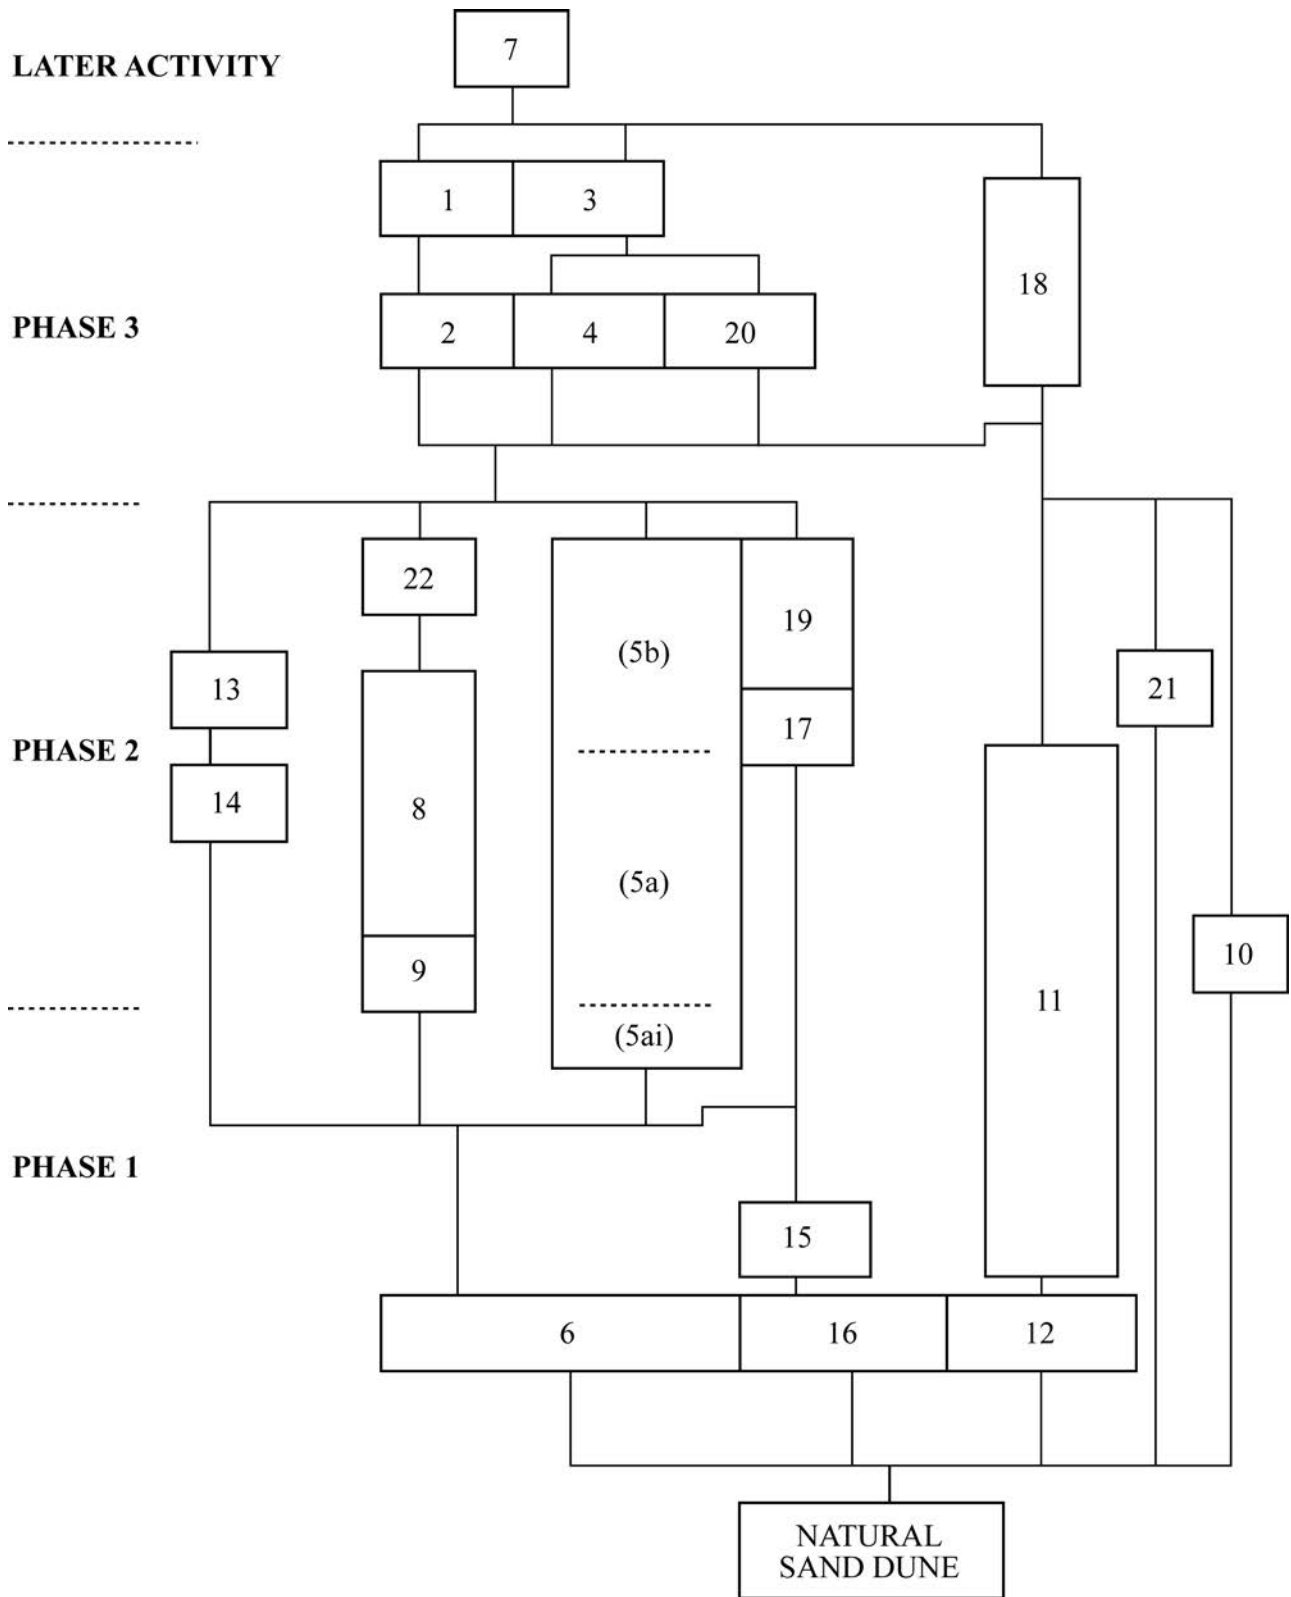
ILLUSTRATION 2.1

Site Matrix, showing the relationship of stratigraphic blocks to interpretive phases (see Table 2.1 for key to blocks).

The Site Matrix (Ill 2.1) indicates the stratigraphic relationships between the various blocks and the relationships of the blocks to interpretative phases (Table 2.1). It is thus the starting point for an understanding of the stratigraphy of the site. Matrices for individual blocks have not been included, for reasons of space, but these can be consulted in the site archive.

Blocks 6, 12 and 16 comprise the construction of, respectively, Wheelhouse 1, Wheelhouse 2 and the expanded entrance passage of the latter (Ill 2.1). The degree to which the fabric of the walls is interconnected suggests contemporaneity, although it is possible to detect parts of the sequence of construction. The attribution of each of these blocks to Phase 1 is secure.

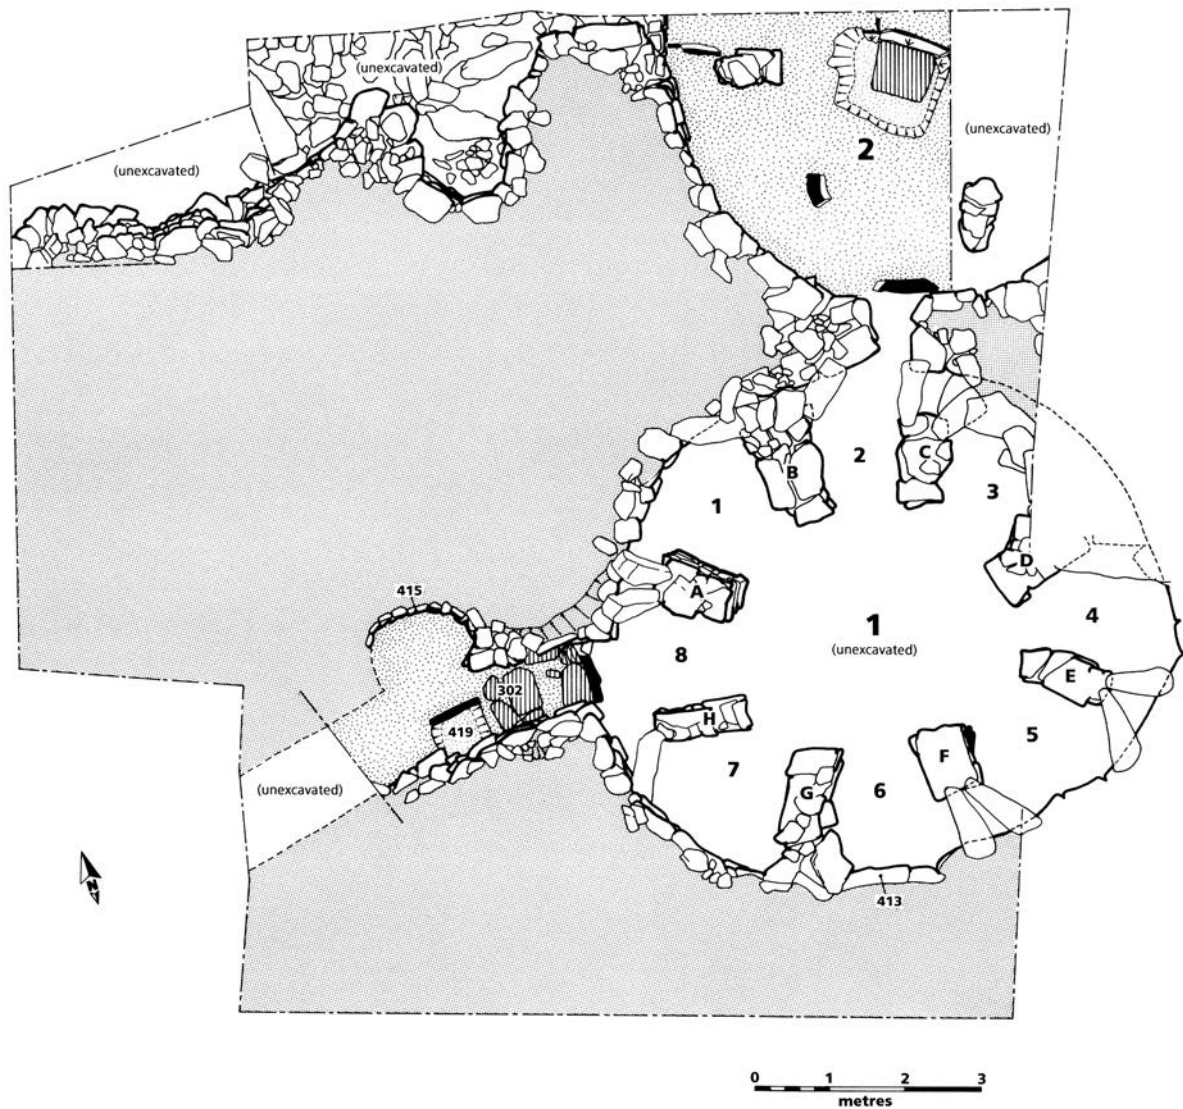
ILLUSTRATION 2.2

Phase 1 summary plan, showing numbering of bays and piers in Wheelhouse 1. This drawing also shows the context numbers of the Wheelhouse 1 entrance passage features; note that elements of paving (C302) have been removed over the pit (C419).

human activity, at least within the excavated area. This phase comprises the construction and occupation of Wheelhouses 1 and 2, of which the latter appears to have been unfinished (Ill 2.2).

The entrance passage deposits associated with Wheelhouse 1 were extremely disturbed, much of this material having been removed in the construction of Structures 4 and 7, and subsequently by the excavations for the linear sump of Structure 8 in Phase 3 (see Section 2.5.1.3). They were also excavated in conditions of near total panic on the final evening before the excavation ended. This meant that they could not be properly planned at a primary level, and relevant sections of the plan presented in Ill 2.2 have been based partly on photographs.

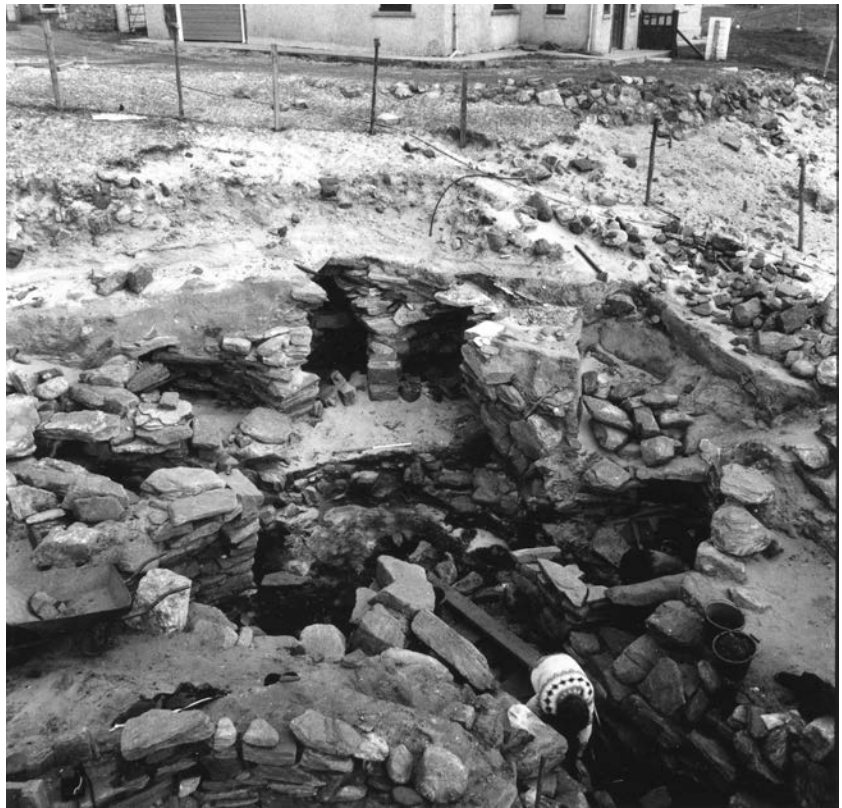
ILLUSTRATION 2.3

Wheelhouse 1, general view from north-west during the excavation. Bays 3–6 can be seen at the limits of excavation.

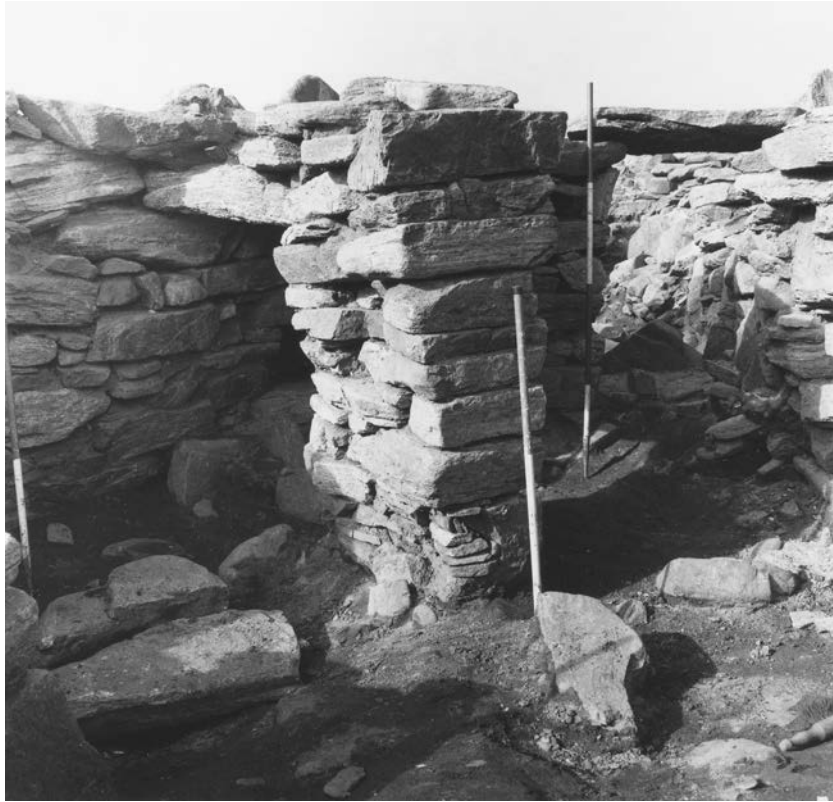
ILLUSTRATION 2.4  
Wheelhouse 1, Pier B.

Pier B (C078) survived to around 1.6m, its upper portion being joined to the enclosing wall by a pair of lintels above an aisle some 1.3m high (Ill 2.4). Preserved on the lintels was a deposit of rubble which seemed to form the base of the infill of the corbelled roof of the adjoining bays. Pier B was also excavated almost to its base, which narrowed to 0.2m in width.

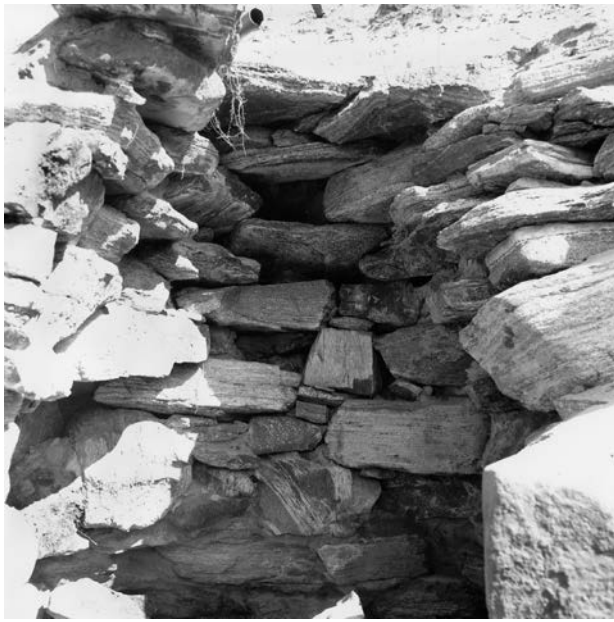
ILLUSTRATION 2.5  
Detail of upper corbelling of Bay 4, looking up from the front  
of the bay.

Piers D and E (C023, C035) survived intact to their corbelled roofs (Ill 2.5), but the unstable masonry prevented excavation within the bays around them (Bays 3–5). Their precise dimensions, and the form of their lower coursing, are thus unknown. This part of the wheelhouse, nonetheless, was of crucial significance for the understanding of the roofing of the structure, and will be discussed in more detail in Section 5.3.3. These bays extended under the main south-east section of the excavation trench, hence the projection of the Wheelhouse 1 floor-plan outside the limits of the main excavation trench. The ground above rose sharply at this point to the drive-way of the adjacent house, and no extension of the excavated area was possible.

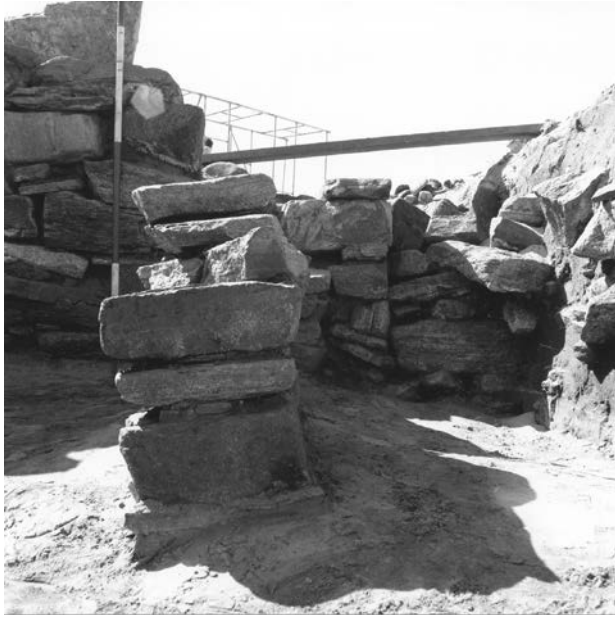
ILLUSTRATION 2.7  
Wheelhouse 2, view of blocked entrance from interior.

entrance passage. This was bisected by the edge of the excavation trench and its width cannot be judged. Its lintel did not survive. This entrance had been blocked by coursed walling (C407) surviving to five courses (approximately 0.45m) in height (Ill 2.7). This blocking walling, too, was set directly upon the natural sand floor, and seems to have been put in place soon after the construction of the main wall (C116).

The excavated portion of Wheelhouse 2 also contained two radial piers (C138, C139) and part of (or a marker for) another (C406). The pier to the south-west of the main (blocked) entrance (C138) was one stone in width, and measured approximately 0.7m high by 0.9m long (Ill 2.7). It ran approximately south-east to north-west and was founded directly onto the natural sand floor of the construction trench. It had been built

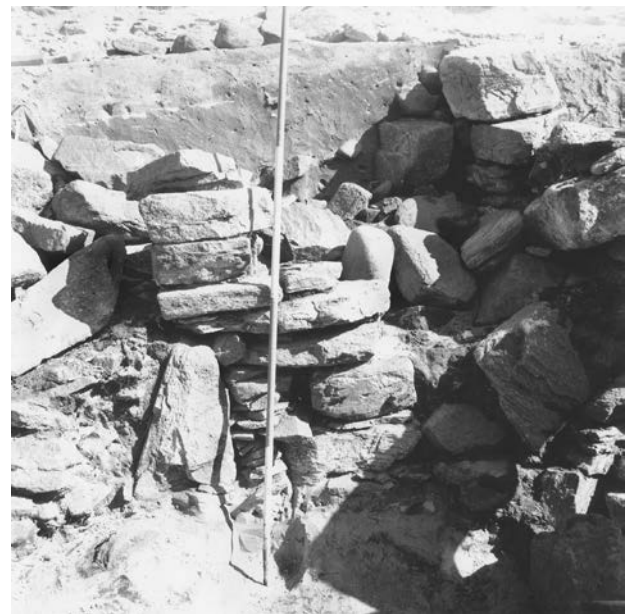
ILLUSTRATION 2.8  
Wheelhouse 2, unexcavated pier in section.

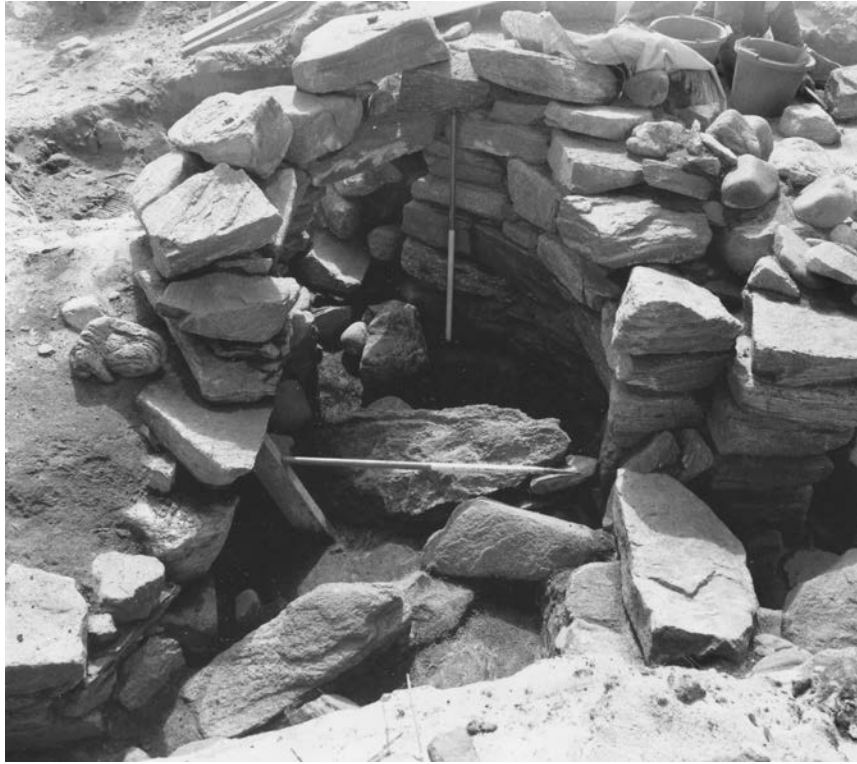
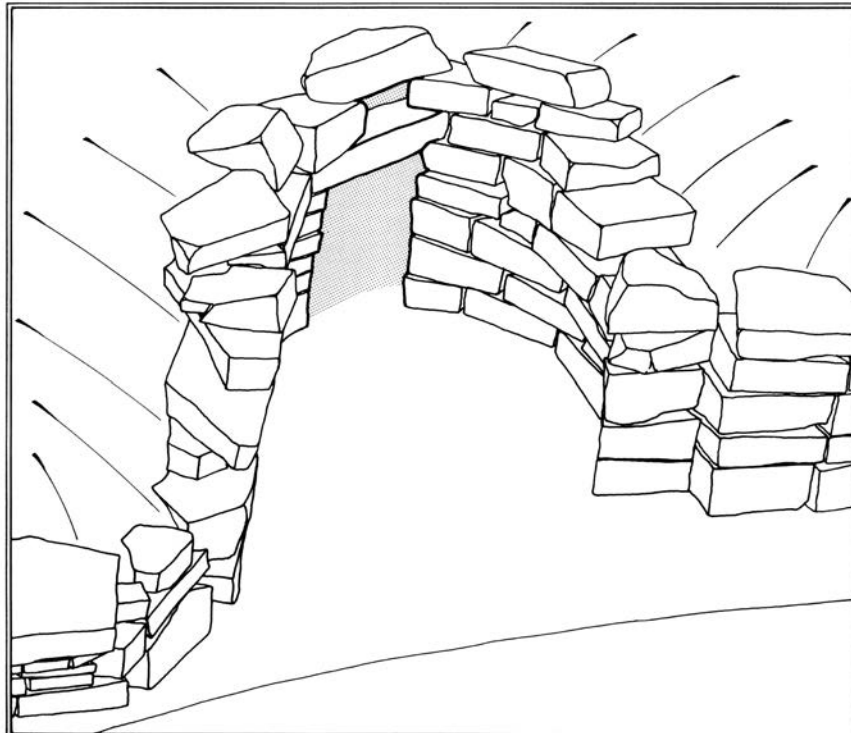
ILLUSTRATION 2.9

Wheelhouse 2, 'false entrance' leading off entrance passage cell. The accompanying drawing highlights the structural features, including the small, square, weight-relieving void above the entrance.

The cell measured little more than 1m wide internally, by at least 3m transversely, across the entrance passage. Built into the south-east wall of the cell was a peculiar feature which appeared as a low, lintelled entrance. This feature was around 0.6m high by 0.4m across and had a distinct ‘void’ above its lintel some 0.2m by 0.2m, seemingly intended to relieve weight stresses above the lintel. This ‘false’ entrance did not lead to any further cell or passage, but simply backed into the clean, unmodified natural sand dune (Ill 2.9).

4. The ‘false entrance’ leading southwards from the Wheelhouse 2 entrance passage cell (C073) seems to have been intended to lead into a cell or passage which was never built. A trench cut into the sand behind this cell found that the area comprised nothing but undisturbed dune sand.

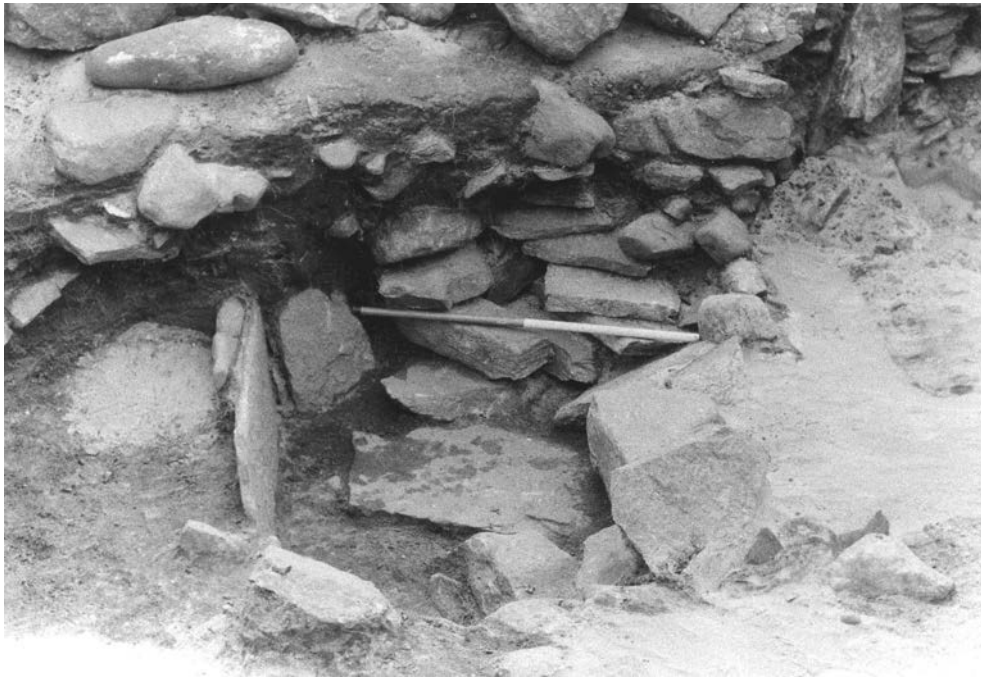
ILLUSTRATION 2.10  
Wheelhouse 2, view of central pit, excavated.

Above this level the pit was almost wholly filled with a carefully constructed stack of building stone (C228) quite distinct from the disorganized rubble contained in the deposits which sealed it (this section). The stone deposit filled and overlapped the pit, standing directly on clean sand (C229). Overall the deposit comprised up to nine courses of stacked stone, rising some 0.5m above the sand floor (visible in Ill 2.10 and 2.20). The lowest courses (C271) appeared to be arranged in such a way as to corbel over the base of the pit, leaving a void which had largely filled with the loose ash deposits mentioned above (C285, C296).

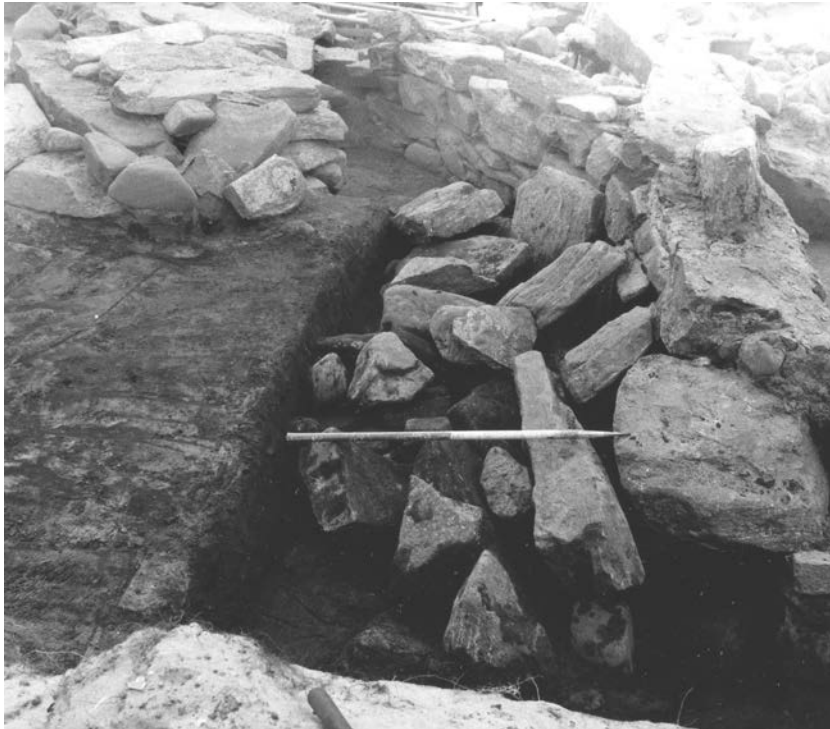
ILLUSTRATION 2.11

Wheelhouse 2, view of collapsed stone in western part of interior.

The quantity of voided rubble in this collapse horizon (C131/130) suggests a single-episode of destruction. The fact that this material was not

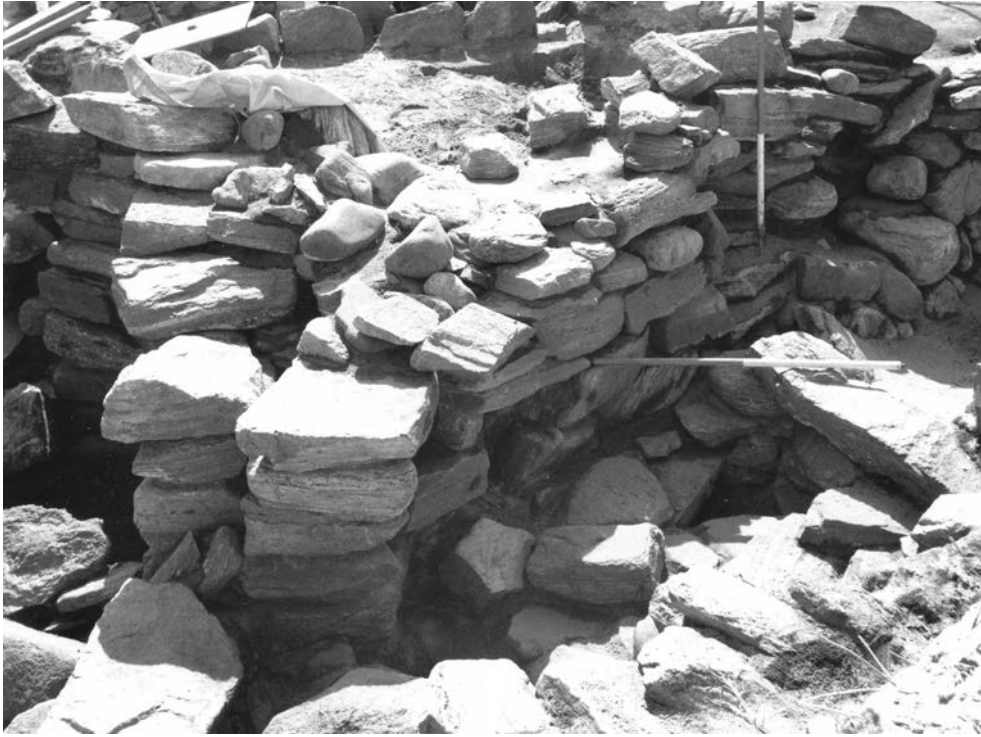
ILLUSTRATION 2.12

Wheelhouse 2, view of stacked stone in entrance passage. The recessed butt-joint of the Wheelhouse 2 wall and its entrance passage can clearly be seen.

The earliest deposits identified comprised a stack of slabs (C401) which occupied almost the whole of the passage, and were particularly densely packed towards the east (wheelhouse) end (Ill 2.12). These were recorded on plan and by photograph, but could

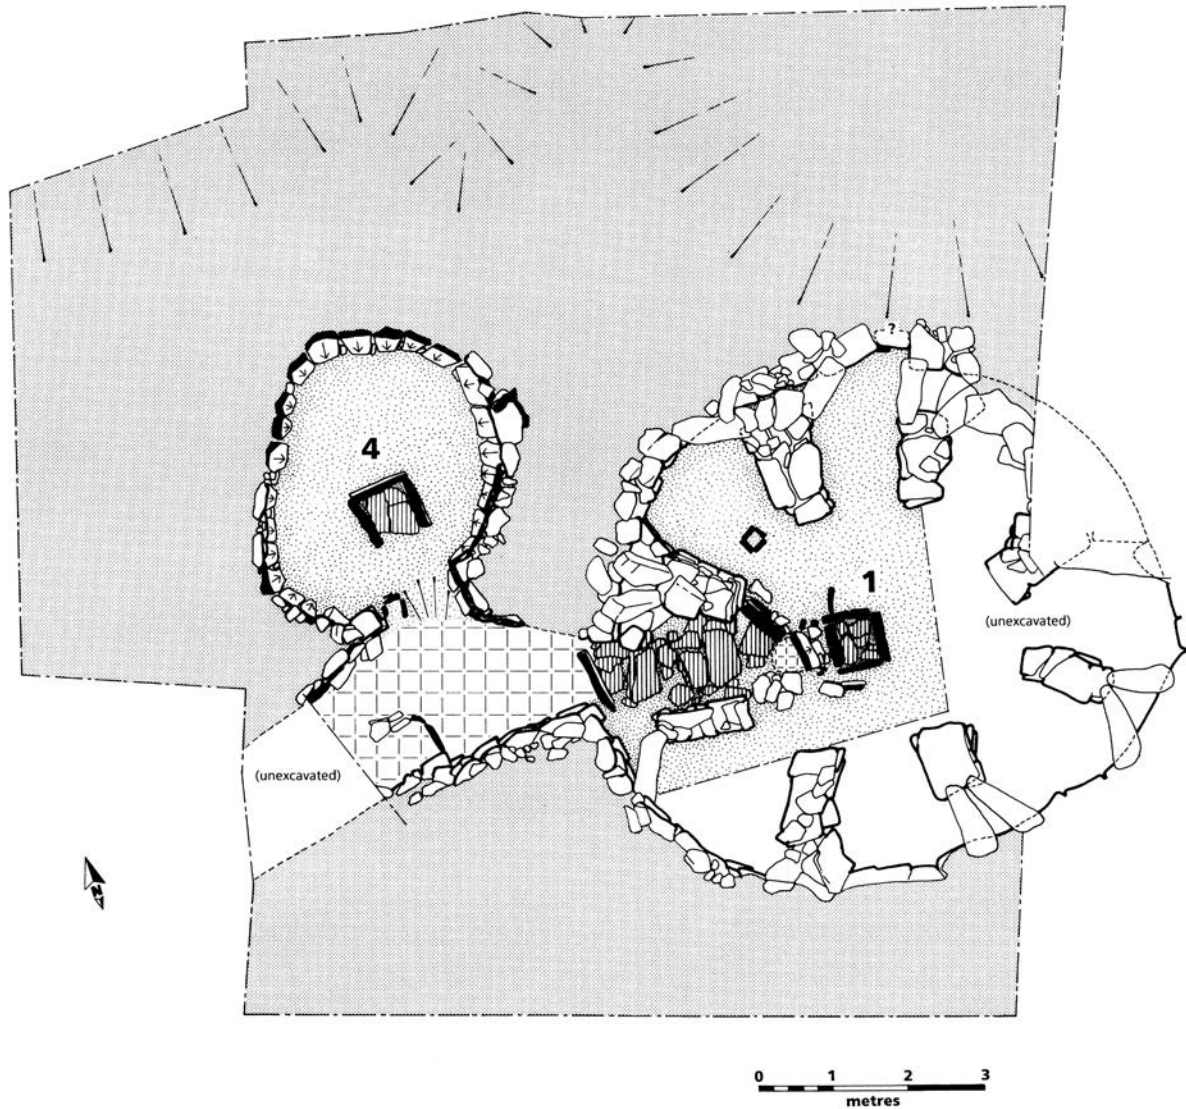
ILLUSTRATION 2.13  
Phase 2 summary plan No 1.

This phase has been divided for descriptive convenience into sub-phases 2a and 2b (Ills 2.13–2.14) which relate to two successive re-orderings of the interiors of the two main structures; Wheelhouse 1 and Structure 4. This division should not be allowed to obscure the continuous nature of the development of the settlement during Phase 2.

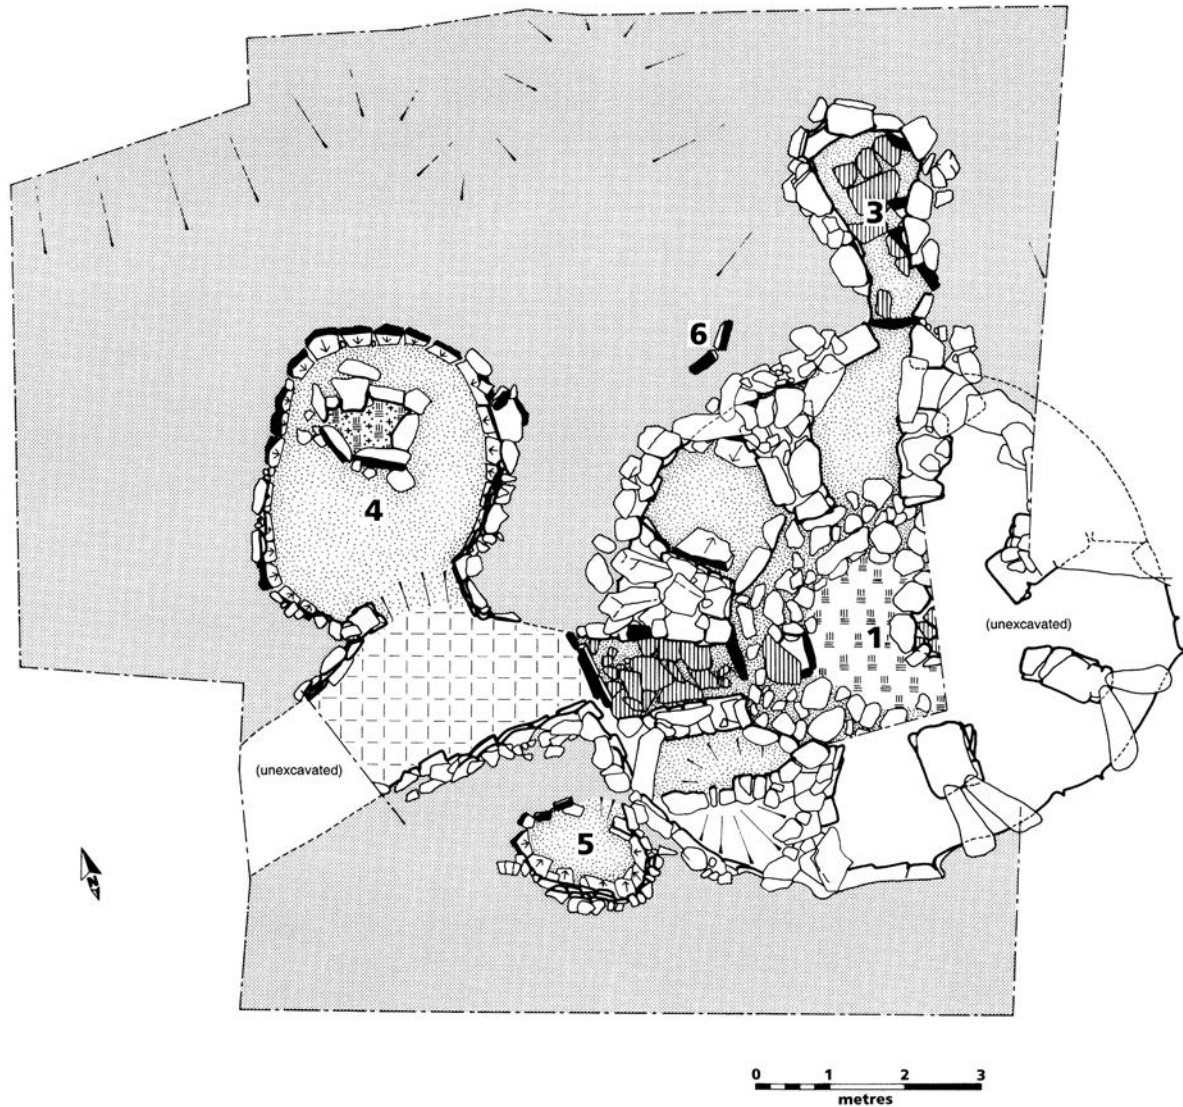
ILLUSTRATION 2.14  
Phase 2 summary plan No 2.

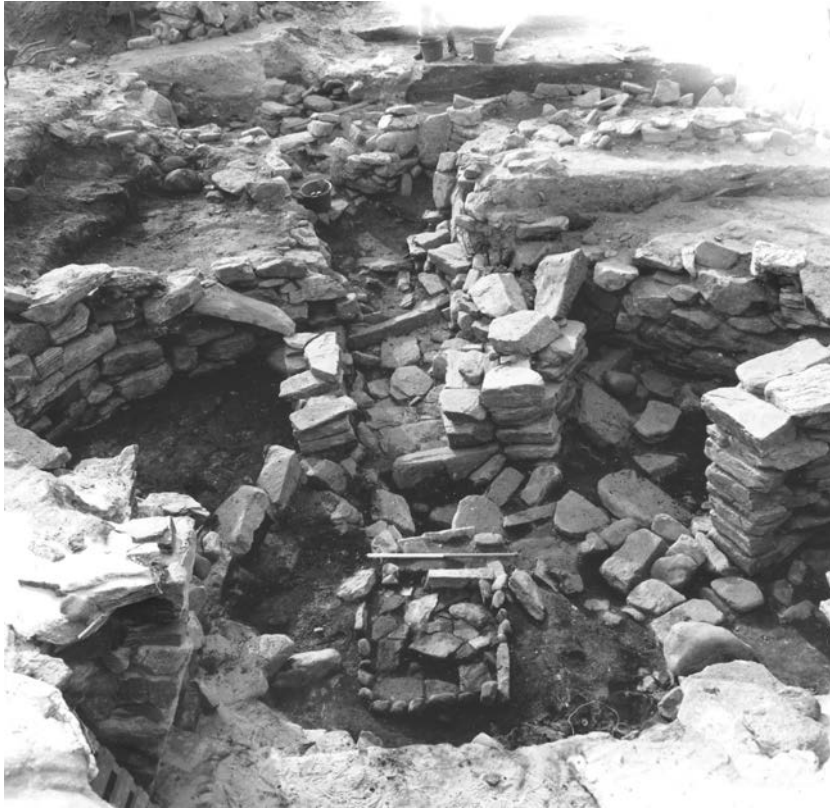
ILLUSTRATION 2.16

Wheelhouse 1, the second Phase 2a hearth from the east. Not all of the elements in this photograph are stratigraphically in phase. The Phase 2b stone features in Bay 1 have been only partly removed, as have those around the periphery of the central area, while the entrance buttress and Bay 7 kerb stones also belong to Phase 2b. The hearth shown here is thus rather earlier than most of the other visible features.

The first hearth was replaced by a second (C222) in the same location but with a rather different design (Ill 2.15 inset and 2.16). The new hearth was again rectangular, slightly larger, and with a base formed by a new layer of heat-cracked slabs. It retained the former bipartite division. The larger sector was re-kerbed with a mixture of edge-set slabs and small, water-worn beach pebbles, and widened to 0.85m. The upright slab between the hearth and the entrance was retained, and further smaller slabs were added to fully enclose this part of the hearth. Further somewhat rounded stones were used to re-pave this smaller sector.

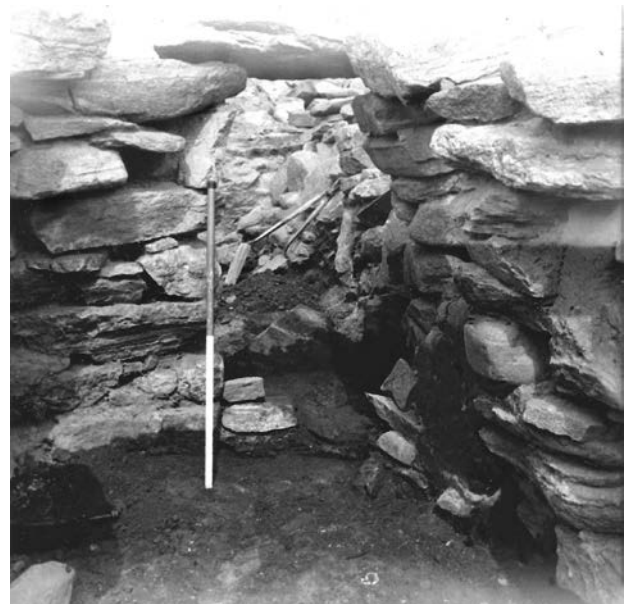
ILLUSTRATION 2.17

View through connecting entrance from Wheelhouse 1 towards Wheelhouse 2, showing three courses of residual blocking wall. Note also the triangular threshold stone on the far side of the entrance.

An entrance (C163), built into the south-west arc of Wheelhouse 2 connected the structure to Wheelhouse 1. This was capped by a substantial stone lintel at a height of approximately 1.5m and was 0.8m wide at the base, narrowing to 0.4m below the lintel. The entrance, and indeed the lintel, had been re-used for the later Structure 3, but there were no signs of secondary modification to the surviving features. An edge-set slab (C408) was set into the natural sand transversely across the connecting entrance between Wheelhouses 1 and 2, to form a threshold on the Wheelhouse 2 side of the entrance. This slab was set in such a way as to form a prominent inverted V (Ill 2.17) and formed rather an irregular obstacle to passage between the two structures.

The deposits of Bay 2 in this first period of Phase 2 activity were similar to those in Bay 1. All formed against a wall of small to medium coursed stones (C505) which blocked the lower portion of the entrance between the two wheelhouses (Ill 2.17). This wall seems to have been dismantled to the level of the top of these deposits (assuming that it originally extended higher) during the next phase of reorganization (see Section 2.4.1.2). It was presumably inserted when the building of Wheelhouse 2 was abandoned, and removed when access was required to the later Structure 3 (see Section 2.4.2).

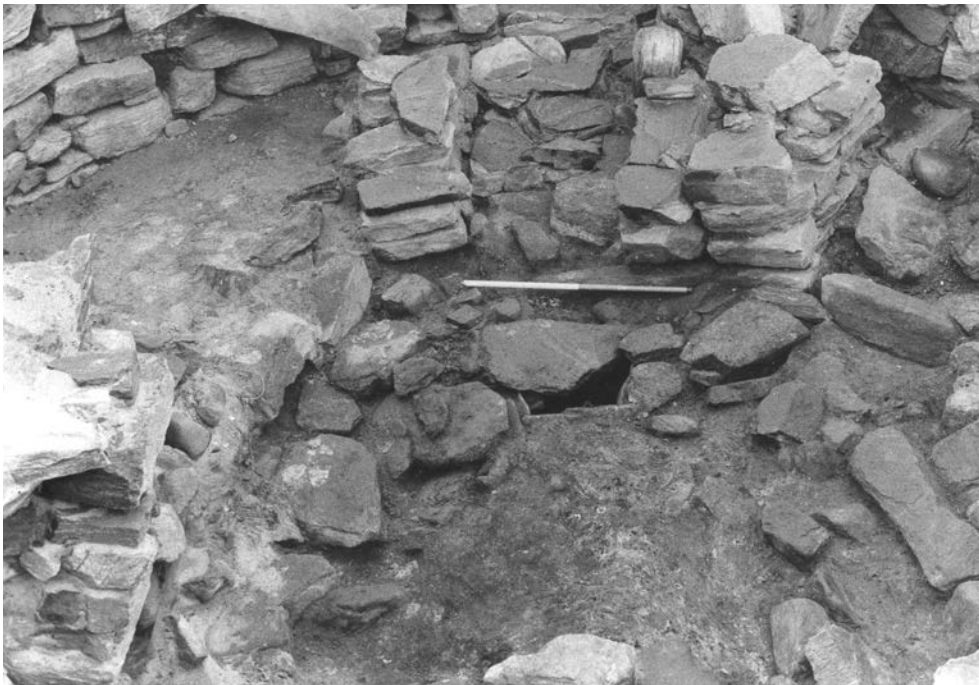
ILLUSTRATION 2.18  
Wheelhouse 1, second Phase 2 floor.

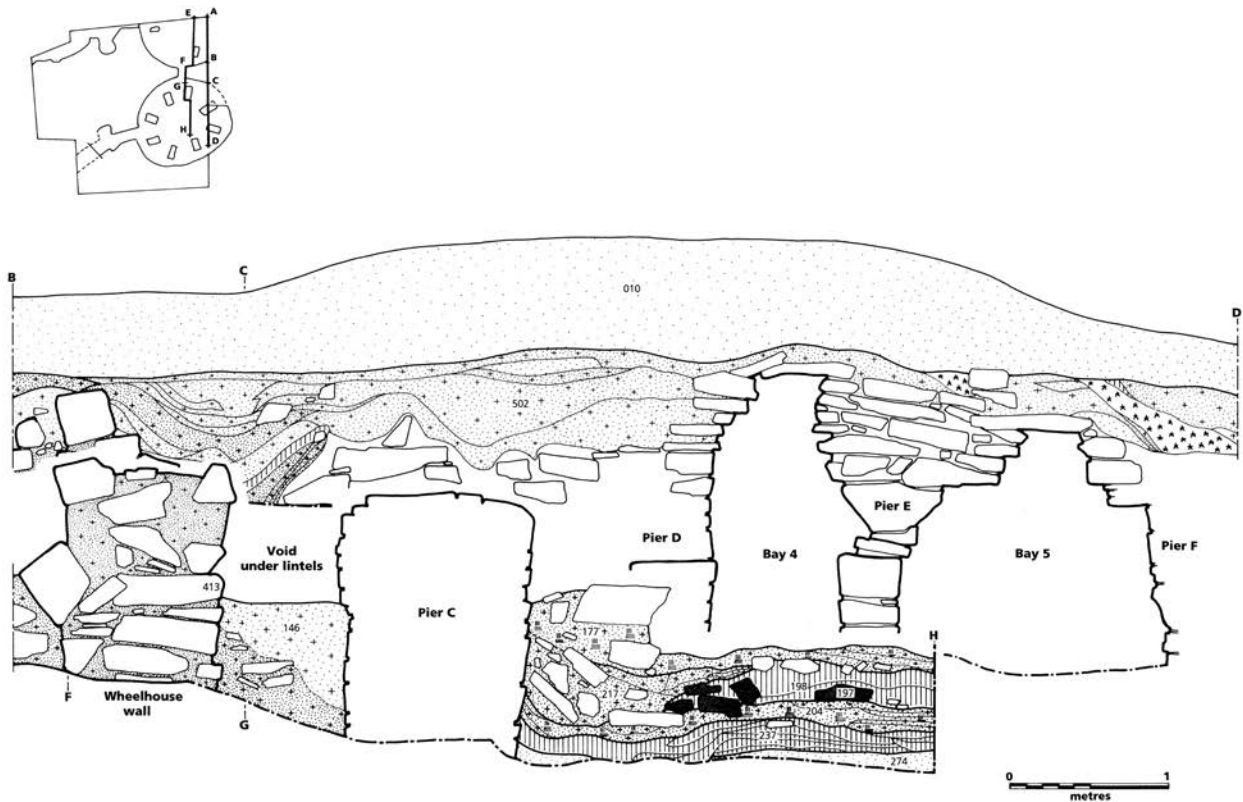
ILLUSTRATION 2.20 (a)

Section through Wheelhouses 1 and 2. *Note 1:* the upper part of the section is drawn along a line set back from the lower part. This was due to the impracticality, for safety reasons, of extending the initial site section downwards. The 'join' between the lower and upper parts is shown on the attached sections. The split does not prejudice any of the stratigraphic relationships shown. *Note 2:* the northern part of the section extends slightly north of the area excavated on plan, as time was available to quickly extend this part of the excavation before the section was drawn. *Note 3:* the section through Wheelhouse 2 clipped the edge of the pit in the centre of the structure. The fill has been projected on, and the slab which lines the side of the pit has been dotted. *Note 4:* the lower part of the section through Wheelhouse 1 shows all layers excavated after the removal of Structure 8. The cut for Structure 8 is reflected in the profile of the uppermost layer shown in this part of the section (C177).

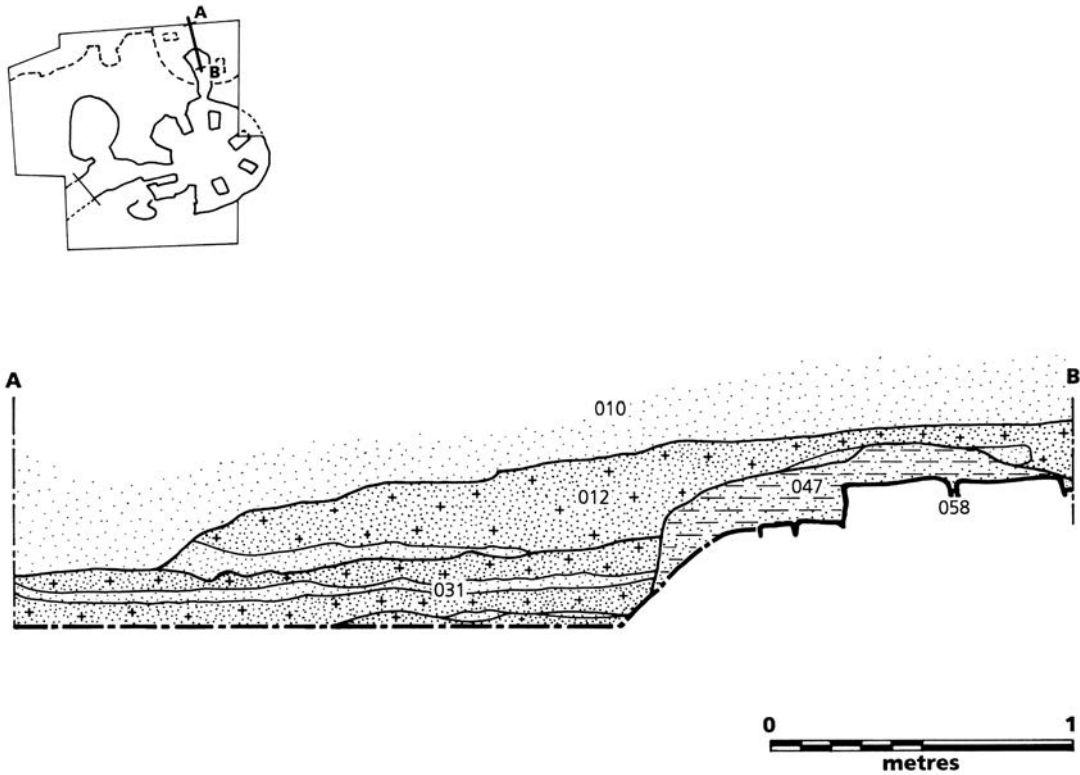
ILLUSTRATION 2.24  
Structure 3 roof.

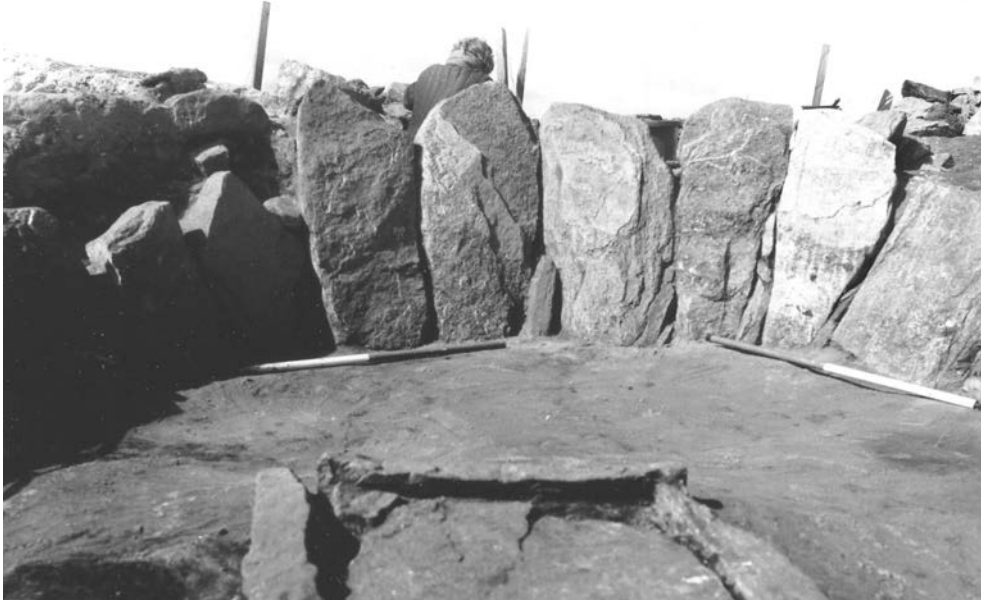
ILLUSTRATION 2.29  
Structure 4: first coherent floor.

One of the most curious structural features within Structure 4 was a ‘shelf’ (C051) set into the east wall, just above the slab foundation course (Ill 2.28a and 2.29). This was formed using a single flat slab (0.7m by 0.4m in size) lined on at least two sides by small kerb-stones (the south side of the kerb did not survive long enough to be recorded, having been disturbed by machining in this area). While the plan indicates that this would have been open to the west (ie facing inwards), a displaced stone recorded before the feature had been properly identified suggests that the kerb may have entirely surrounded the slab, creating a feature not dissimilar to a stone bowl set in the wall. This would have had internal dimensions of approximately 0.4m by 0.15m, by around 0.15m in depth.

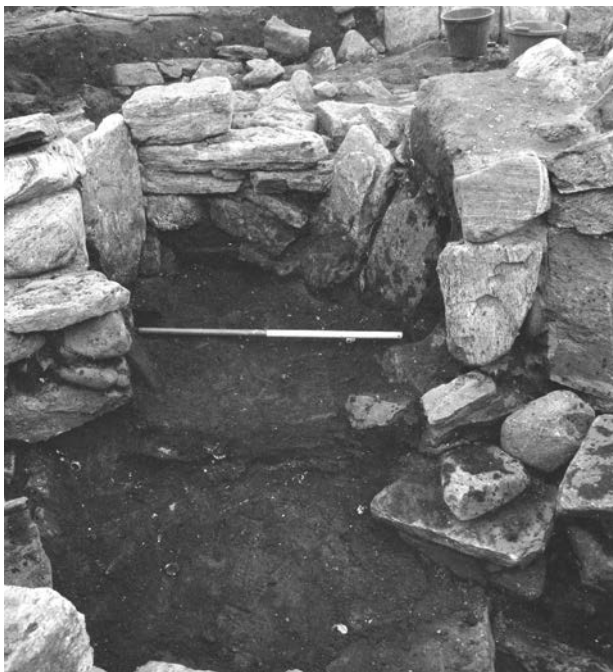
ILLUSTRATION 2.32  
Structure 9, from the north-west.

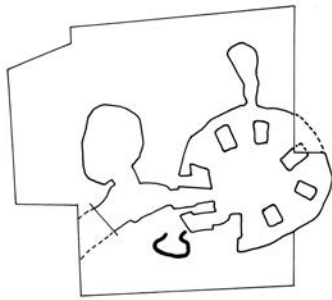
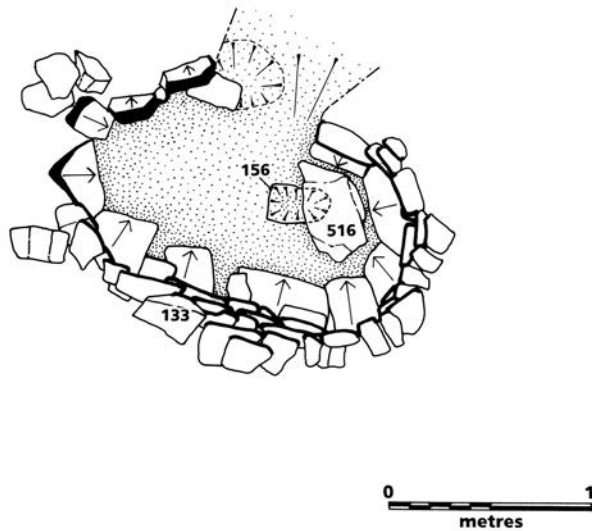
ILLUSTRATION 2.33  
Structure 7.

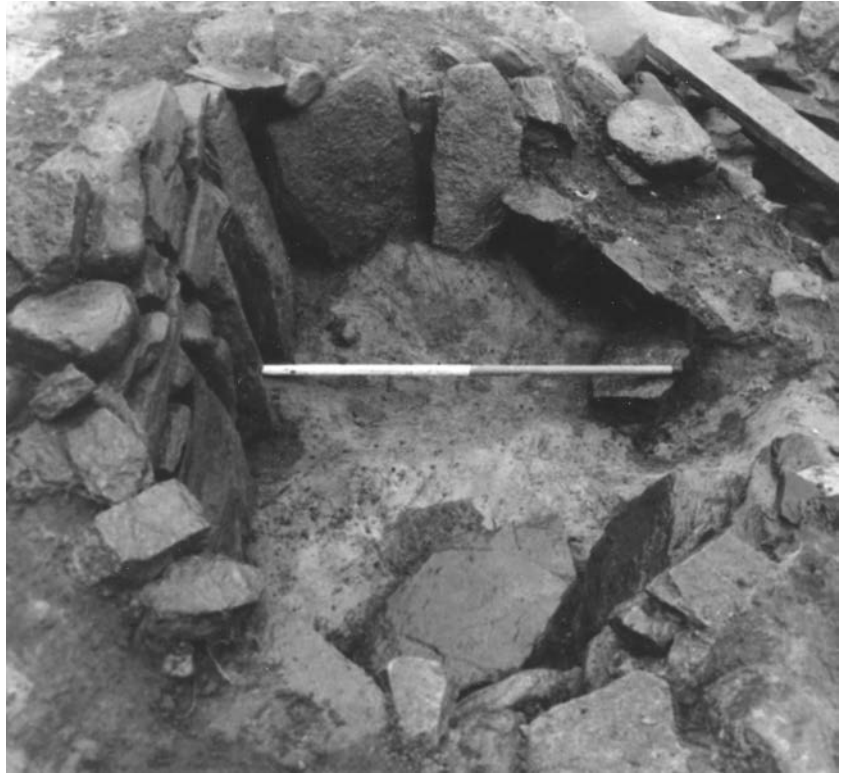
ILLUSTRATION 2.35  
Structure 5 from south (fully excavated).

of the wall (Ill 2.35). This stone appears to derive from the adjacent north-eastern circuit of the wall, where a slab of similar dimensions was missing. This would seem to imply that the wall of the structure had collapsed or been partly dismantled prior to the accumulation of any substantial deposits on its floor. Indeed only a thin deposit of stained sand and ash (C153) seems to have been in place before this partial collapse occurred.

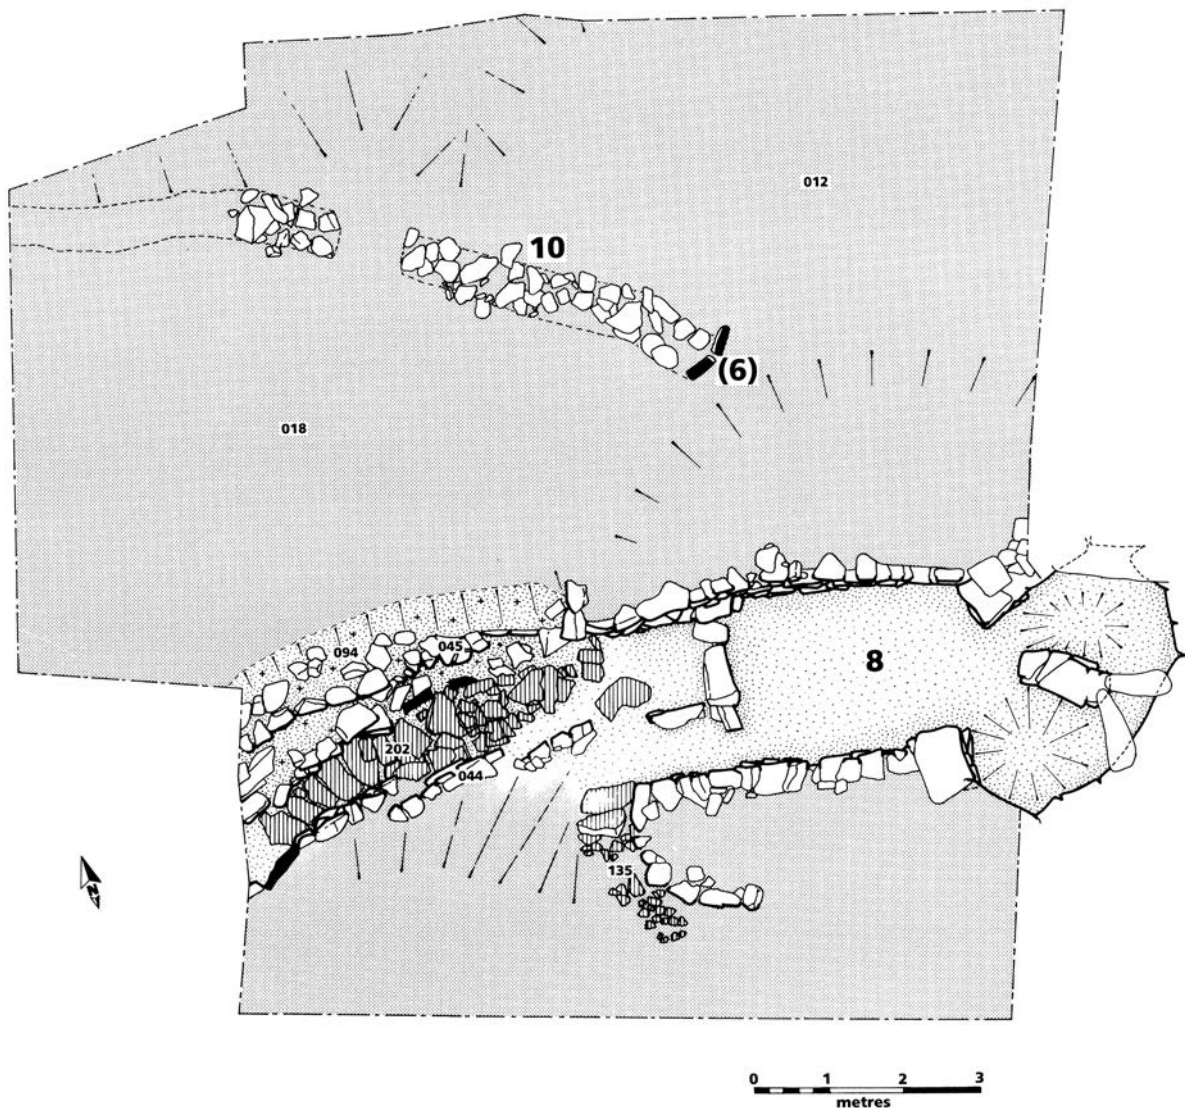
ILLUSTRATION 2.36  
Phase 3 summary plan.

During Phase 3 the cellular layout of Phase 2 was replaced by a single, rectilinear domestic building, Structure 8 (Ill 2.36). A wall, Structure 10, was also constructed, possibly as part of an enclosure around the settlement.

path directed movement towards the northern half of the entrance while a rough cobbled path (C135, this section) from the south led into the southern half of the entrance (Ill 2.36).

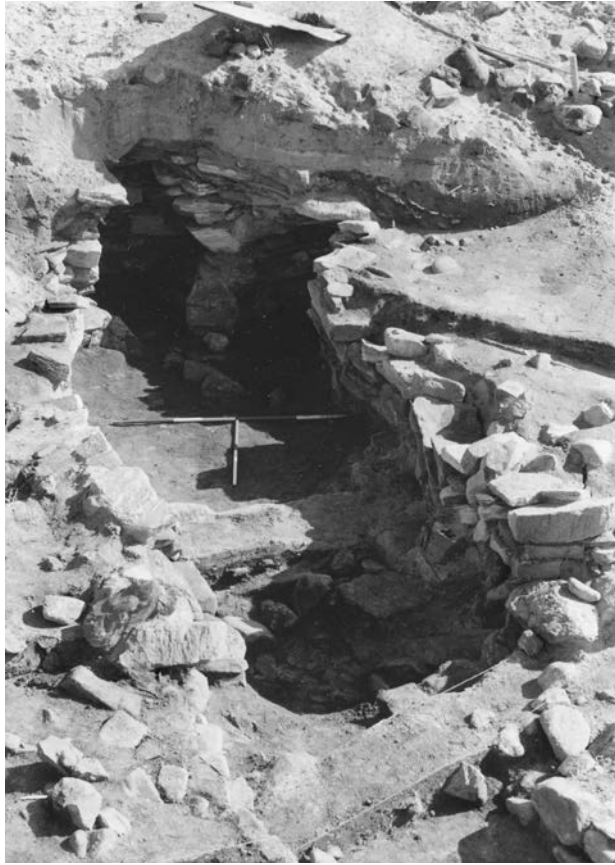
ILLUSTRATION 2.37  
Structure 8, from north-west, showing primary floors and re-use of corbelled cells.
