# Anatomy of an Iron Age Roundhouse

The Cnip Wheelhouse Excavations, Lewis

Ian Armit

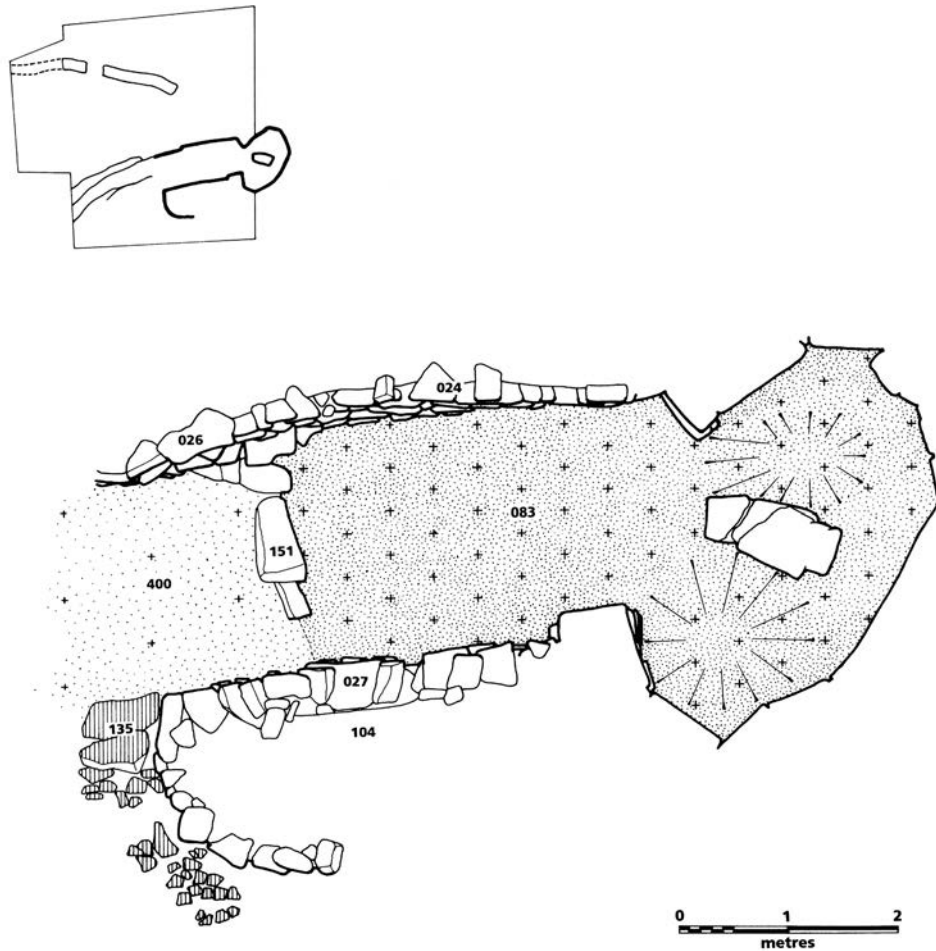
ILLUSTRATION 2.38

Structure 8, plan of primary floor. Note that the sub-division (C151) would, in reality, have been covered over by C132 by the time C400 and C083 formed.

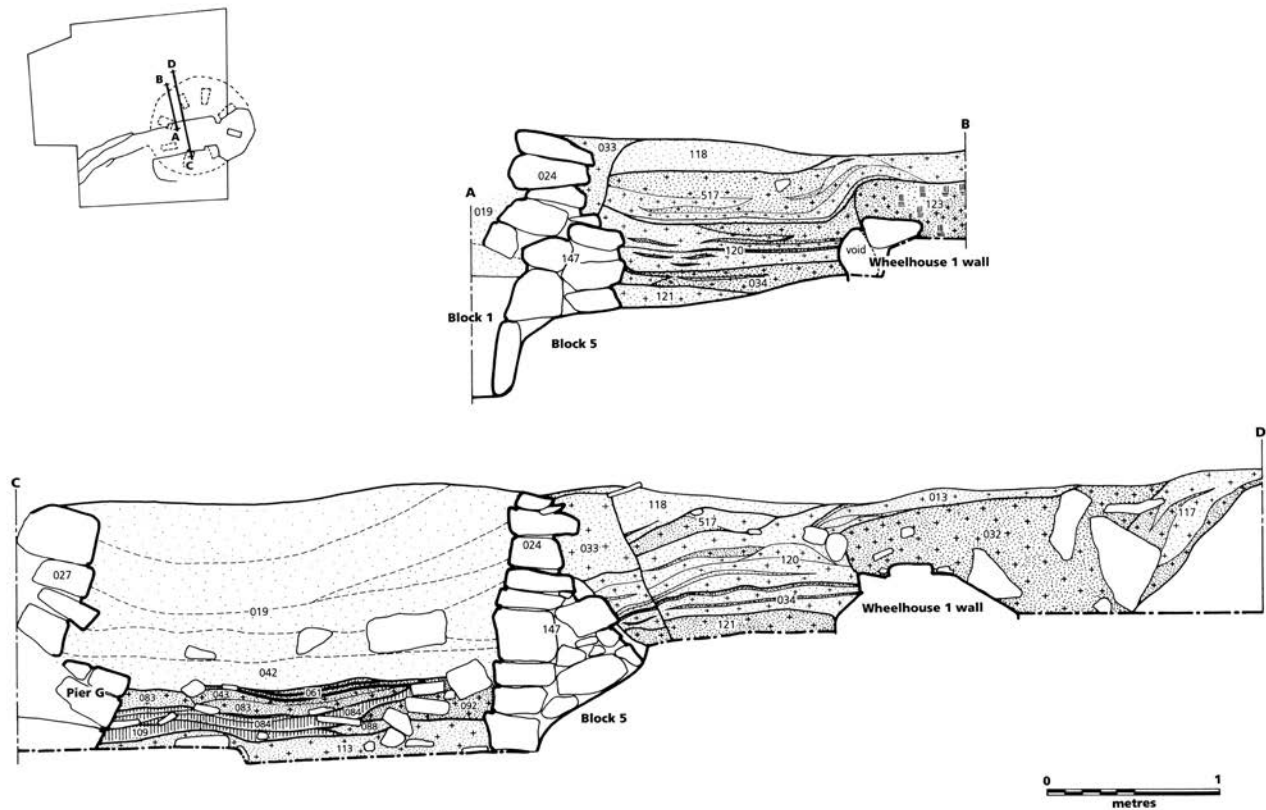
ILLUSTRATION 2.39  
Structure 8, sections through the interior, north wall and upper fill of Wheelhouse 1.

The condition of Wheelhouse 1, immediately prior to the construction of Structure 8, can be reconstructed to some extent. The walls around the circuit seem to have been reduced to around head height everywhere except for the two surviving corbelled cells on the south-east. The other bays were clogged with unconsolidated sand, rubble and midden (the latter presumably fallen roof packing or sealing material). The interior, however, does not seem to have been deeply buried, and we must assume that the central timber roof had been removed. The floor of Structure 8 was dug into the uppermost occupation deposits of Wheelhouse 1, over which only a thin coating of sand and rubble had accumulated (no more than around 0.4m at the centre, Ill 2.39).

The primary part of the north wall (C147) had a foundation course formed by slabs and boulders revetted directly against earlier deposits within the interior of Wheelhouse 1. It included the upper stone of a small rotary quern (SF086, see Section 3.6.2). A maximum of around 0.3m of Wheelhouse 1 occupation deposits appears to have been removed, although in places it was probably considerably less. Above this basal course the north wall of Structure 8 had a distinct outer as well as inner face and appeared in section as a free-standing structure (Ills 2.39–2.40).

of multi-phase construction on this side of Structure 8, although its periodic collapse and instability made investigation extremely hazardous. The published section does not, therefore, extend through this wall (Ill 2.39). Nonetheless, the impression of ad hoc re-use of the collapsed or dismantled wheelhouse superstructure is clear enough.

The final deposit within Structure 8 was a deep (c 1m) deposit of clean windblown sand (C019) which filled the structure to its wall-head (Ill 2.39). Numerous striations within the sand seem to show the pattern of deposition, with sand having formed against both walls leaving a linear hollow along the centre of the building. On the basis of observation of sand movement in the modern machair it seems likely that this structure could have infilled entirely within a short time after its final de-roofing; perhaps within a single winter.

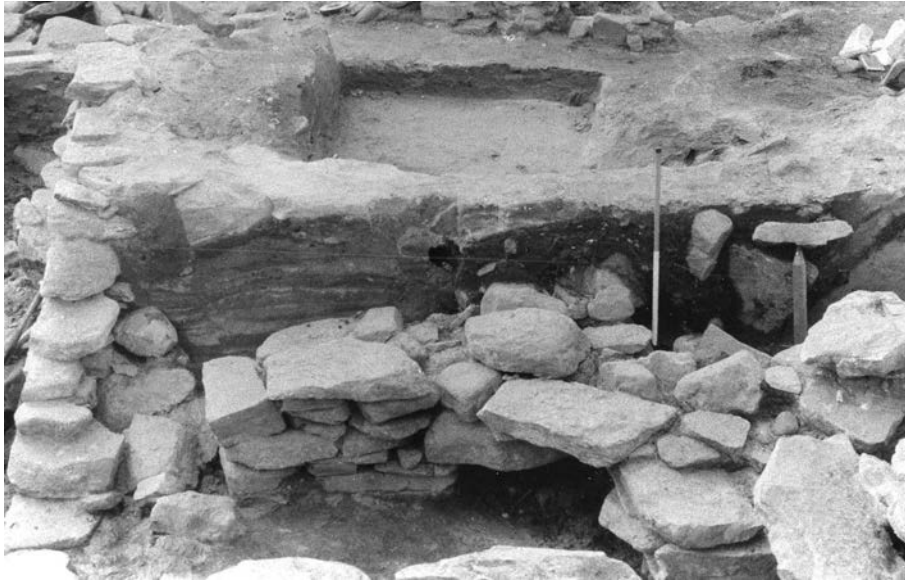
ILLUSTRATION 2.40

Photograph showing the section through the wall of Structure 8 and the upper fills of Wheelhouse 1. The upper part of Pier B can be seen in the foreground. The emergence of this pier made it impossible to maintain this section line at a lower level.

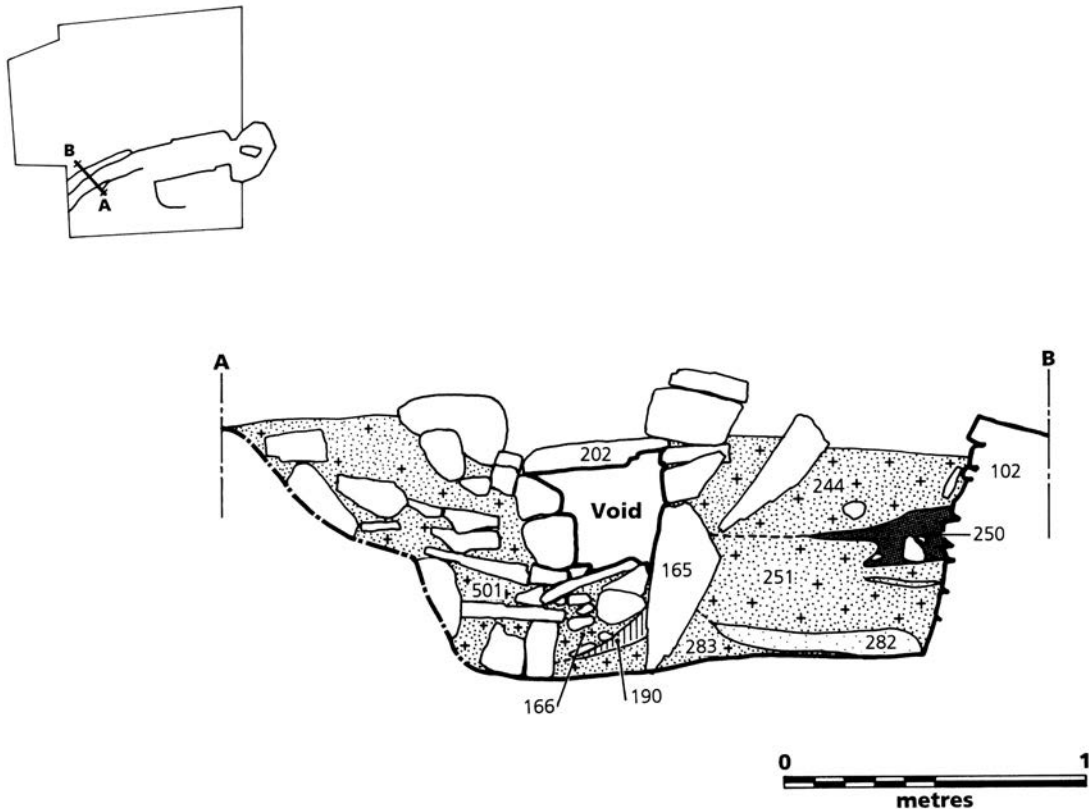
ILLUSTRATION 2.41  
Section across sump in the entrance to Structure 8.

This structure must presumably be envisaged as a sump rather than a drain since it ran downhill towards the Structure 8 entrance, which would have made it a peculiarly ineffective means of re-distributing unwanted water. Presumably the intention was simply to create a channel through which surface water could escape quickly through to the underlying natural sand. The material through which it was cut itself comprised mainly stained sands, but even the limited midden content of these deposits may have been sufficient to cause drainage problems in the constricted entrance passage. Conceivably, surface water may otherwise have found its way into Structure 8.
