A Cromwellian Warship wrecked off Duart Castle, Mull, Scotland, in 1653

Colin Martin

ARCHAEOLOGICAL INVESTIGATION

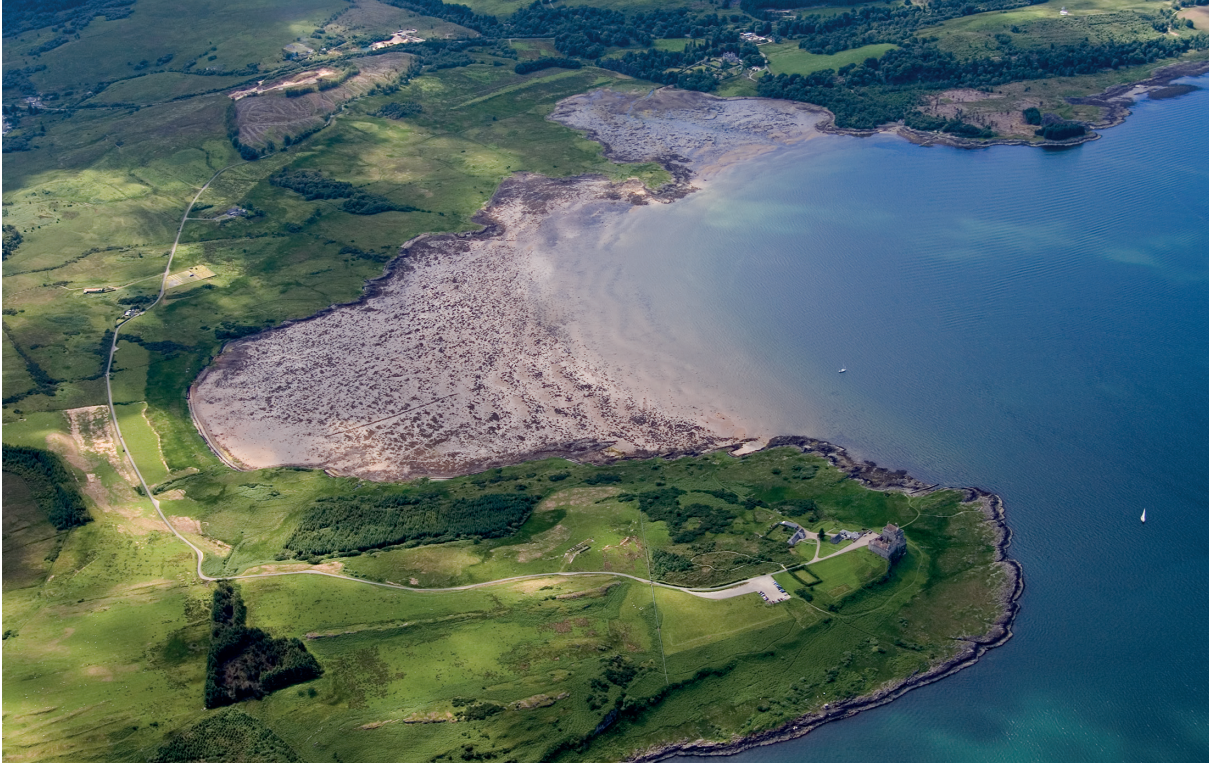
Illustration 53

Duart Point and Bay from the east, photographed at low water. Note the Bay's wide and shallow sandy fringe with deep water beyond (DP 173096)

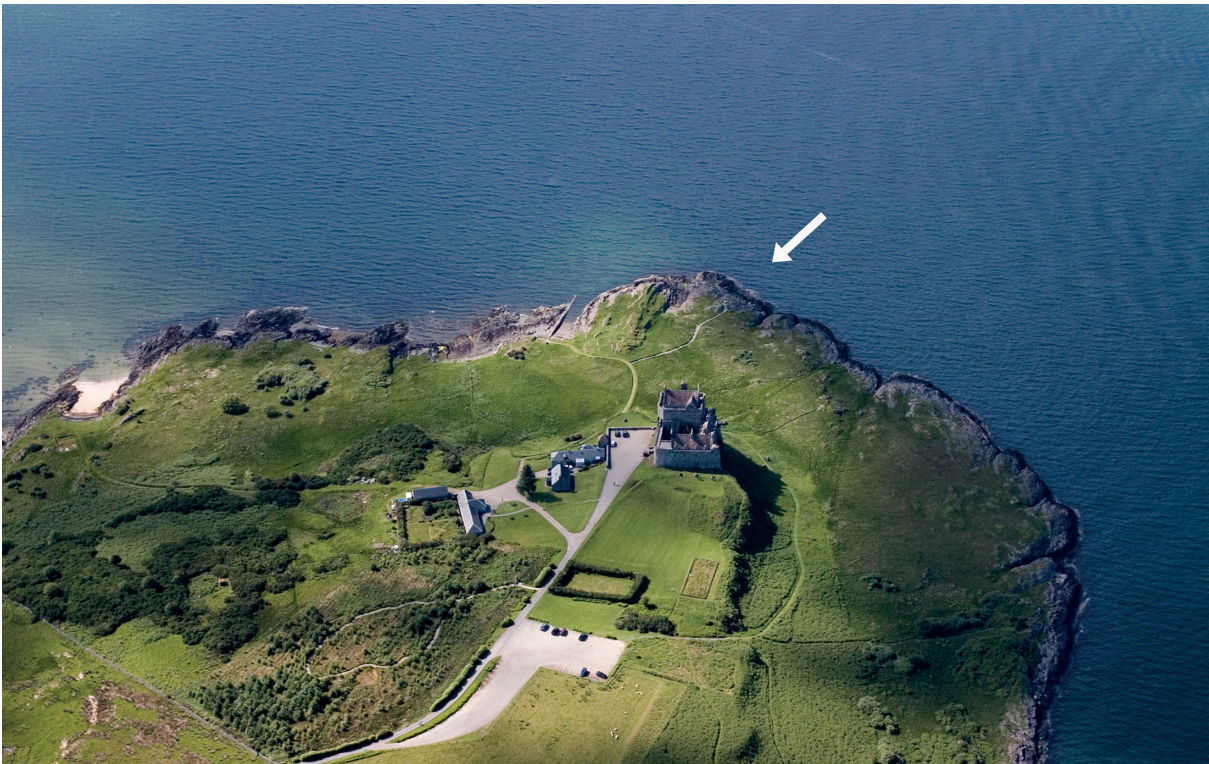
Illustration 54

Duart Point and Castle from the south, with the wreck-site arrowed. The sandy beach at the head of Port na Birlinn is at far left (DP 173100)

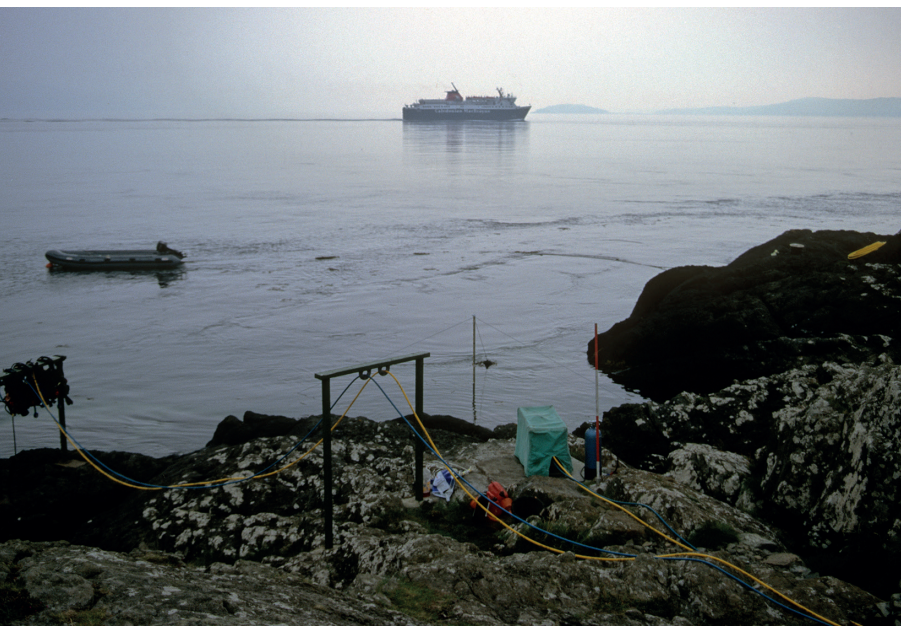
Illustration 55

View from the shore adjacent to the east end of the wreck, looking north-east. The strong easterly run of the tide is evident in line with the inflatable boat, with eddies curving from it towards the shore (DP 173709)

There is little water-movement around Duart Point during the flood tide, but throughout the ebb a strong current flows from north-west to south-east, reaching a surface speed of up to 2 knots during spring tides. This movement is evidently caused by the large volume of water which accumulates in Duart Bay as the tide rises, entering on a broad front from the north until high water is reached. During the ebb, however, some of the emptying water is deflected eastwards to flow in a clearly defined stream across Duart Point, eventually discharging into the confused waters where the Sound of Mull, Loch Linnhe, and the Firth of Lorn meet (*Admiralty Chart 2390* 1976). Just to the east of the Point, where the wreck lies, the inner run of the stream breaks off to eddy shorewards (Illus 55). When the ebb-current coincides with strong north-westerly winds a secondary effect is triggered. The pulses of waves which build up as they move unimpeded along the Sound break violently in the shallow fringes of Duart Bay, displacing large quantities of sand during the rising phase of the tidal cycle. Much of this material remains in suspension when water drains out of the bay on the ebb, to be carried with the stream which runs across Duart Point. Under such conditions the discoloured flow is clearly visible, its offshore edge sharply distinct against the clear water beyond (Illus 56). This phenomenon has had a significant effect on the wreck's site-formation characteristics, as explained below.

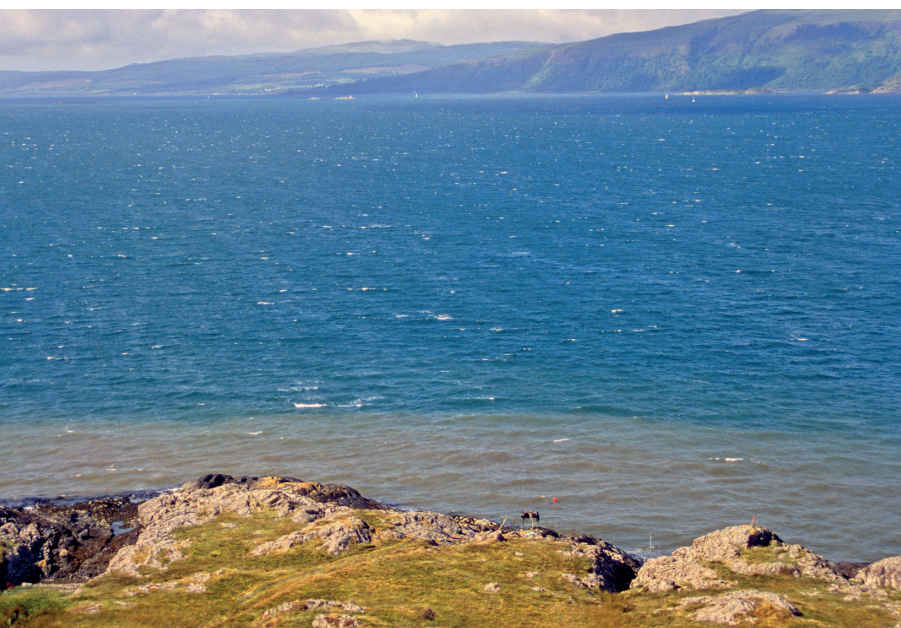
Illustration 56

View from the top of the castle looking north-west across the wreck-site at mid ebb tide in a Force 7 north-westerly wind. The inshore run of silt-laden water, with its sharply defined seaward edge, is strikingly evident (DP 173703)

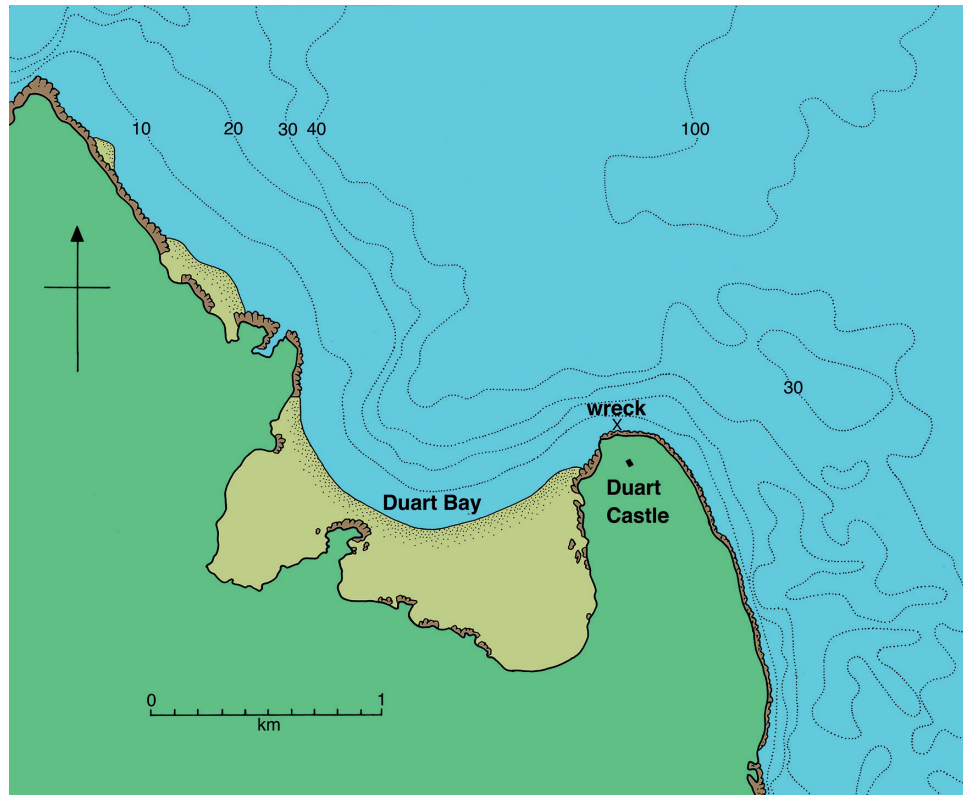
Illustration 57

Duart Point and Bay. Depth contours in metres (Edward Martin, adapted from Admiralty Chart 2390, 1976)

East of Duart Point a fissured rock-face slopes from the surface at an angle of $c 35^\circ$ to a sea-bed of gravel, sand, pebbles and shells among which the remains of the wreck lie at a depth of $c 7\text{m}$ below Mean Low Water Springs (Illus 57–8). There are some intrusive boulders and larger rocks, most of which were probably carried to the site by glacial action. The more substantial of these appear, from their relationship to archaeological deposits in their vicinities, to have been stable during the recent geomorphological past, and were probably in the same locations when the wreck took place. This was subsequently demonstrated by the way in which archaeological remains sometimes appear to have been

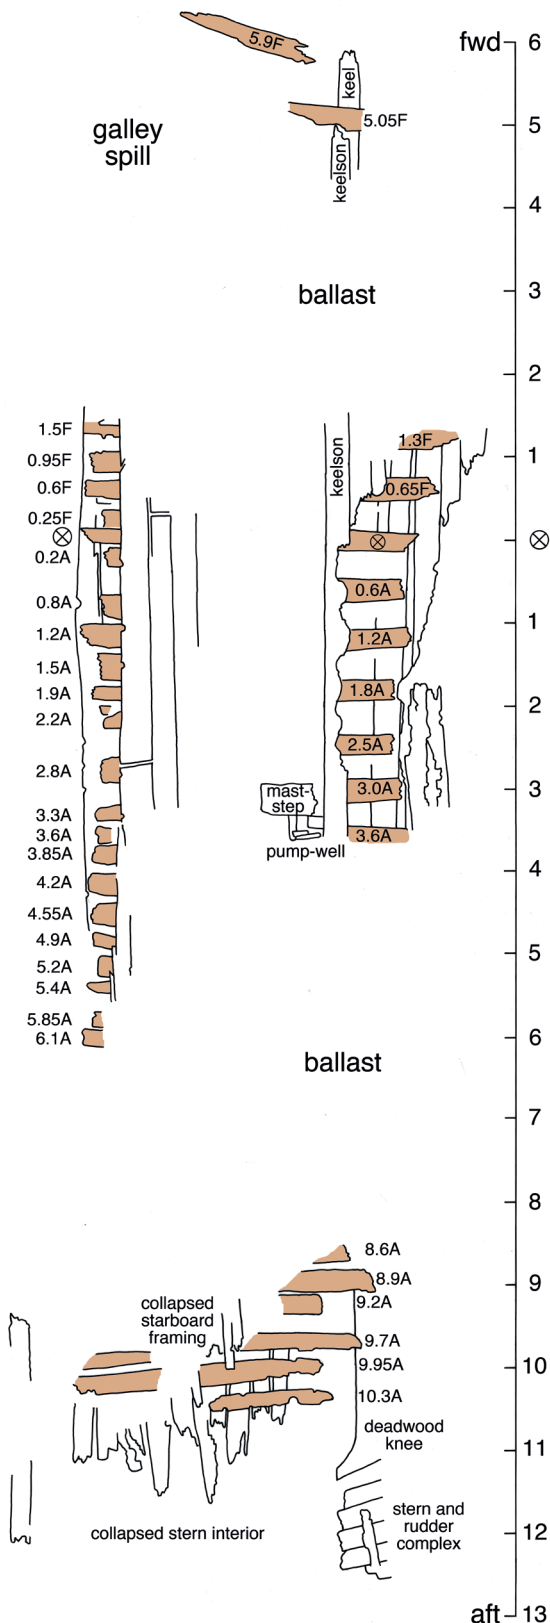
Illustration 60

Plan showing the surviving floor-timbers and frames (tinted). These are identified by their distances in metres forward (F) or aft (A) from the Master-Frame ⊗

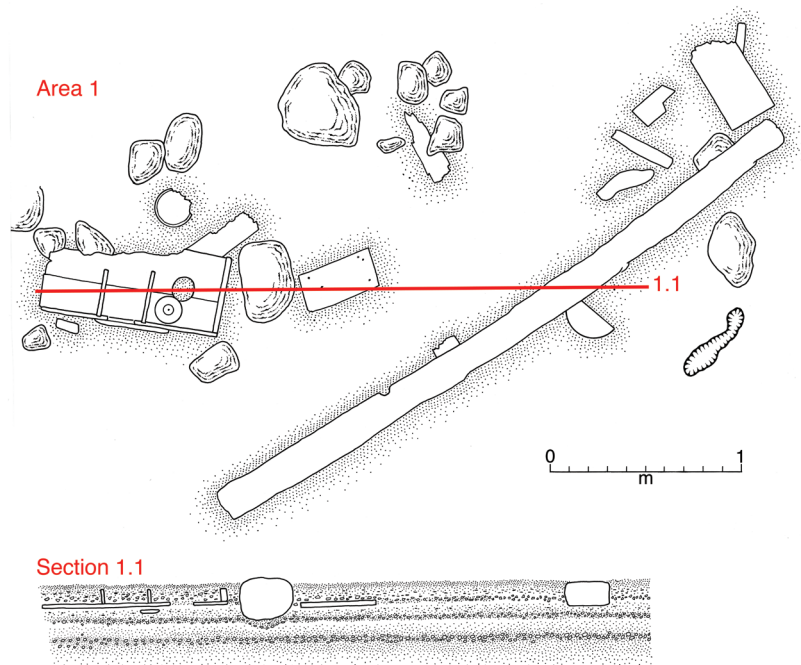
Illustration 61
Plan of Excavation Area 1 and Section 1.1

The stratigraphy of the first 0.5m is presented in Illus 61. Seven layers can be recognised. Layer 1 at the sea-bed/water interface is composed of fine grey silt, with a few inclusions of small pebbles and shells. Its condition suggests that it is mobile from time to time in currents and surges. Layer 2 is also grey, and consists of a band of silt similar to Layer 1 but with more shells and small pebbles. Layer 3 is a thin spread of larger pebbles. Below it, Layer 4 is a band of fine grey silt similar to Layer 1, while Layer 5 resembles Layer 3 with a spread of larger pebbles. Layers 1 to 5 are penetrated by razor shells (*Ensis siliqua*), including a flourishing live population. Layers 6–8 follow a pattern similar to the upper sequence but without the live razor shells, and are presumably stable. It is not unreasonable to suppose that the fine silts represent transport and deposition during relatively mild storm events as discussed above, while the pebble layers derive from more robust sea-bed agitation during rare 'super-storms' such as the one on 13 September 1653.

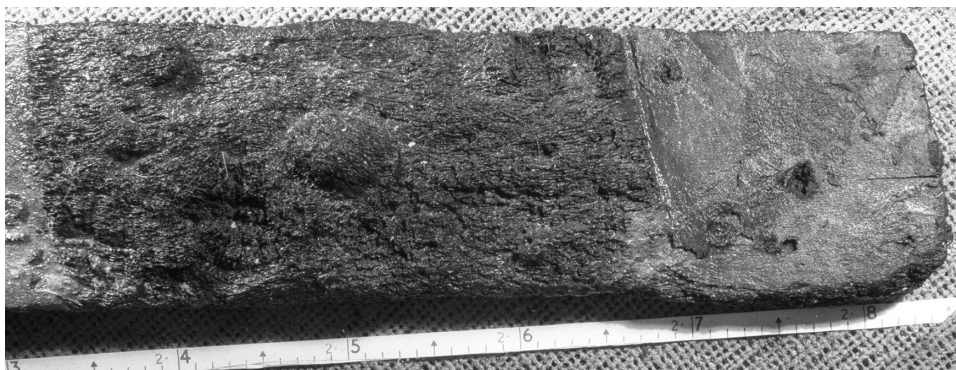
Illustration 62
Starboard end of the transom counter-timber [1] from Area 1. Note that in spite of the heavily abraded surface, relief decoration of a central boss and four smaller corner bosses remains visible. The end is slightly recessed, and shows a joint-face with an unabraded surface, revealing five nail-holes in a quincunx pattern (DP 173183)

from the upper-stern structure ¹ (Illus 62). Traces of raised decoration were visible near its presumed starboard end, while the outer surface showed evidence, in the form of unabraded joint-faces with fastening-holes, of six uprights which had been attached along its length. A fragment of one of the oak uprights remained in place. The unabraded character of these faces contrasts with the degraded surfaces everywhere else on the timber, suggesting that the uprights had remained in place for some time after deposition, and may have become detached quite recently.

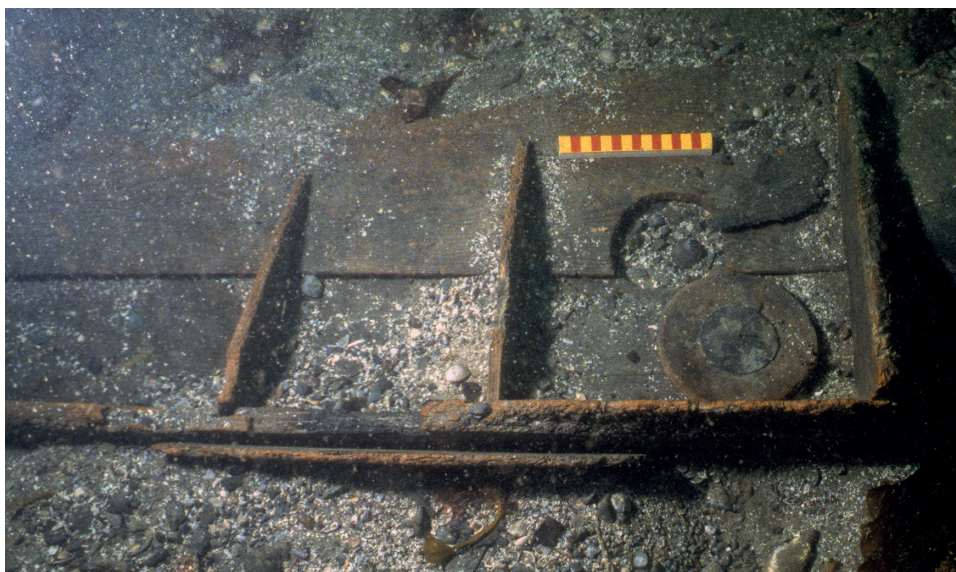
Illustration 63
The remains of the binnacle after excavation. Note the unabraded condition of the lower planks and the compass-base in the right-hand compartment, in contrast to the active biological and mechanical damage along the upper edges. Scale 15 centimetres (DP 174234)

Associated with this object were other presumed structural timbers, all heavily abraded, and half a barrel-end which showed little evidence of abrasion. Adjacent to the transom-beam, between **002.015** and **012.014**, were the remains of a box-like structure ⁸⁸ with three compartments (Illus 63). At one end was the base of a mariner's compass. The box was identified as the rear part of a binnacle cabinet (see Chapter 8.1), in which two compasses and a central lamp or candle would have been housed. Although in its original state the binnacle cabinet would have been some 30cm deep to accommodate the gimballed compass-bowls in their compartmented housings, only 12cm now survives, quantifying the extent to which the front part, lying uppermost, had once intruded into and above

The upper edges of both the binnacle and the transom-timber lay at the interface between Layers 1 and 2, while the interior of the binnacle-box appears to have attracted a filling of rather larger pebbles which may have helped to protect it. Though the surviving upper parts of the binnacle have suffered some biological and mechanical degradation, its lower parts are relatively well preserved, the rear planking showing clear tool-marks on its surface. It seems likely that the bottom of Layer 3 represents the sea-bed profile at the time of the wrecking, and that the material above (Layers 2 and 1) is composed of post-wreck sedimentation. This interpretation broadly reflects the interpretation of stratification in an open wooden chest [110], discussed below.

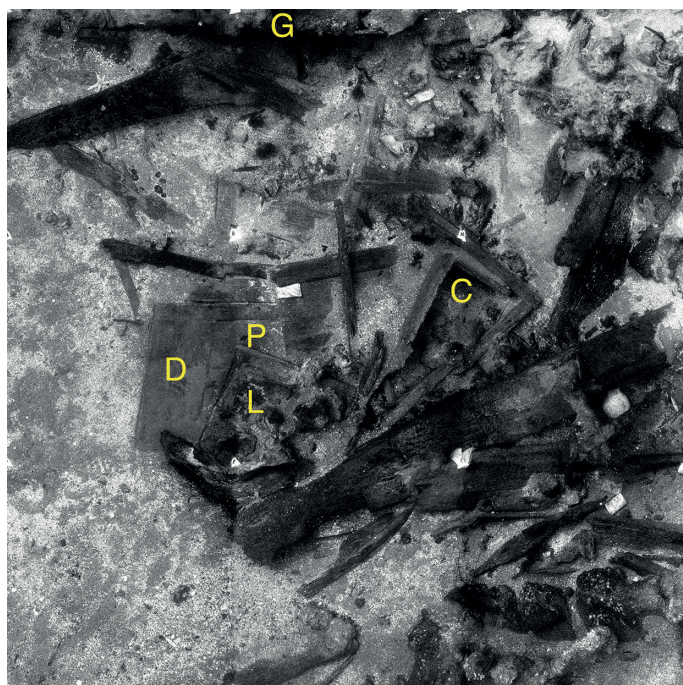
Illustration 65

Vertical mosaic showing the framed-and-panelled door [17] (D), gun-port lid (L), run of panelling [21] (P), open chest [110] (C) and Gun 8 [82] (G)

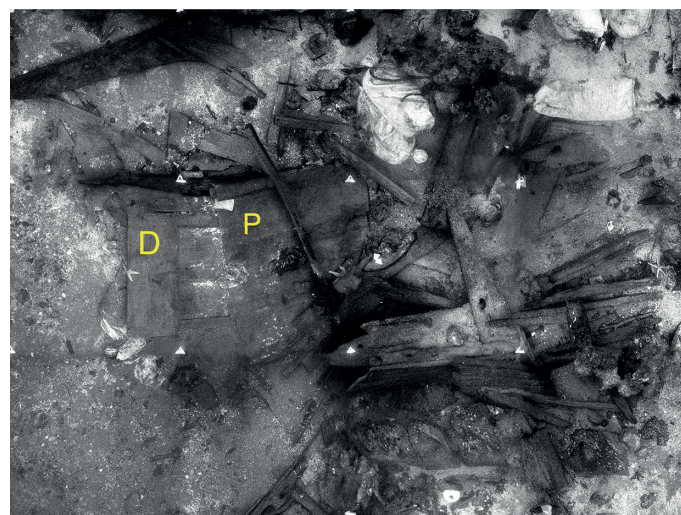
Illustration 66

Vertical mosaic showing door [17] (D) and panelling [21] (P) after removal of the gun-port lid and chest. 1m grid indicated by triangular targets

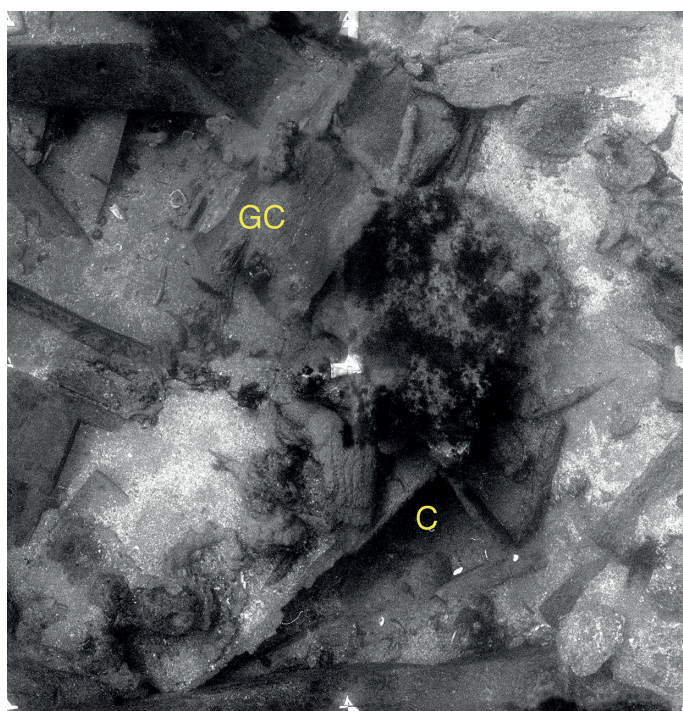
Illustration 67

Vertical mosaic showing detail of the inverted gun-carriage [83] (GC) and the open chest [110] (C)

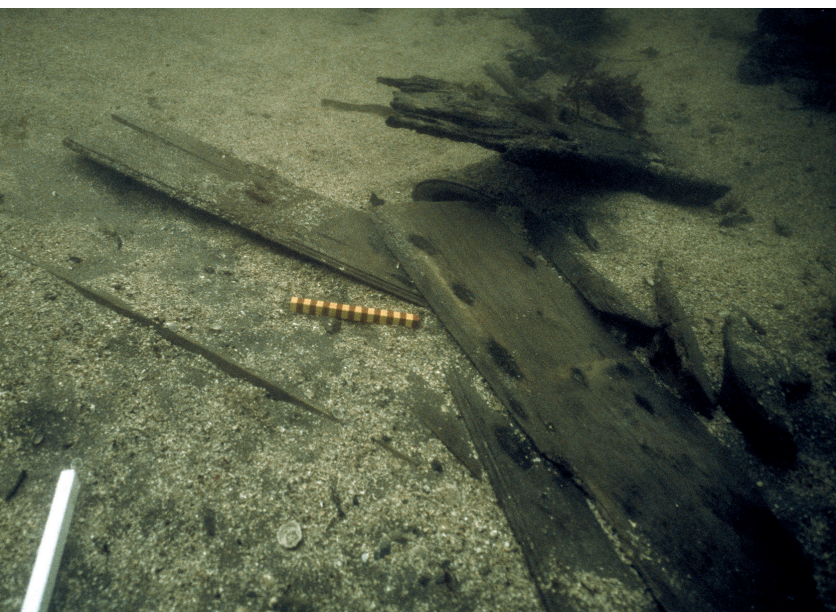
Illustration 68

Edge-moulded pine planking near the inshore end of Area 3. Note the relatively unbraded state of the lower timbers, in contrast to the highly degraded condition of the rising upper piece, which has clearly lain within earlier unstable levels. The plank in the foreground shows no evidence of degradation apart from the stains of corroded iron nails and, at its top left-hand edge and corner, infestation by barnacles. This pattern is continued by the mouldled-edged plank which extends towards the upper left, where the 'tide-mark' between infested and uninfested zones is very clear. The infestation, however, is relatively slight, and may reflect a recent short episode. The edge of a wooden lantern-top [200] can be seen towards top centre: this lies within the previously buried zone and is well preserved. Scale 20 centimetres (DP 173727)

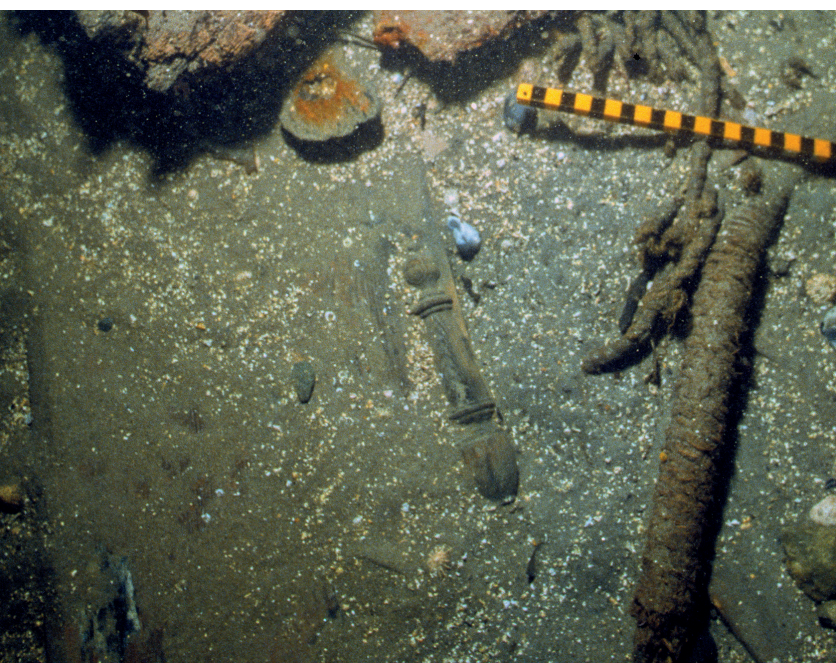
Illustration 69

Pine planking in Area 3 showing a turned decorative piece in situ. Scale in centimetres (Steve Liscoe, DP 173695)

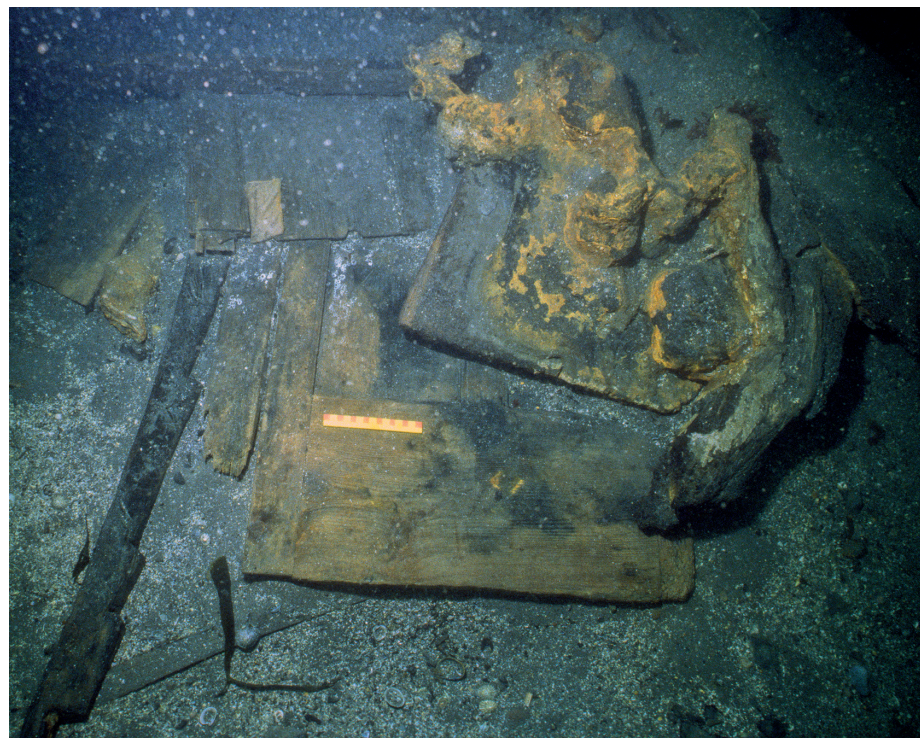
Illustration 70

Collapsed aft interior deposit associated with the framed-and-panelled door [17]. The door is overlain by a run of paneling [21] (top, just left of centre) which in turn is overlain by a gun-port lid partly obscured by concretions associated with its iron strap-hinges. On the left is a notched frame-timber [12] from a quarter-gallery roof. Scale 15 centimetres (DP 173890)

Just beyond this deposit, and running in a line from **060.110** to **095.074**, the clearly defined edge of the main organic deposit was encountered. This deposit consisted mainly of substantial and well-preserved timbers from the interior of the ship (Illus 65–7). It included edge-moulded pine planks (Illus 68) and associated turned decoration (Illus 69). A complex stratified deposit comprised a gun-port lid at **088.087** lying on top of a framed-and-panelled door [17] and a run of panelling [21] incorporating four articulated muntin-and-panel sections (Illus 70–2).

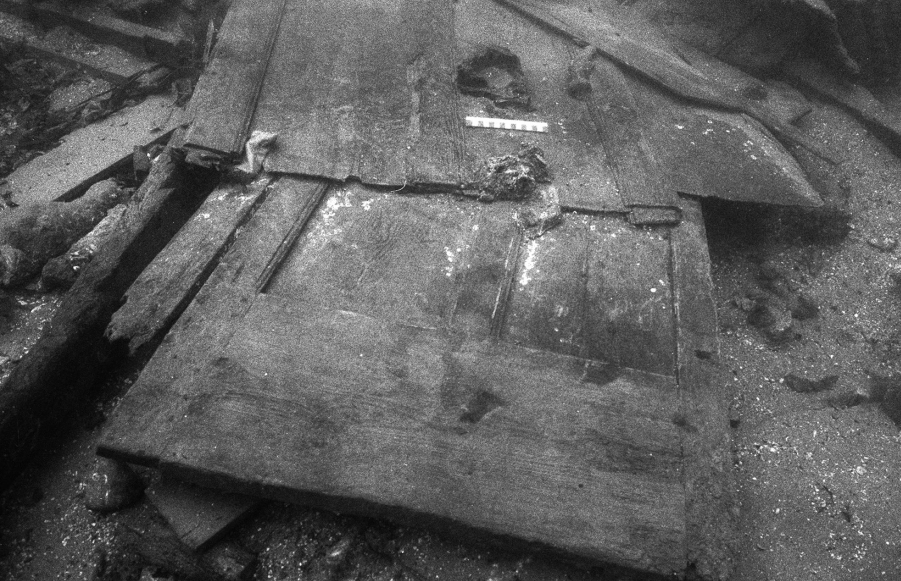
Illustration 71

The framed-and-panelled door complex after removal of the gun-port lid. Three segments of framed panelling [21] lie on its upper half. Scale 15 centimetres (DP 173139)

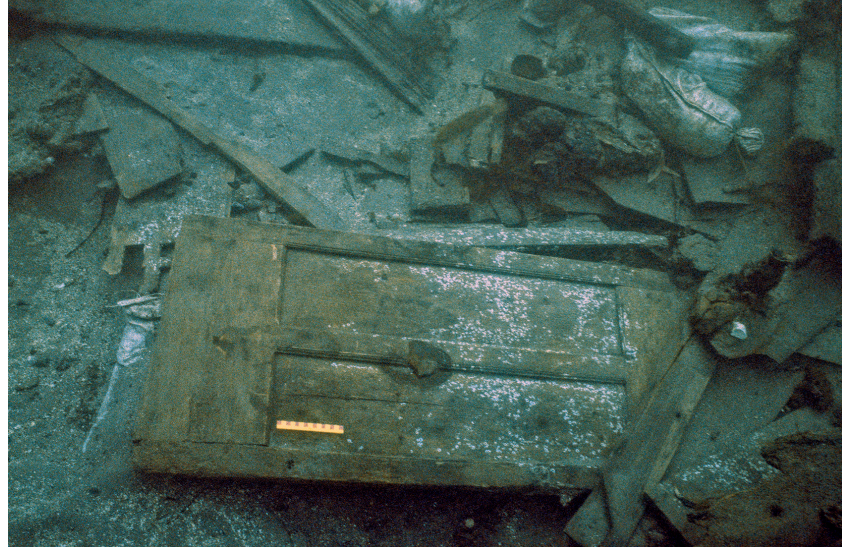
Illustration 72

The framed-and-panelled door [17] with the framed panelling above it removed. Scale 15 centimetres (DP 173893)

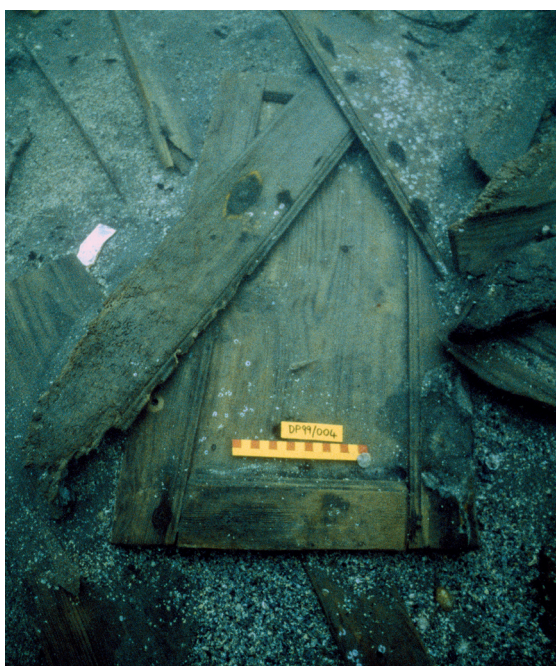
Illustration 73

Framed single-panel cupboard door [18] overlain by moulded-edged planks. Scale 15 centimetres (DP 173904)

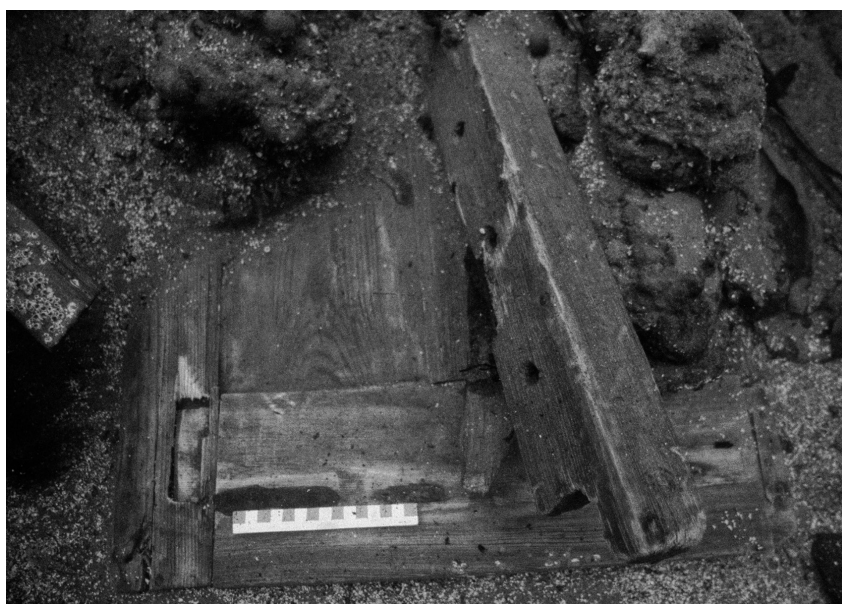
Illustration 74

Framed two-panel cupboard door [19]. Scale 15 centimetres (DP 173908)

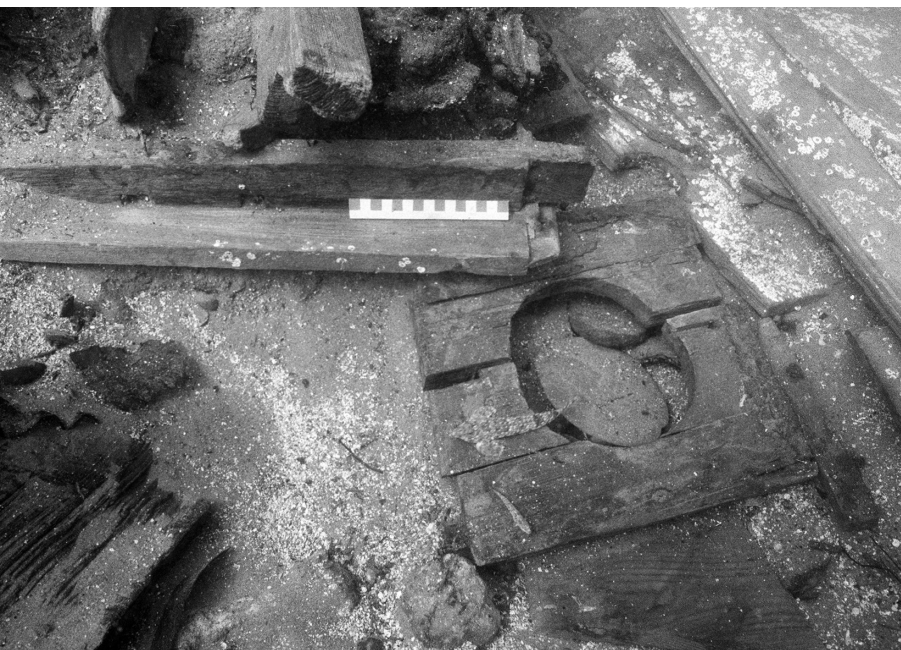
Illustration 76

Quarter-gallery roof-frame [12]. The lower part of a carved moustachioed face is above it, and the bottom corner of the articulated run of framed panelling [21] lies to its right. At top right are the partially excavated remains of the drake gun-carriage [83] with its resident crab inside. Scale 15 centimetres (DP 174043)

Although excavation was not continued below the level of the door, it was evident that more material lay further down, confirming that the deposit was over 0.5m deep and consisted of stratified material almost certainly derived from the interior of the stern cabin. Close by were two small framed-and-panelled cupboard doors [18–19] at **094.096** and **077.103** (Illus 73–4). Other features adjacent to the complex included an oval wooden port-surround (**091.095**) (Illus 75), part of a carved face [6] (**086.095**), and a notched timber [12] identified as a quarter-gallery roof-frame (**085.095**) (Illus 76).

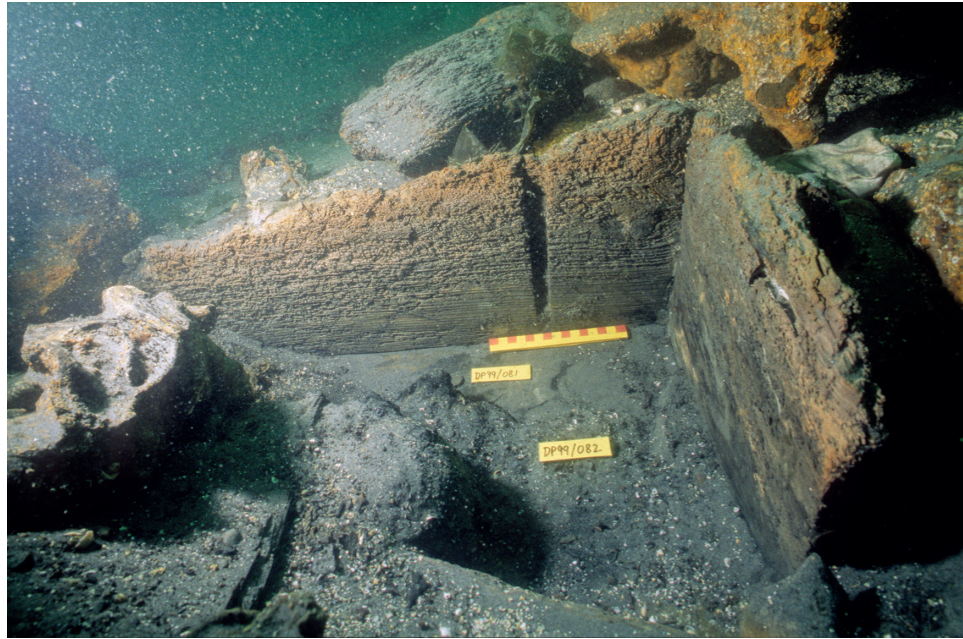
Illustration 77

The remains of a wooden chest [110] after excavation. It was filled with silts which had accumulated following its deposition. Scale 15 centimetres (DP 173925)

been almost wholly reduced by abrasion towards the other (see Chapter 8.4) (Illus 77). There was no lid, and no trace of the second side, while only a fragment of the second end survives. In its original state the box would have measured $c 1.06\text{m} \times 0.37\text{m} \times 0.27\text{m}$ deep. Its internal stratigraphy is illustrated in Illus 78. The chest had either been almost empty when deposited, or perhaps had contained perishables of some kind. Lying on its largely intact bottom-plank were two concretions containing three pieces of cast-iron roundshot [86] (the only examples recovered from the site), three lead musket balls, and small pieces of wood and fibre. These

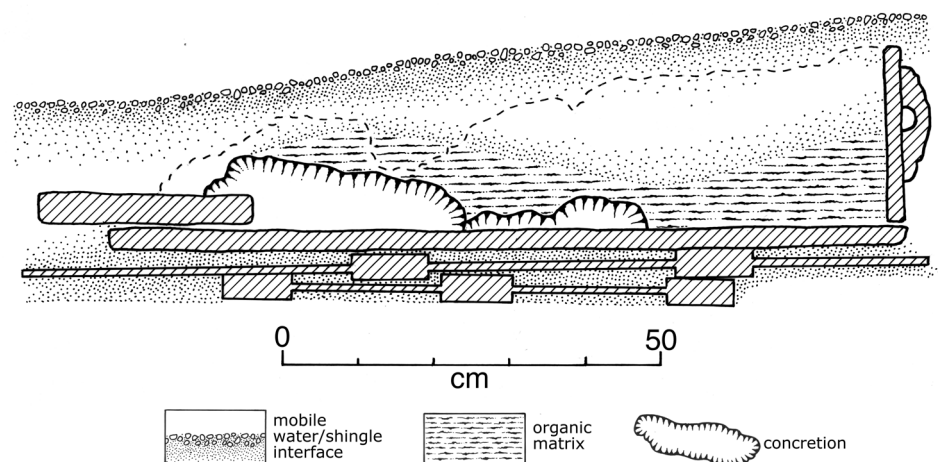
Illustration 78

Section 3.2, showing post-wrecking sedimentation within the chest [110]. The dotted line indicates the extent of the surviving side

finds were associated with a layer of fine grey silt mixed with fragmented organic matter (Layer 3). Above it, and continuing almost to the top of the chest, was a homogeneous matrix of similar grey silt without organic inclusions (Layer 2). On the top surface of Layer 2 was a single musket ball. The top layer (Layer 1) was a semi-mobile cover of sand, pebbles, and shells characteristic of the natural sea-bed at this location. Its occasional movement will have been responsible for the erosion of the upper edges of the chest.

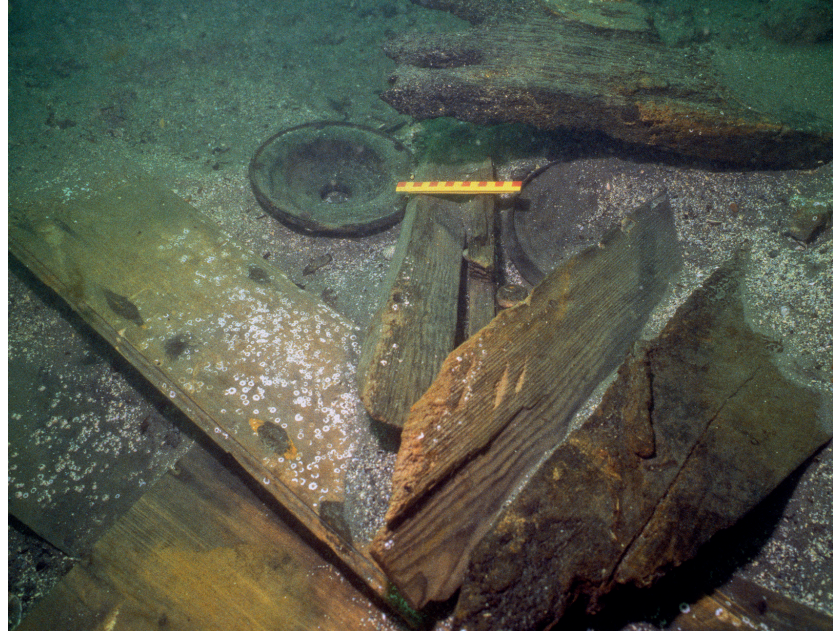
Illustration 79

The concretioned minion drake [82] during excavation (the 15cm scale lies along its top axis). Note that the slanting timber above it is eroded at its top end, which indicates the level to which it has previously been exposed, but lower down the lack of erosion confirms burial since deposition. The gun therefore lies within the zone of permanent burial, which partly explains its excellent preservation. The edge of the oar-port lid [38] is visible at centre left (DP 174275)

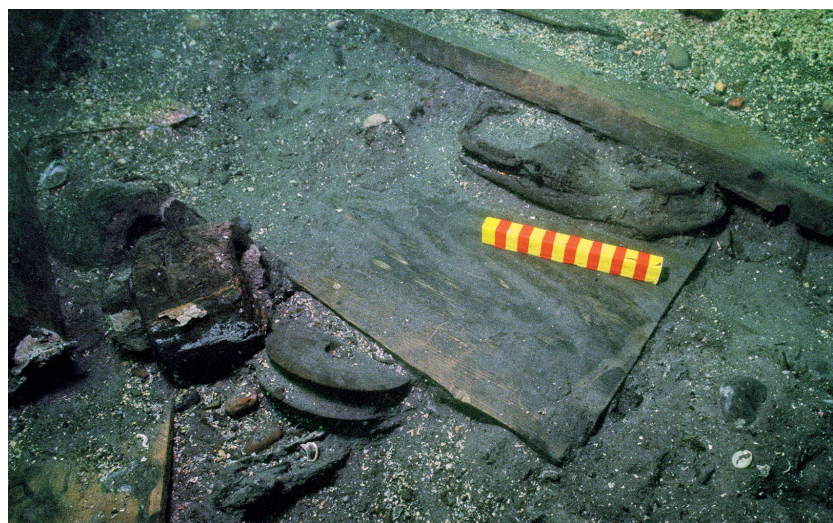
Illustration 81

A wooden oar-port lid [38] with iron strap-hinges concretioned to the side of the minion drake [82]. The surface of the gun runs along the bottom of the photograph. A wooden deadeye [65] is concretioned to the oar-port lid's upper right corner, while below the 15cm scale is a small square of glass surrounded by corroded lead, which can be identified as a quarry from the glazing of the stern-cabin windows (DP 173937)

iron-studded wooden lid with strap-hinges [38], identified as an oar-port lid (Illus 81). Concreted to the cover's ironwork was a wooden deadeye [65] and a square piece of window-glass surrounded by the lead comes by which it would have been joined to its neighbours. Other loose comes [16] were found close by. Adjacent to the gun, at **090.096/093.104**, lay its inverted carriage [83]. This area also contained several dislocated elements of the ship's external decorative carving and parts of the outer structure.

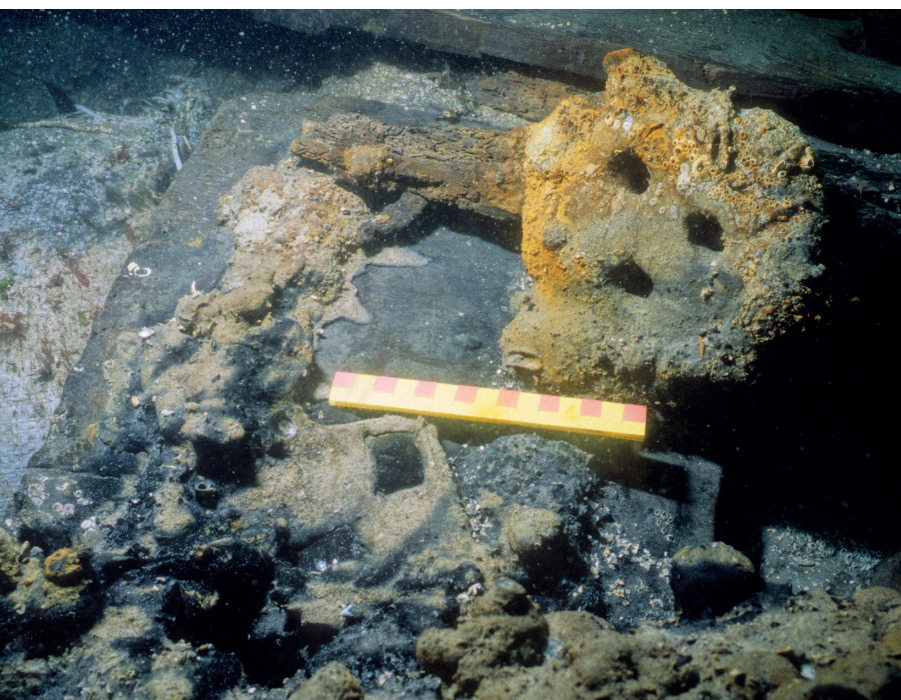
Illustration 83

A shoe, wooden sheave and two pump-valves (far left) incorporated in the stratigraphy of the collapsed interior stern structure. Scale 15 centimetres (DP 174022)

Among the collapsed stern deposit various loose artefacts were found (Illus 82–5). These included a wooden lantern-top, sheaves, leather shoes, pump-valves, a pewter plate, and a powder-cartridge box. This deposit also yielded high-status items including a pocket-watch [118], a gold-and-silver sword-hilt [107], and part of a high-quality pistol [104]. Most of the decorative carvings came from this area. Lead musket shot and human bones were also present in the silt (Illus 86).

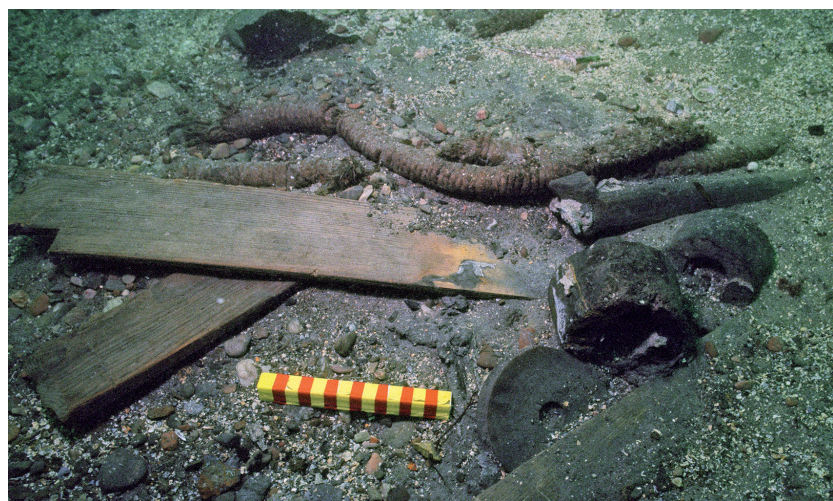
Illustration 84

Parcelled rope, sheave, and pump-valves. Scale 15 centimetres (DP 174021)

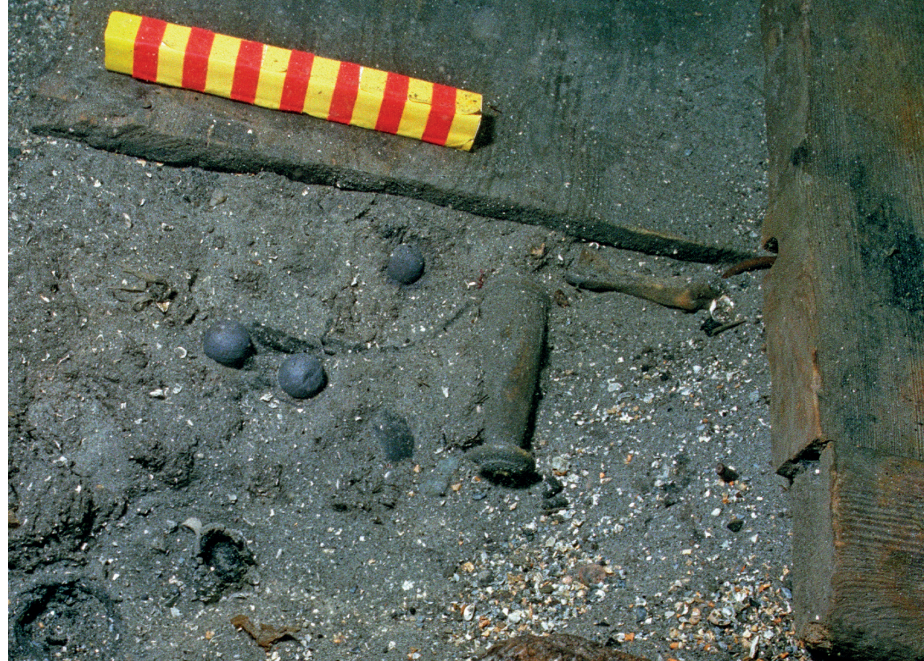
Illustration 86

Deposit with lead musket shot, a turned panel decoration and a human finger-bone. The grey silt is typical of the drifted material common across the site.
Scale 15 centimetres (DP 174036)

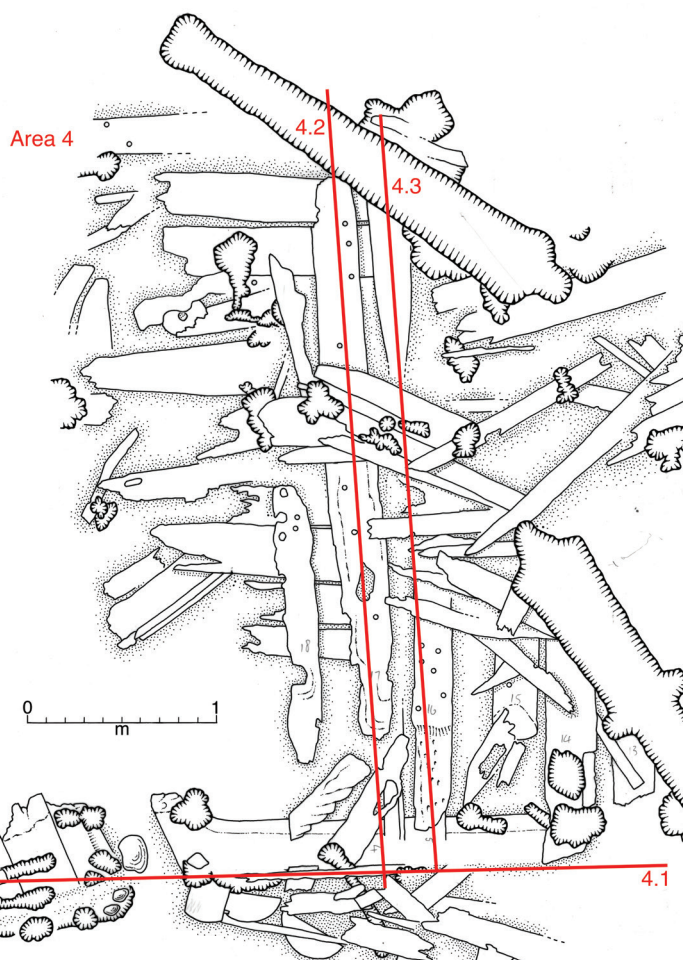
Illustration 87
Plan of Excavation Area 4

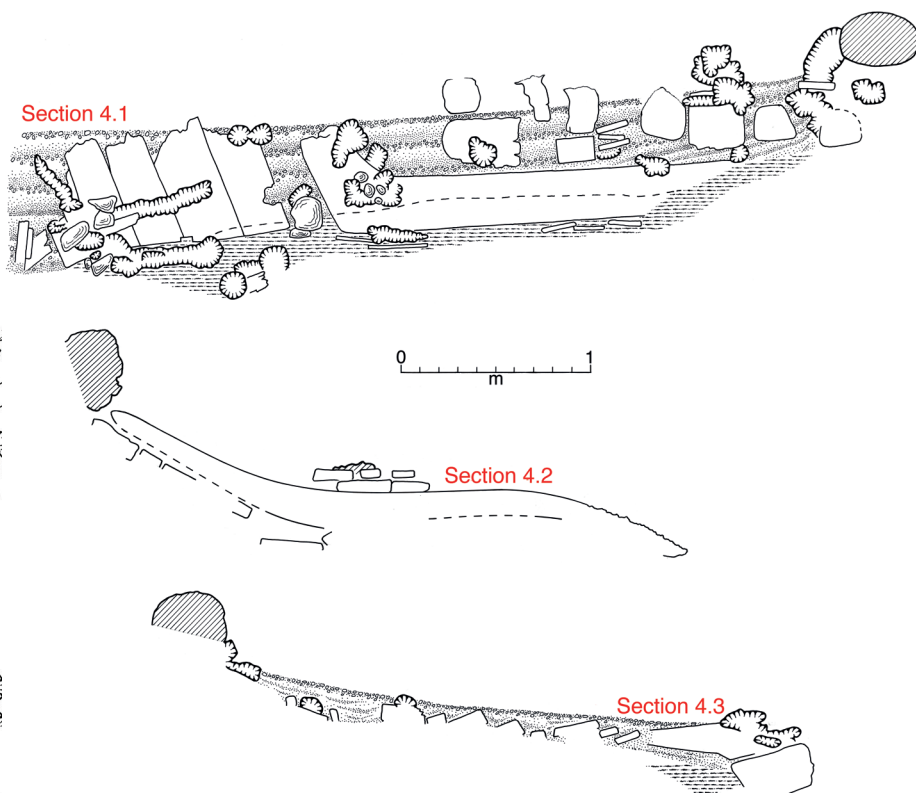
Illustration 88
Sections 4.1, 4.2 and 4.3

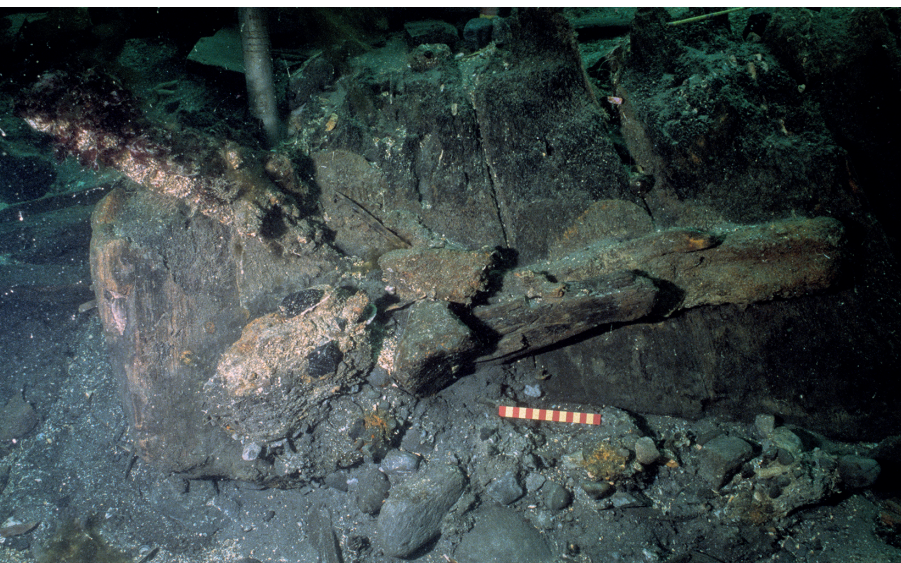
Illustration 89

Lower stern structural complex. The left-hand element is the bottom of the rudder's inboard timber, the upwardly bent iron concretion rising from it being a pintle strap. The next timber to the right is the foot of the sternpost, followed by two pieces of vertically set deadwood. The concretion joining these three timbers is the strap of the lower gudgeon. Scale 15 centimetres (DP 173804)

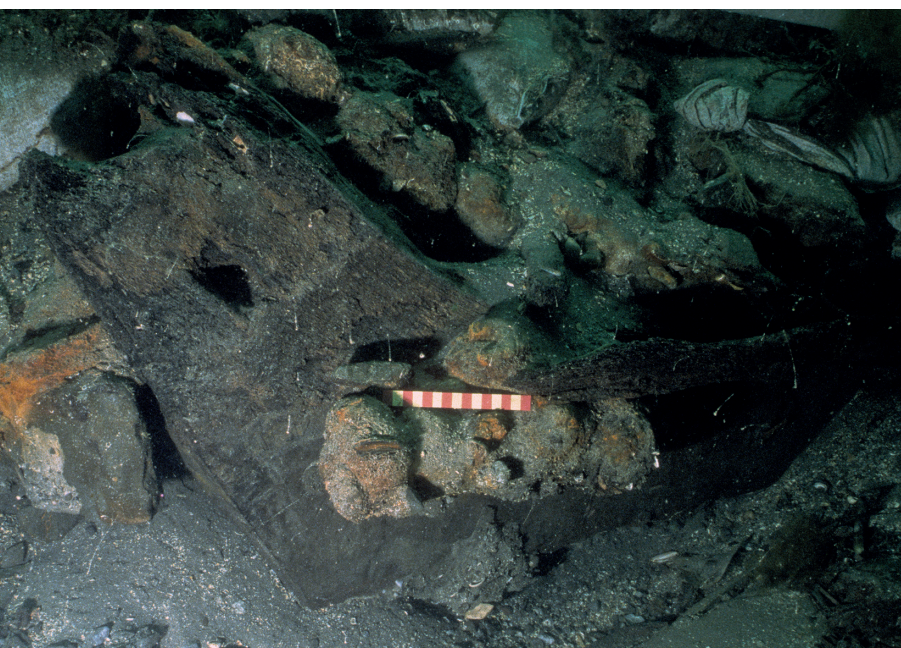
Illustration 90

Deadwood-knee. Scale 15 centimetres (DP 173822)

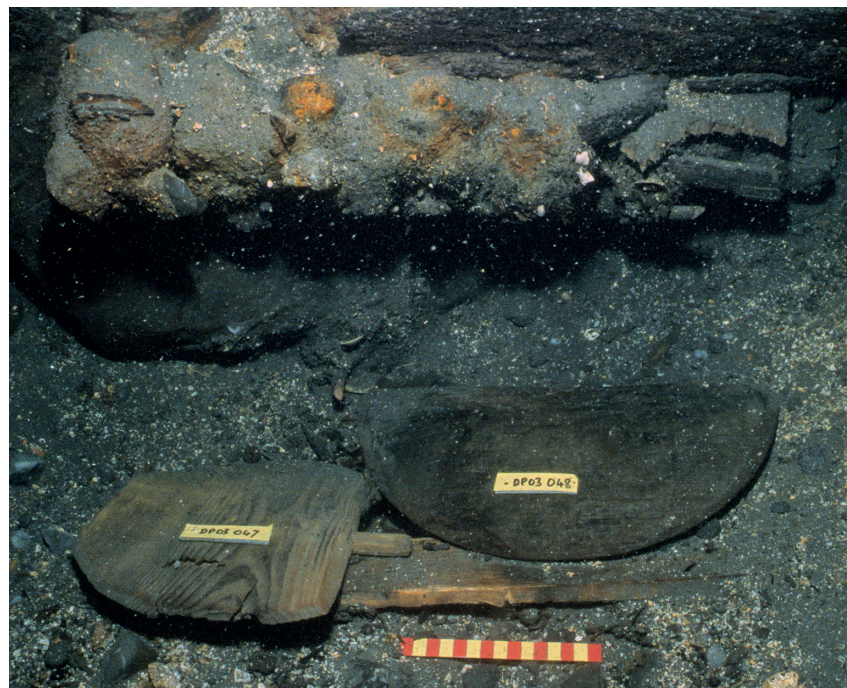
Illustration 91

Wooden butter-crock lid [189] and part of a cask-end [45] in the organic matrix beside the deadwood-knee. Scale 15 centimetres (DP 173942)
