A Cromwellian Warship wrecked off Duart Castle, Mull, Scotland, in 1653

Colin Martin

ARCHAEOLOGICAL INVESTIGATION

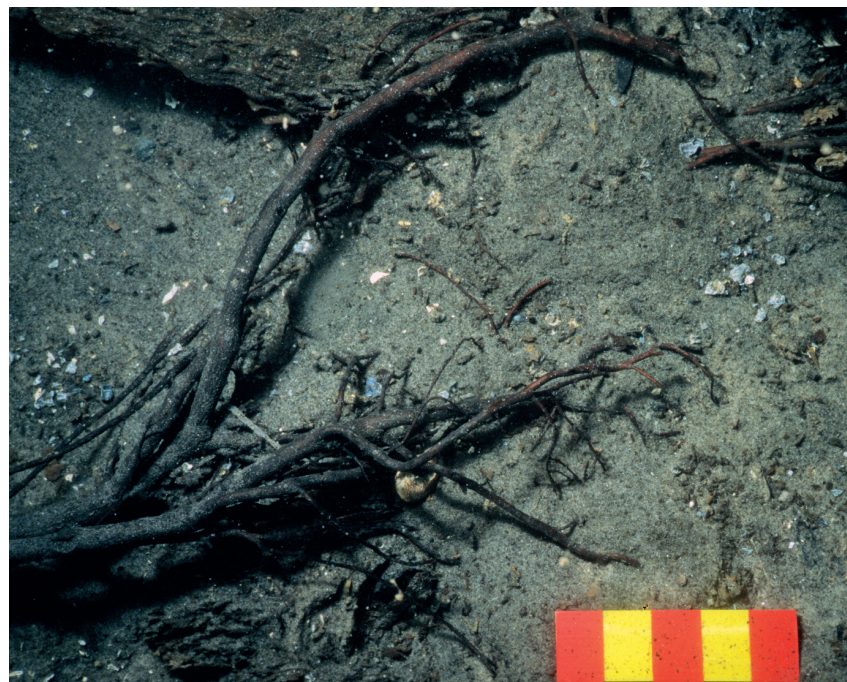
Illustration 92

Heather dunnage associated with ballast towards the stern. Scale 5 centimetres (DP 173764)

stern assemblage closely aligns with the longitudinal axis of the keel and keelson at the midships and forward parts of the hull, described below (Areas 6 and 7). The forward end of the deadwood-knee continued under the eastern ballast-mound, beyond which it was not followed. It was noted, however, that a cushioning of heather had been placed between the timbers and ballast-stones in this area, and samples were recovered (Illus 92).

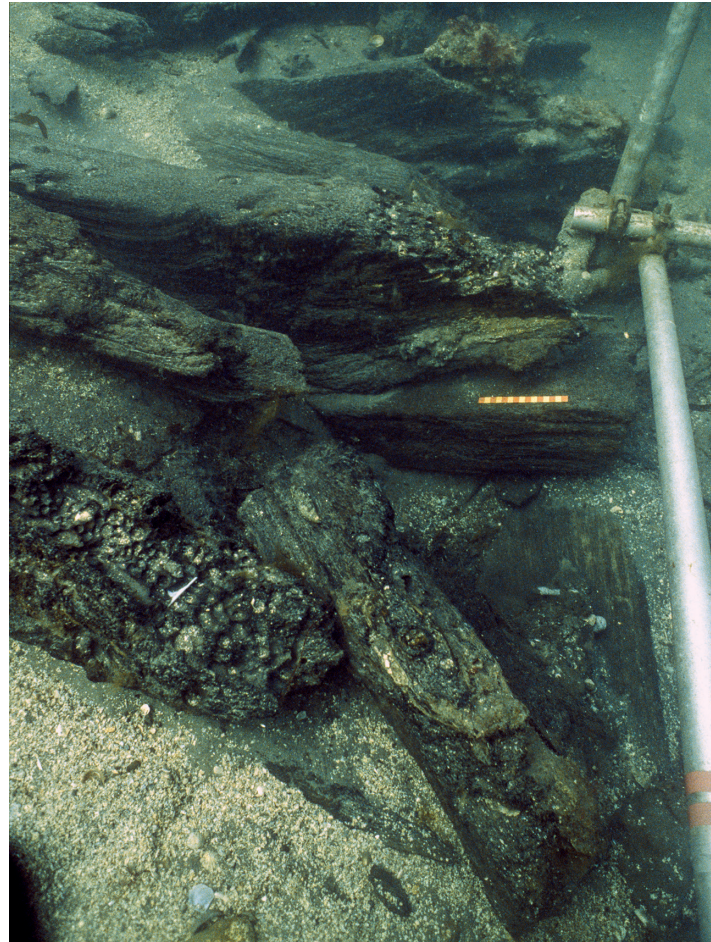
Illustration 93

Detail of construction at Frame 9.7A (see Illus 60). The top face of the keelson (or possibly part of the deadwood) is seen running forwards from the lower right. Bolted to it is a chock with flared sides (identified by the 15cm scale lying on it). From this the upwards-curving port side of Frame 9.7A rises towards the left. Nothing remains of its starboard side, which because of the ship's heel would have been above the stable sediment zone. Whether this was a separate piece or a 'grown' timber whose grain structure matched the required shape is unknown (DP 173873)

dislocated and abraded oak timbers which run at right-angles to the presumed keel-axis. These are evidently frames approaching the stern, and are numbered 8.6A, 8.9A, 9.2A, 9.7A, 9.95A and 10.3A (Illus 60). Their centreline spacings are approximately 0.3m (1ft). Their lie suggests they have fallen onto their sides and stabilised on the sediment slope at the foot of the rock-face. Frames 8.9A and 9.2A are associated with trapezoidal chocks or cross-pieces which, though now displaced (Illus 93–6), evidently coupled them to the

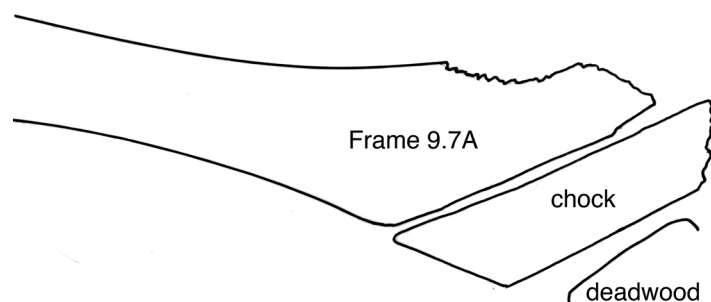
Illustration 94

Diagrammatic representation of chocked Frame 9.7A

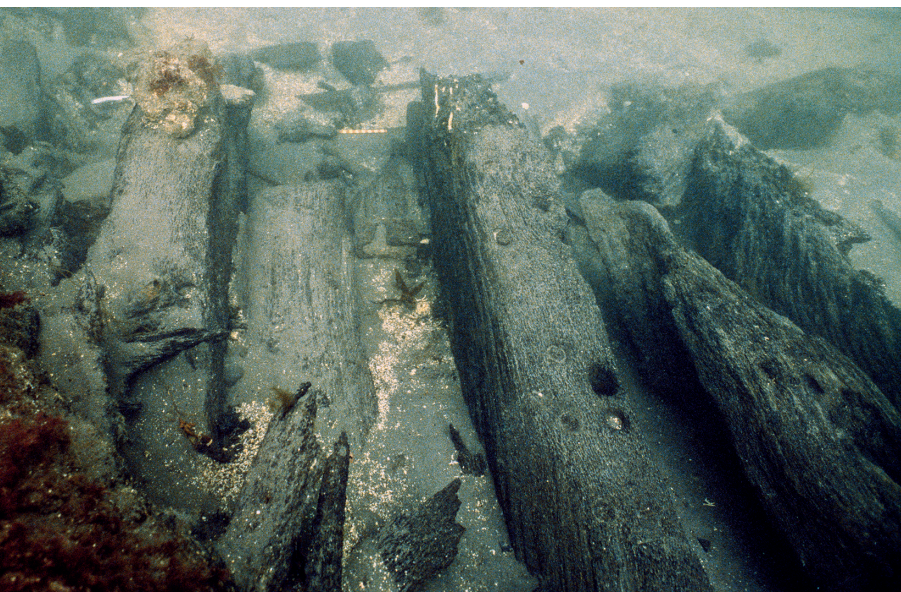
Illustration 95

Inboard ends of the aft port-side framing, looking to starboard. From the left they are Frames 8.9A (with concretions at the end), 9.2A, 9.7A, 9.95A and 10.3A. Part of Gun 2 is visible at lower left (DP 173818)

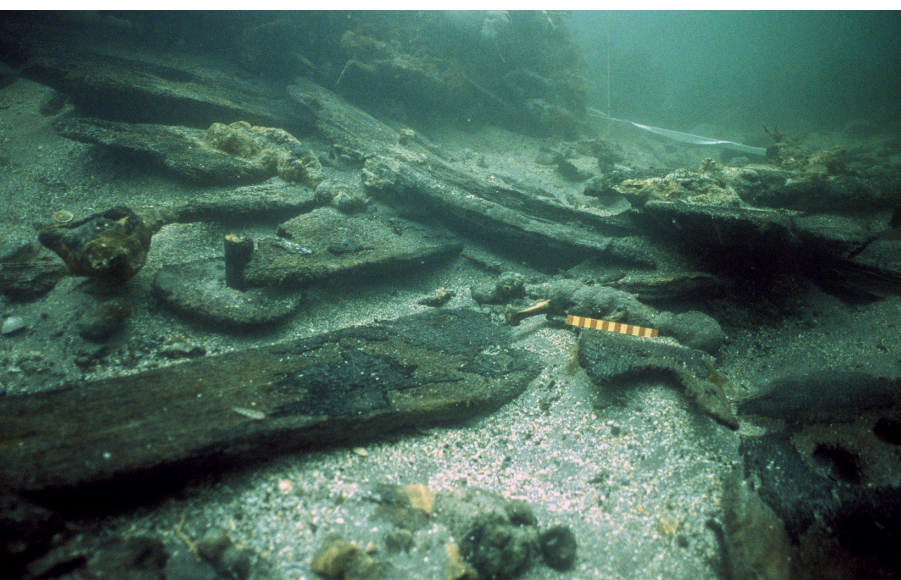
Illustration 96

The abraded and partly dislocated upper stern framing and planking, looking towards Gun 1 (top centre). The curvature of the framing is evident. Scale 15 centimetres (DP 173819)

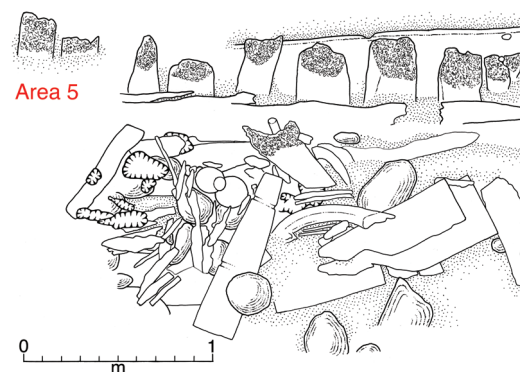
Illustration 97
Plan of Excavation Area 5

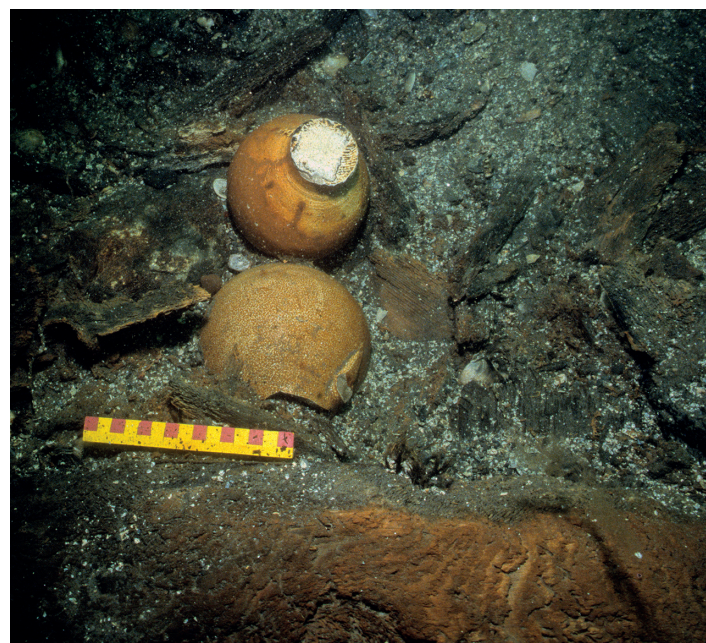
Illustration 98

The deposit in Area 5, with two stoneware jars 129-30 exposed. Scale 15 centimetres (DP 174200)

As well as loose ballast-stones, the curve of the bilge was filled with a jumble of fragmented and dislocated wood, rope, and other artefacts. These included two stoneware jars (Illus 98), a pewter 'tappit hen', several heavily degraded silver coins, a wooden oil-box, and a tapered circular-sectioned wooden

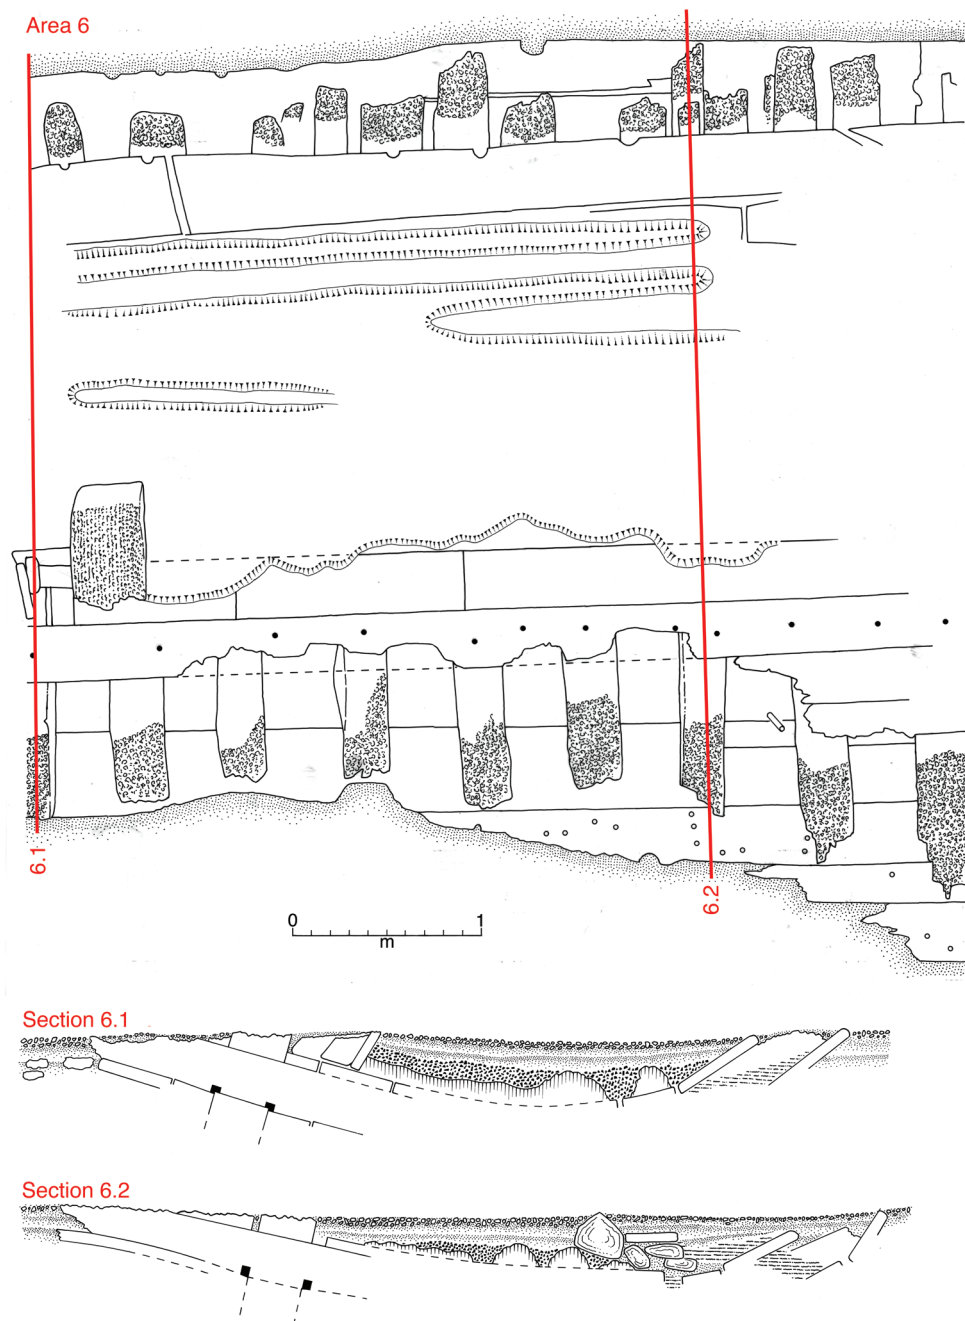
Illustration 99

Plan of Excavation Area 6 and Sections 6.1 and 6.2. Section 6.2 is aligned along the Master-Frame ⊗

could be planned, and two partial cross-sections obtained (Illus 99–101).

The sections (Illus 99) were taken across Frame 3.0A and the Master-Frame ⊗, consistent with minimising disturbance to the articulated structure. The hull at both sections is heeled to port at an angle of $c 15^\circ$, so that most of the exposed starboard side has been removed by abrasion, but the buried port structure survives to the start of the rising curve at the bilge. In both sections the stratigraphy contained within the slight concavity of the lower hull’s profile is similar. The top level (Layer 1), as elsewhere on the site, is characterised by a semi-mobile cover of pebbles, shells, and sand. Beneath it (Layer 2) is a more stable level of greyish silt, interspersed with darker bands. Layer 3 is a distinctive layer of dark gravel containing water-worn sherds of pottery, which has been interpreted as a ballast component (see Chapter 6.1). It lies on top of another layer of ballasting material, Layer 4, made up of light clay, which in turn lies directly on the ship’s ceiling planking. Within the voids created by the frames and the inner and outer planking a thick viscous sludge of organic material (Layer 5) has accumulated. Analysis shows that this contains fragments of wood, fibre, leather, and bone, but no

The longitudinal axis of the vessel is defined by the abraded keelson, visible between **181.071** and **237.065** and continuing beneath the ballast at each end (Illus 99–100). This much-

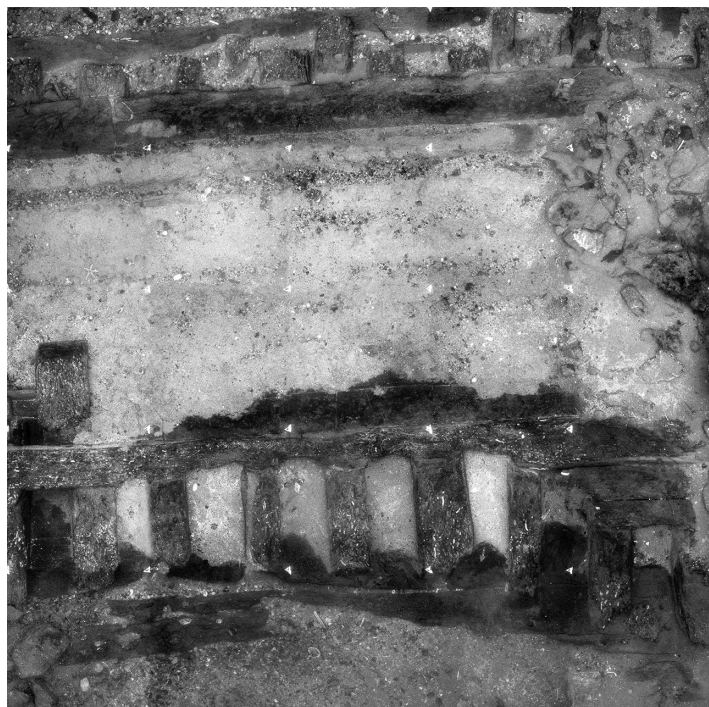
Illustration 100
Vertical mosaic of the central hull-structure

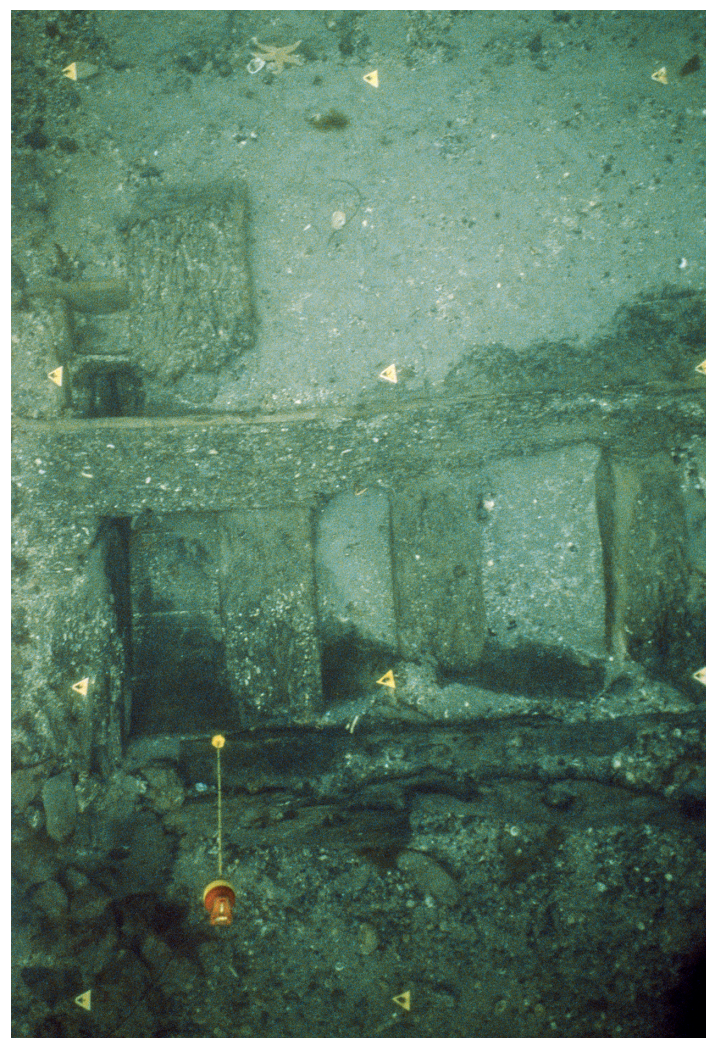
Illustration 101
Detail of the central midships area showing (from bottom) fragmentary starboard-side planking, starboard-side floor-timbers, the abraded keelson, the port-side pump-sump and box (top left), and the abraded remnants of the transverse mainmast-step to its right. The yellow triangular targets are at 1m intervals (DP 173806)

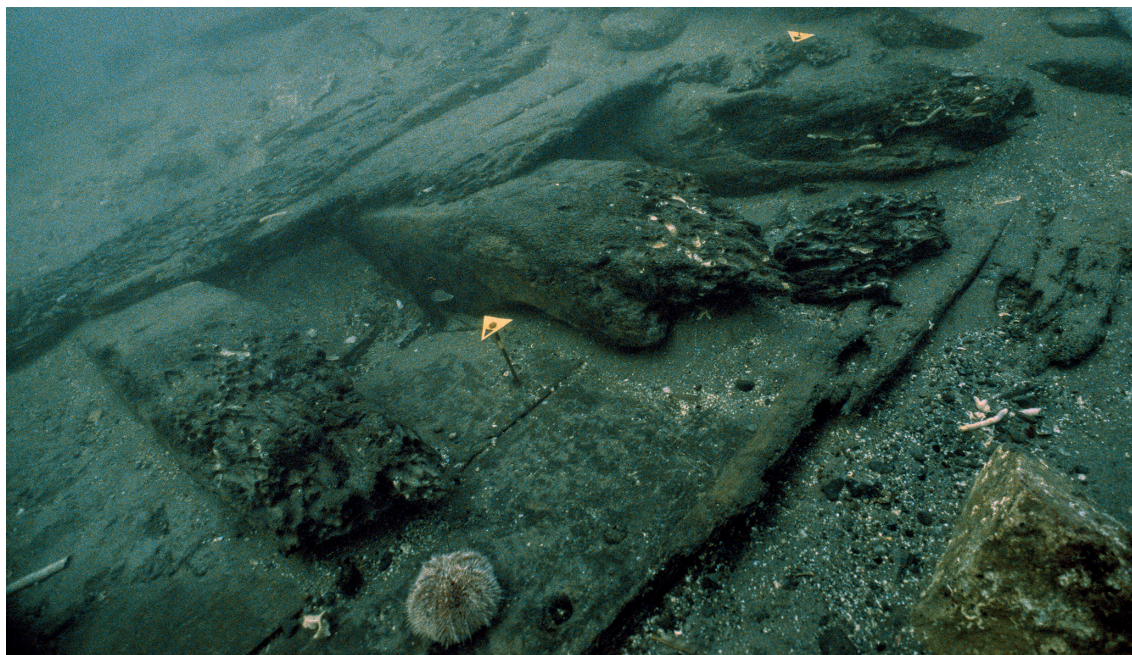
Illustration 102

From left: Frames 0.6A, Master-Frame ⊗ and 0.65F on the starboard side just aft of the forward ballast-mound (DP 173803)

Along the outer port side of the surviving structure, between **190.100** and **240.096**, a run of 12 closely spaced squared timbers continue the line of nine frames described in Area 5. Their sided and moulded measurements range from 0.17 to 0.22m ($6\frac{3}{4}$ to $8\frac{3}{4}$ in) and 0.17 to 0.29m ($6\frac{3}{4}$ to $11\frac{1}{2}$ in) respectively (Illus 102). These timbers are angled some

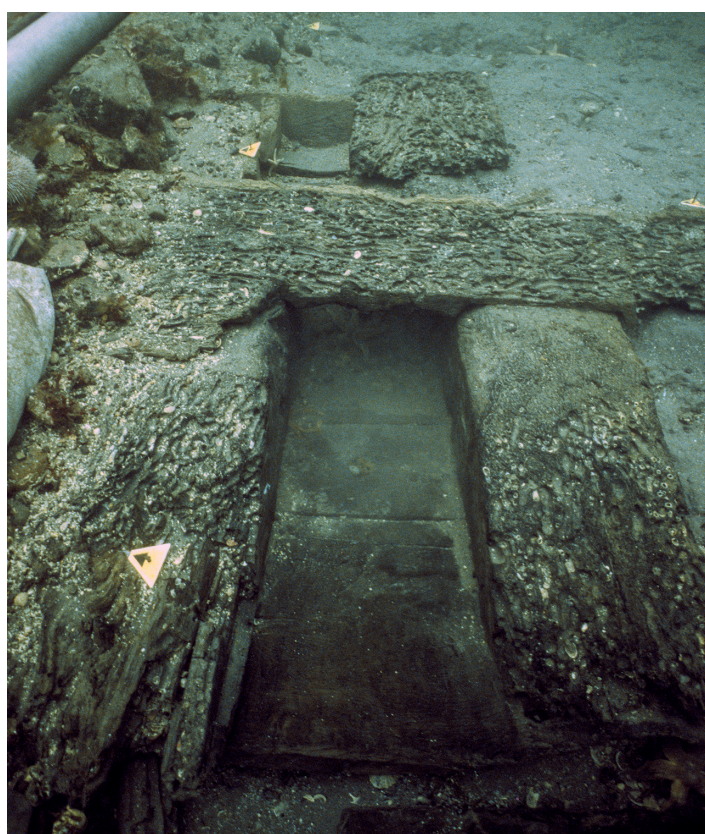
Illustration 103

Oblique view of the central midships section. The abraded keelson is notched over the starboard-side floor-timbers, and the outer planking is visible between them. The yellow triangular targets are at 1m intervals (DP 173779)

of a pump-sump (Illus 103–4). It consists of an open box measuring $0.2\text{m} \times 0.3\text{m}$ ($8\text{in} \times 12\text{in}$) made up of short pieces of 50mm (2in) plank. A corresponding sump appears to have been provided on the starboard side. Though its components have been destroyed by erosion, a shallow rebate has been cut on the forward face of the adjacent frame (187.068), presumably to accommodate the side-planking of a box replicating the port-side one. As both sections show, 40mm ($1\frac{1}{2}\text{in}$) square holes have been cut through the bottoms of the frames on either side of the keelson (Illus 105). These are limber-holes, which allowed water to flow freely along the lower axis of the ship towards the pump-wells (Manwaring & Perrin 1922: 180). No trace was noted of the light limber-ropes normally threaded through the limber-holes so that blockages could be freed along the length of the framing (Manwaring & Perrin 1922: 180). The ship's pumping arrangements are discussed more fully in Chapter 6.3.

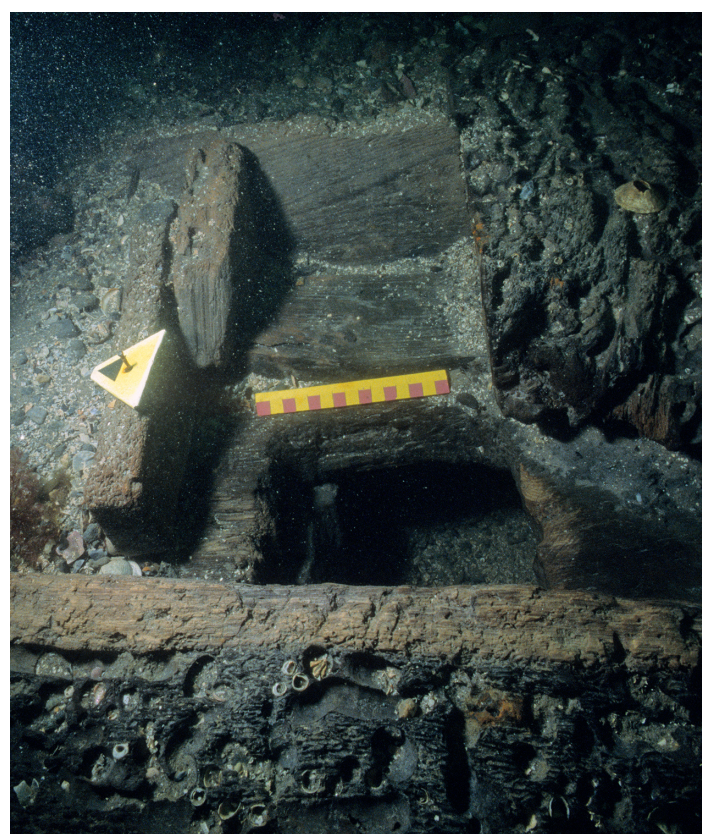
Illustration 104

Oblique view of the pump-sump and mast-step complex looking to port. The abraded and shipworm-damaged surface of the keelson (across bottom of picture) and transverse mast-step (top right) are clear. Scale 15 centimetres (DP 173777)

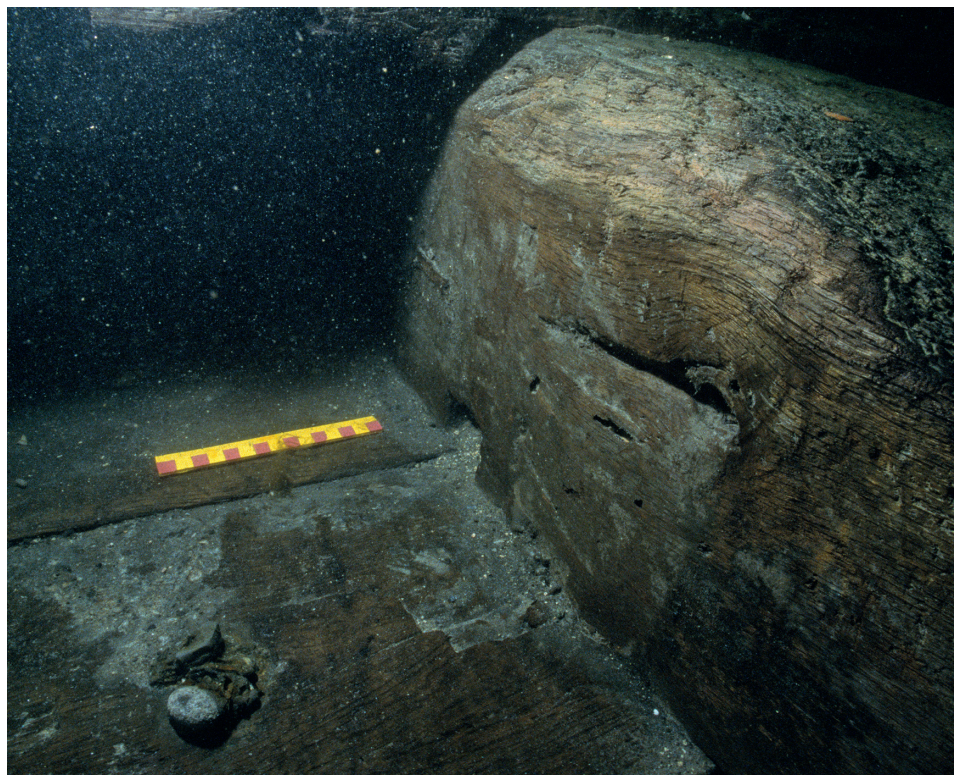
Illustration 105

Starboard limber-hole in Frame 3.0A. The 15cm scale is resting on the top surface of the keel, the sharp edge and smooth surface of which is evident (DP 173778)

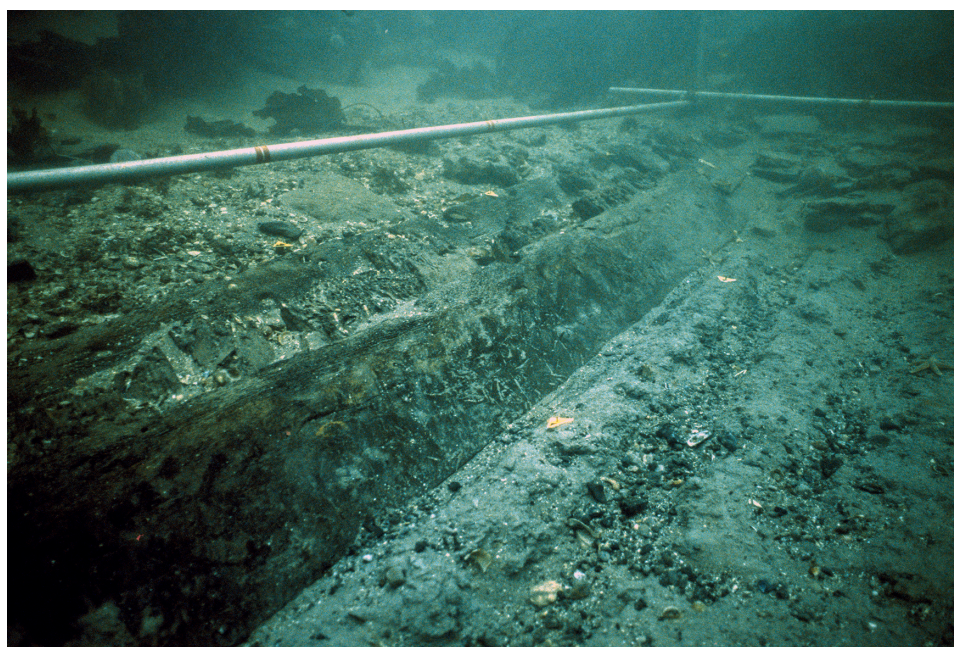
Illustration 106

The run of port midships timbers in Area 6 at the turn of the bilge, looking forwards. The inner plank is ceiling, with the outer planking beyond it on the left. The overlapping floor and first-futtock timbers are sandwiched between them. The clay and gravel ballast in the hold obscure the structure beneath. Targets set at 1m intervals (DP 173776)

The run of ceiling planks along the port edge of the keelson is made up of shorter pieces than elsewhere in the inner hull (Illus 106), the one closest to the port-side pump-well being only 0.85m long. These are limber-boards (Falconer 1780: 177), designed for easy removal to clear out the waterways via the limber-holes. A similar run along the starboard side is indicated by a single surviving board at the edge of the forward ballast-mound.

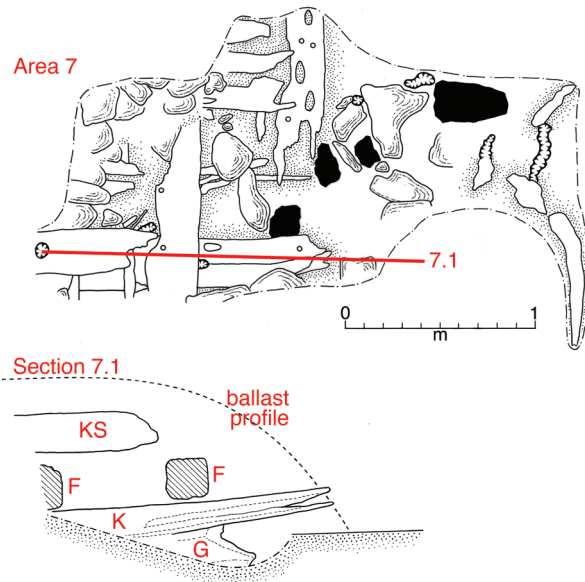
Illustration 107

Plan of Excavation Area 7 and Section 7.1. KS=keelson; F=frame; K=keel; G=gripe

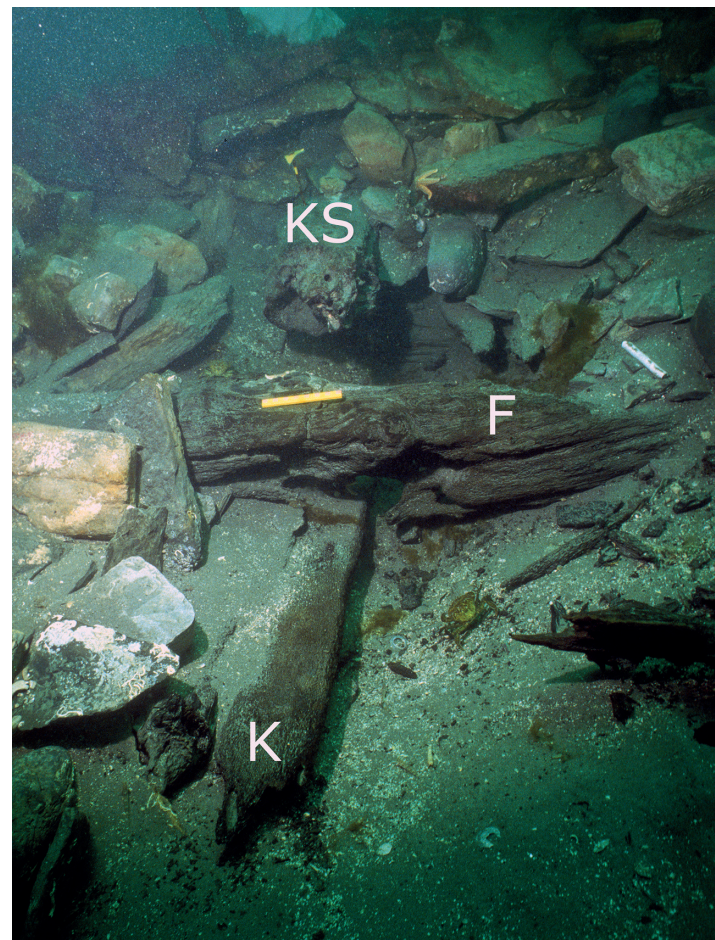
Illustration 108

Surviving forward structure, looking aft. K=keel; KS=keelson; F=frame. Packed stone ballast from the forward mound is in the background. Scale 15 centimetres (DP 173827)

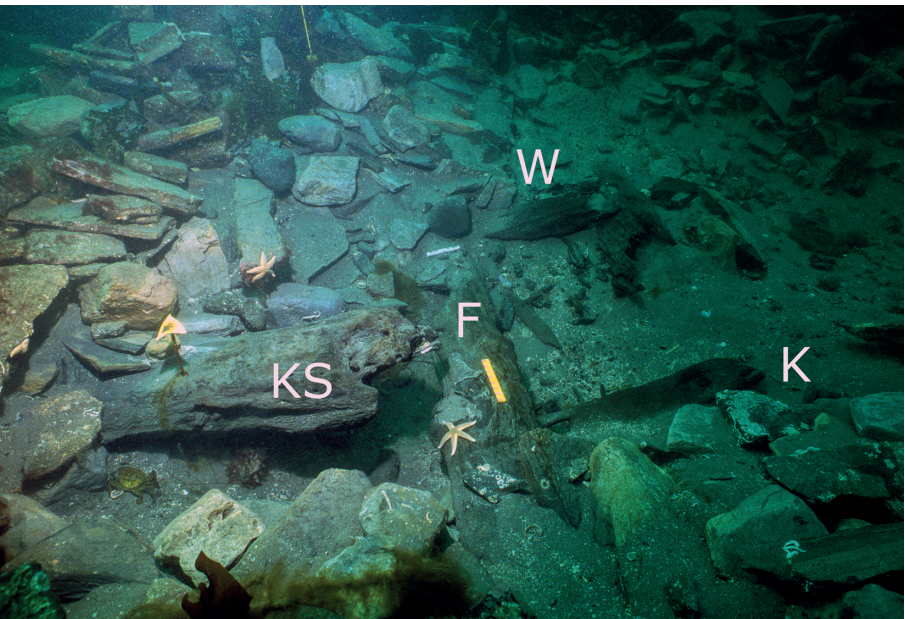
Illustration 109
Surviving forward structure, looking to port. KS=keelson; F=frame; W=wale; K=keel. Scale 15 centimetres (DP 173830)

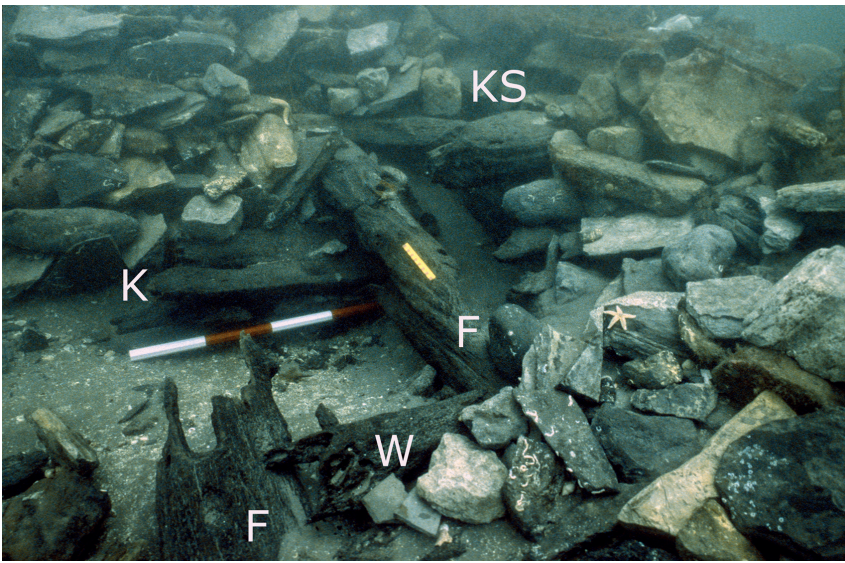
Illustration 110
Surviving forward structure, looking to starboard. F=frame; W=wale; K=keel; KS=keelson. Scales 1 metre and 15 centimetres (DP 173832)

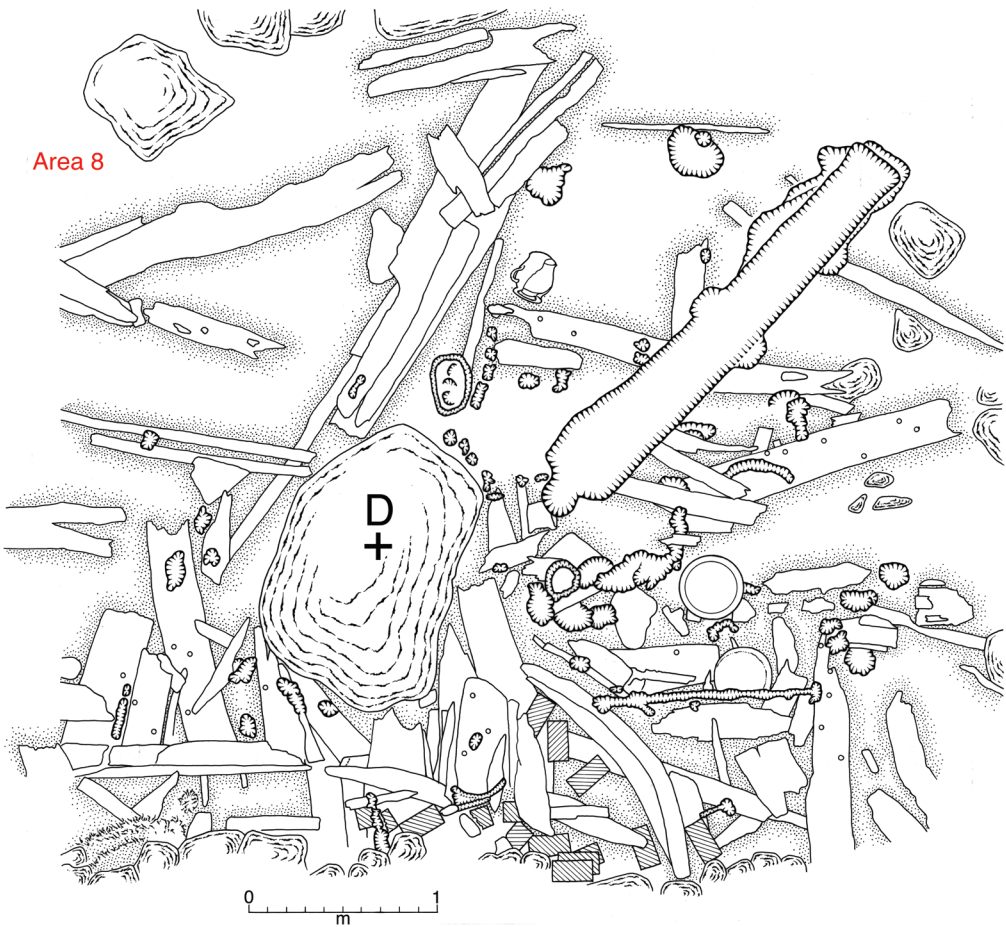
Illustration 111
Plan of Excavation Area 8

To complete the investigation of the wreck it was decided in 2002 to excavate an area from a line just shorewards of Gun 6 to the edge of the western ballast-mound, a 4m x 5m rectangle, where it was anticipated that outfall from the collapse of the forward structure might have stabilised (Illus 111). The area is dominated by a large rock at Datum D, centred on **266.093**, which rises about 1m above the sea-bed. A complex of dislocated timbers clusters around, but not beneath, this rock, suggesting that it had been there at the time of the

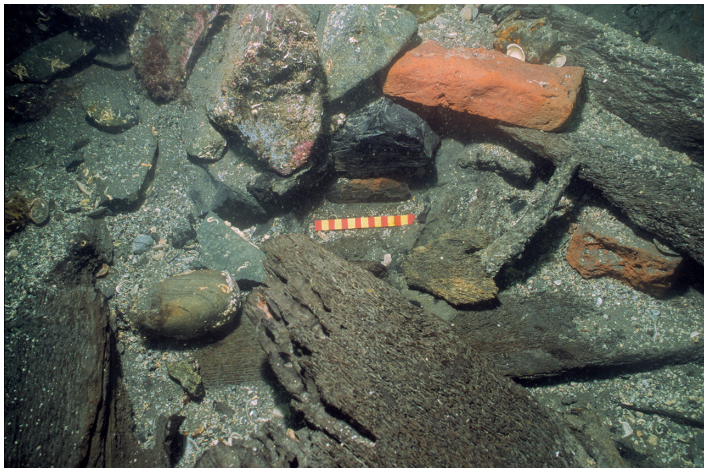
Illustration 112
Bricks, coal and collapsed timber debris in the galley deposit. Scale 15 centimetres (DP 173996)

rotary hand-mill [62] (Illus 112–14). It was hereabouts that the copper-alloy kettle [61], believed to be the galley cooking-pot, was found in 1979 (John Dadd pers comm).

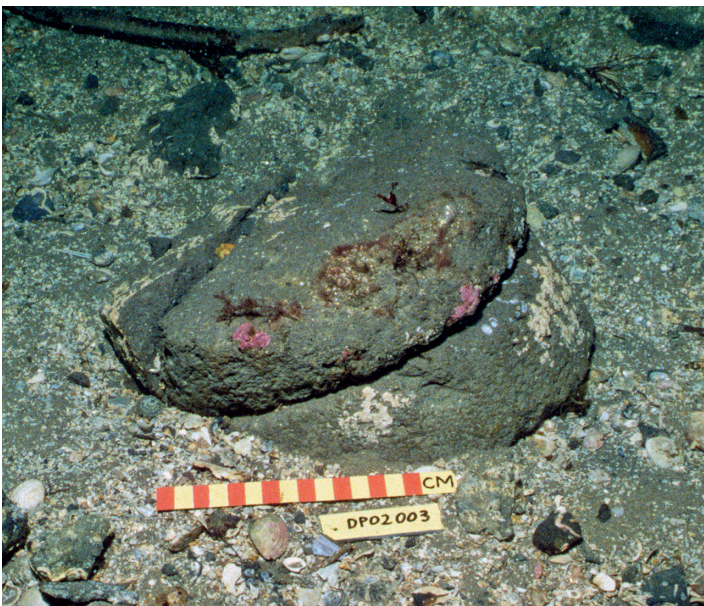
Illustration 114
The two conjoined halves of a rotary hand-mill [\[62\]](#). Scale 15 centimetres

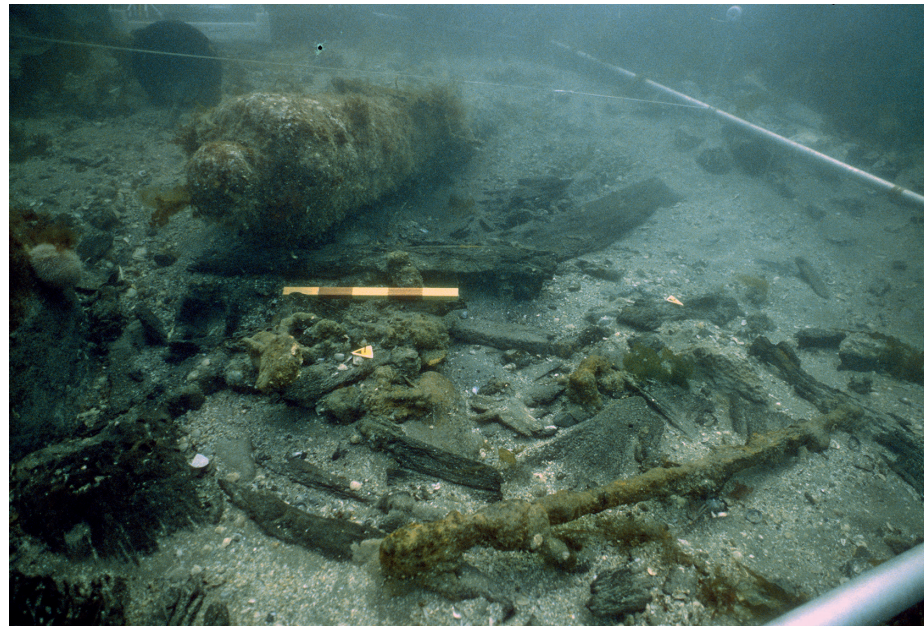
Illustration 115
Eroded debris from the forward collapse of the hull around Gun 6. The long concreted object in the foreground is probably a chain-plate for securing the shrouds. Scale 50 centimetres (DP 173837)

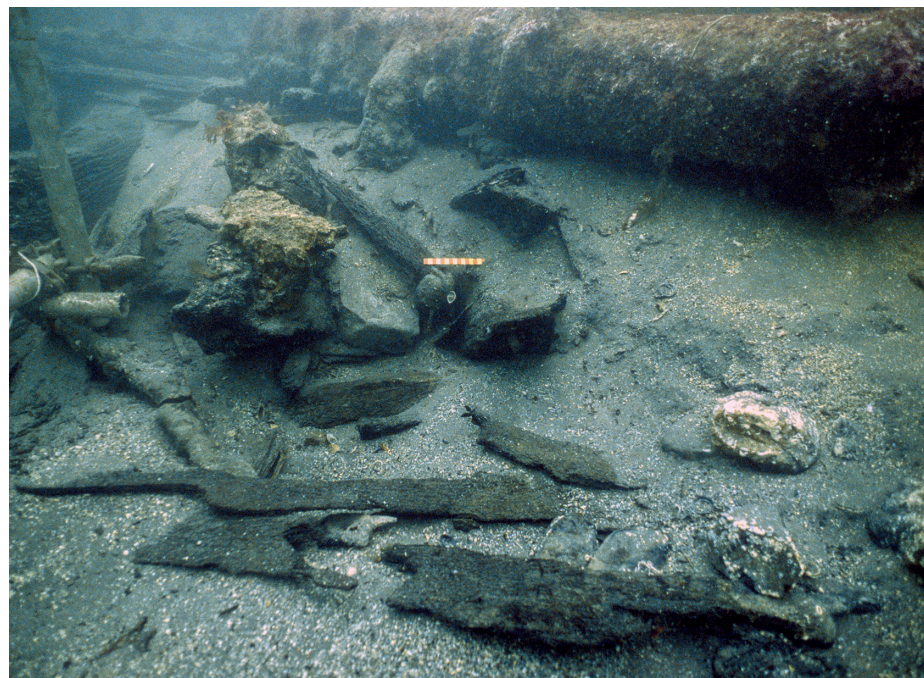
Illustration 116
Eroded debris from the forward collapse of the hull around Gun 6 (top). Scale 15 centimetres (DP 173795)
