# A Cromwellian Warship wrecked off Duart Castle, Mull, Scotland, in 1653

Colin Martin

## Chapter 4

# SITE-FORMATION PROCESSES

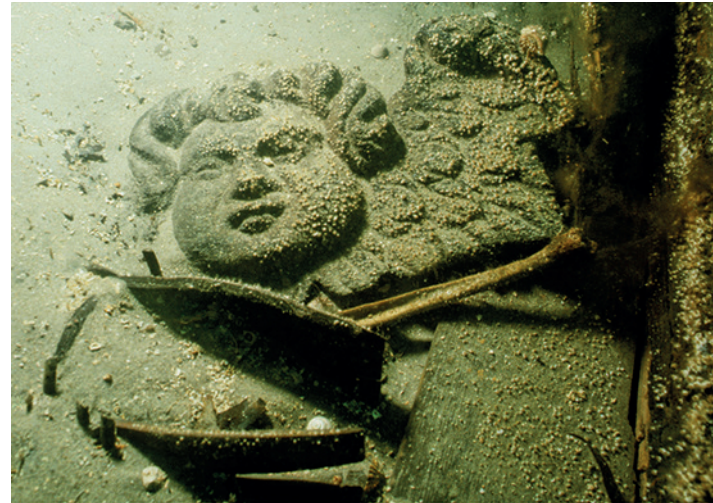
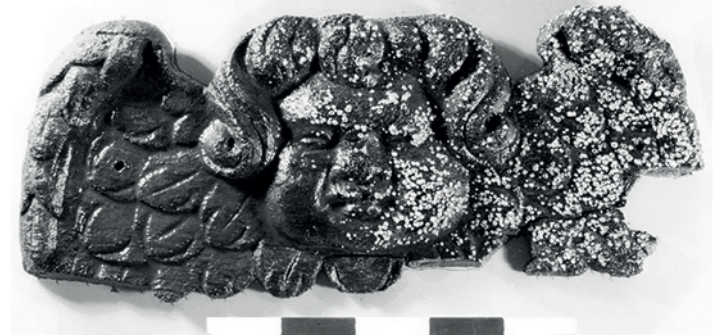
Illustration 118

Top: partly buried wooden cherub's head <sup>[5]</sup> photographed during the ADU's rescue and recovery operation in 1992. In the foreground are the remains of a staved costrel <sup>[184]</sup>, collapsing as the sand-level falls. Between the two objects is a human ulna (Kit Watson, DP 173909). Bottom: the wooden cherub after recovery, showing the distribution of barnacles. Scale 25 centimetres (DP 173176)

Among the exposed organic deposits noted during the rescue operation by the ADU in 1992 was a wooden cherub <sup>[5]</sup>, one of the ship's decorative carvings, emerging from the sand (Illus 118). Its right wing (as viewed from the front) was propped against a plank so that the object lay at an angle of about 15° from the natural level of the sandy sea-bed, within which the left wing remained buried. The upper wing had been colonised by common barnacles (*Balanus crenatus*), with the heaviest infestation clustered around its upper parts. Less-intensive colonisation was evident on the right face and hair, while the left cheek and curls remained largely unaffected. The left wing, when excavated, was entirely free of biological infestation and its pristine surface condition indicated that it had never been attacked. None of the barnacles associated with the object was more than about six months old.

From these observations it may be concluded that the cherub was buried shortly after its initial deposition and remained encapsulated in an anaerobic environment for 339 years, during which time it became waterlogged and fragile but suffered almost no biological or mechanical degradation. It was not visible during the Archaeological Diving Unit's first visit in 1991. During the following year the surrounding sediments dropped to levels below which they had not fallen since deposition, progressively exposing more than half the object and allowing biological colonisation on its previously unavailable surface. Had this process been allowed to continue the object would probably have become completely uncovered and all its surfaces exposed to attack. Once free of the encapsulating silts it would, almost certainly, have been displaced by the tidal current and carried eastwards from the site into deep water where – loose, fragile and vulnerable to further biological and mechanical degradation – it would rapidly have been destroyed.

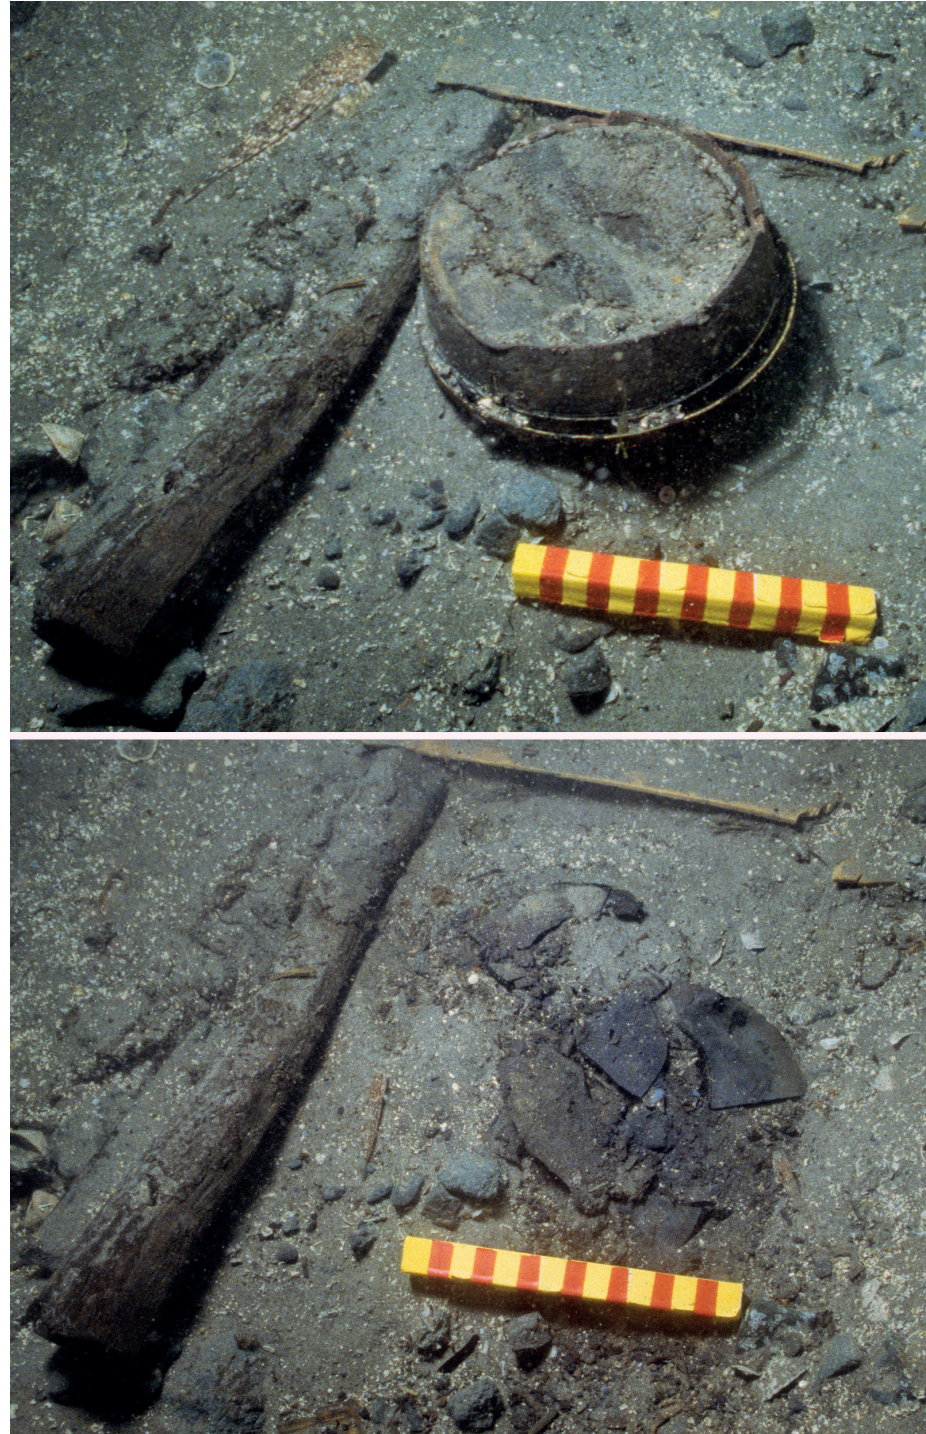
Illustration 120

Top: inverted mariner's compass [91], in situ after excavation. Its base is cracked and imploded (DP 174253). Bottom: shattered glass face of the compass after removal of the bowl. That it retains its circular shape indicates that it broke when the compass reached the sea-bed, and that neither object has moved since. Scale 15 centimetres (DP 174255)

An intact mariner's compass [91] in excellent condition was found at 060.096, towards the eastern extremity of the wreck, buried some 0.15m deep in sediment and covered by

a wooden plank. The bowl was inverted and the base had imploded, indicating that when the object sank it had been air-filled and air-tight, and must therefore been held down by some container or structural element (Illus 120). Its sealed glass front must have remained intact until at some time during its progress to the bottom, some 10m down, where the external pressure would have doubled, the wooden base gave way. That the broken glass and the compass were still in close association when found demonstrates that neither has moved since primary deposition, and that burial was rapid.

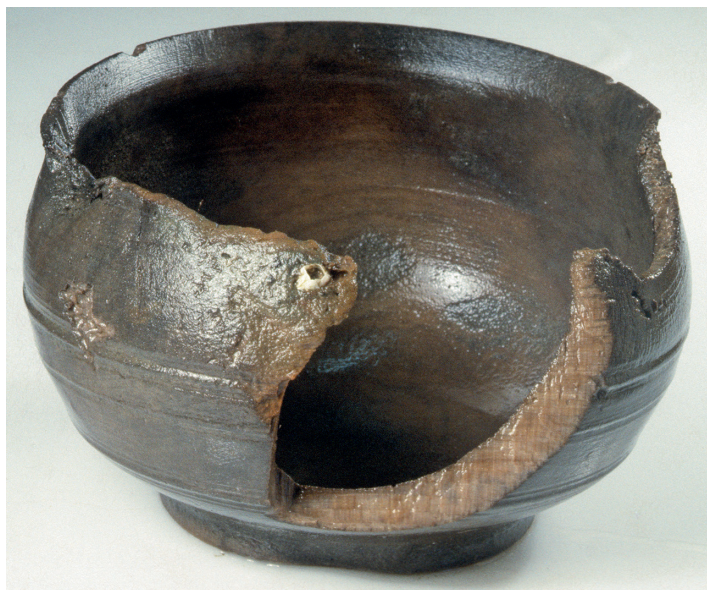
Illustration 124

Turned wooden bowl [179], largely intact and unabraded but showing evidence of three episodes of partial exposure: a recent clean break; earlier biological attack and abrasion around the rim; and a single colonising barnacle (DP 173699)

A similar conclusion can be drawn from the characteristics of a small wooden bowl [179] which became exposed at 055.087 during the winter of 1992/93 (Illus 124). On recovery it showed evidence for at least three episodes of partial exposure: a recent one indicated by a clean break (mid-front in the photograph), an earlier one indicated by a slightly eroded fracture-line (to the right), and an area of degradation towards the left which has allowed at least one barnacle to colonise the surface.

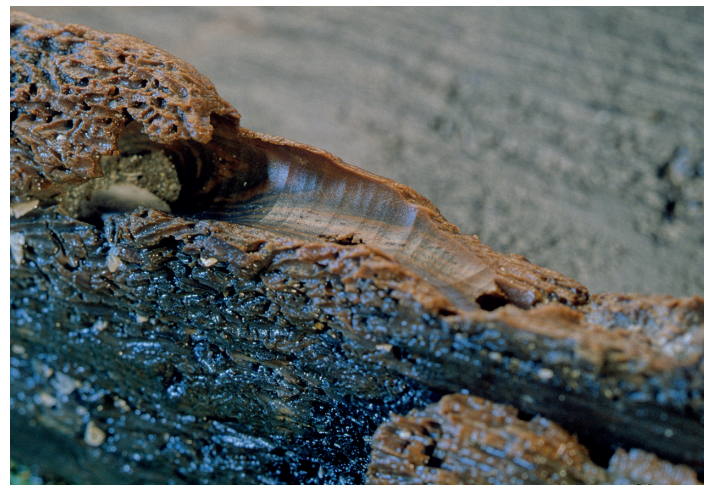
Illustration 125

Top: biological infestation at the surviving edge of the wooden binnacle [88]. The single shipworm tunnel (*Teredo navalis*), about 10mm in diameter, bores into the interior of the wood, dwarfing the surface nibbling of gribble (*Limnoria lignorum*) (DP 173733). Bottom: characteristic infestation by gribble, following the grain on the surface of the wood. Scale in millimetres (DP 173734)

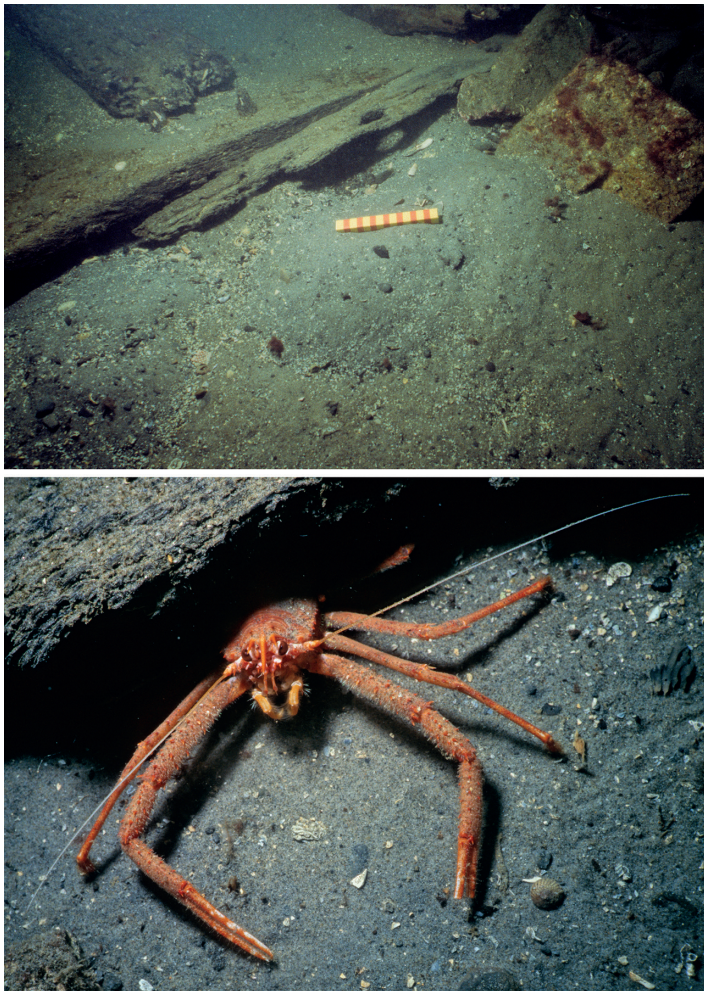
Illustration 126

Top: burrow-scrapes thrown up by creatures seeking shelter beneath the hull-timbers. Scale 15 centimetres (DP 173749). Bottom: a long-clawed squat lobster (*Munida rugosa*) in its lair beneath eroded ship timbers (DP 173740)

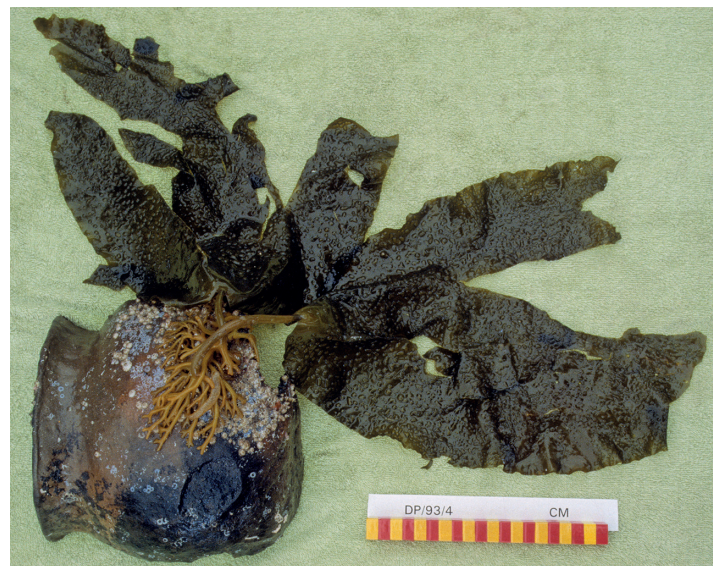
Illustration 127

Hebridean *crogan* pot [144] with the attached kelp plant (*Laminaria hyperborea*) which acted as a sail in the current to drag it off the site. Scale 20 centimetres (DP 173721)

On occasion direct biological activity can lead to the movement of archaeological material. An observed example involved half of a Hebridean *crogan* pot [144], which was found lying loose on the sea-bed some 20m down-current from the eastern end of the site (Illus 127). Since the object no longer retained an identifiable archaeological association with the wreck, the possibility that it is intrusive cannot be discounted, although the chances that it derives from another source are slight. Closer inspection revealed the pot's recent history. It had been buried save for a circular area some 150mm in diameter, revealed by a dense patch of barnacle

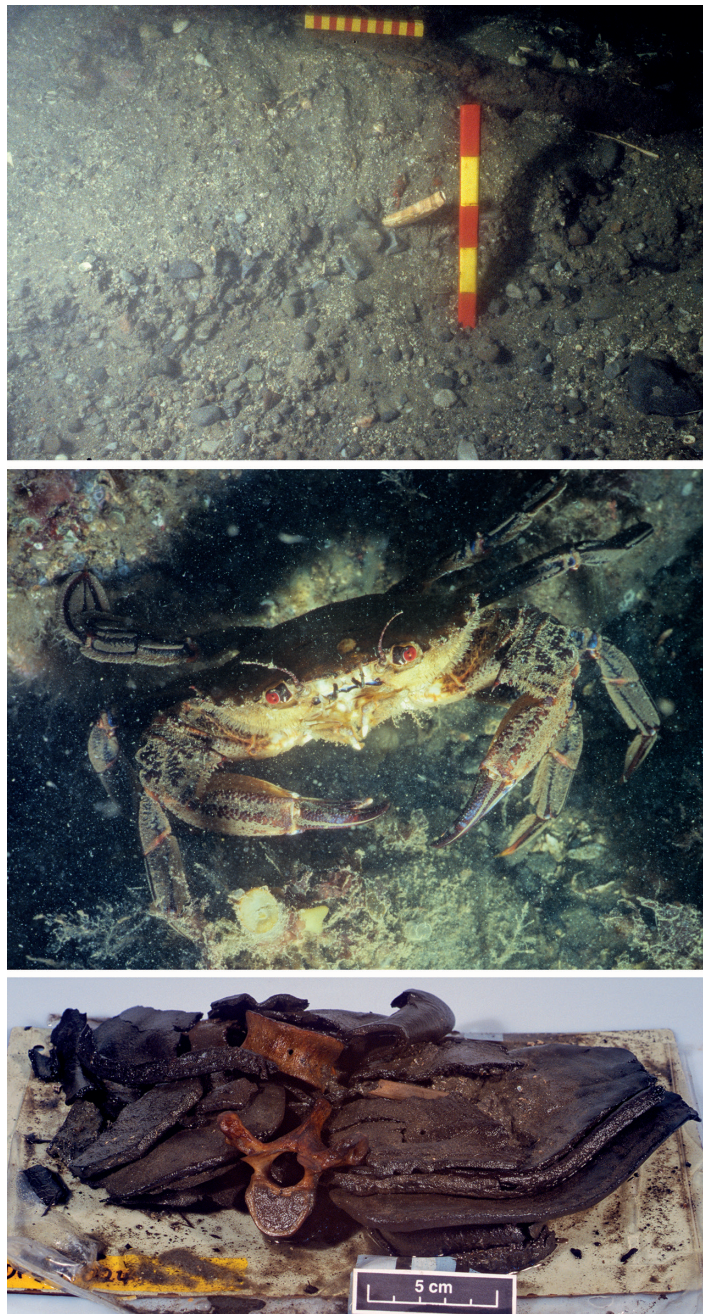
Illustration 128

Top: section through sediments close to the binnacle deposit showing alternating levels of gritty sand and gravels. A razor shell (*Ensis siliqua*) has been exposed next to the upright 25cm scale (DP 173697). Middle: the highly aggressive velvet swimming crab (*Liocarcinus puber*), which abounds on the site, may have been responsible for the dispersal of human remains in the collapsed stern area (DP 173741). Bottom: partly collapsed shoe [205] with human vertebrae and a clay-pipe stem within it (DP 174136)

During excavation it was noted that the deeper deposits of sand and shingle, particularly at the eastern end of the site, carry large populations of razor shells (*Ensis siliqua*). These burrow vertically into the sediment and feed through a tube which extends into the water and retracts when threatened (Illus 128). The animals appear to have little detrimental effect on the archaeological deposits into which some had penetrated, but when exposed they are defenceless against predation. In particular they excite a voracious feeding-frenzy among the numerous velvet swimming crabs (*Liocarcinus puber*) (Illus 128), which swarmed into the area being excavated to seize the exposed razor shells by their muscular 'feet' and scurry off to nearby lairs. Such behaviour might explain the dispersal of the skeletal remains of the only known human victim of the wreck, whose substantially complete bone assemblage was recovered disposed randomly throughout the aft organic deposit but not extending beyond it. This suggests that the after hull was still partly intact when this activity took place, providing predators with numerous secure lairs within it but restricting their movement beyond. One even appears to have taken up residence in a shoe (Illus 128)

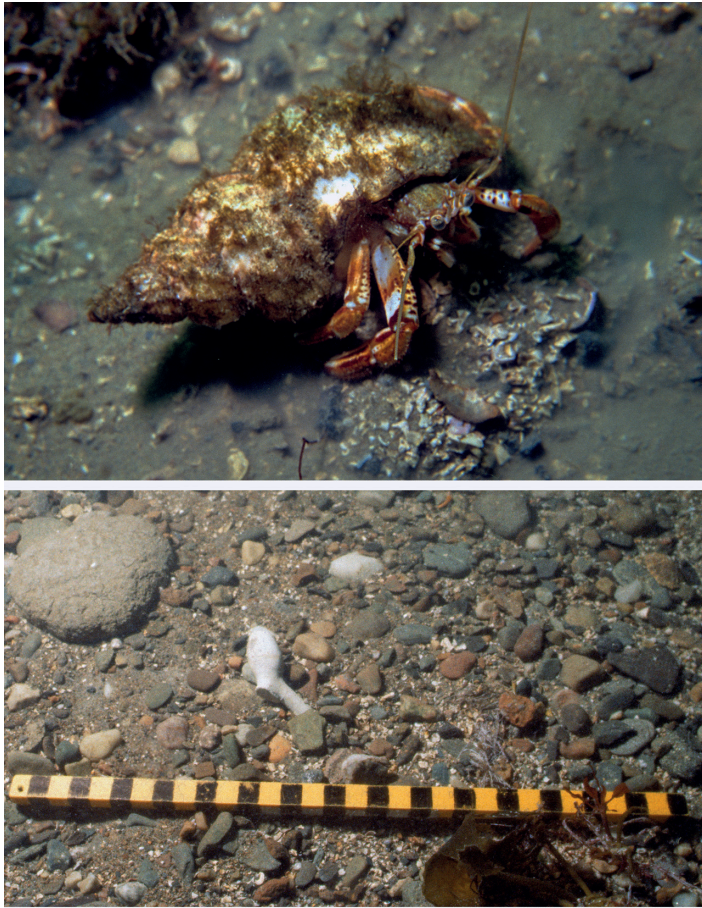
Illustration 129

Top: a hermit crab (*Pagurus bernhardus*) which has adopted the shell of a common whelk (*Buccinum undatum*) as its home (DP 173747). Bottom: clay-pipe bowl of distinctive 17th-century form, similar to others recovered from secure contexts on the wreck-site, lying on top of gravel derived from a quarry on shore and laid as a consolidant a month earlier. This object can only have come from elsewhere on the site, and transport by a young hermit crab is a possibility. Scale in centimetres (Steve Liscoe, DP 173666)

Apocryphal stories of hermit crabs (*Pagurus bernhardus*) adopting artefacts such as clay-pipe bowls as mobile homes have long been current among underwater archaeologists, though I know of no positively authenticated example. However this mechanism might provide a plausible explanation for a phenomenon observed on the site over two successive monitoring visits in 1992. In October of that year an eroding area in which an organic deposit had been uncovered was consolidated by the application of sterile gravel obtained from a local quarry. A month later a clay-pipe bowl of mid 17th-century date was noted lying on the gravel surface (Illus 129). The pipe was of the same type as others found on the wreck, and the possibility that it had been contained within the intrusive gravel can be discounted. Transport by an animal such as a hermit crab seems the most likely explanation.
