# The Archaeology of Finlaggan, Islay

Caldwell, D H 2025 *The Archaeology of Finlaggan, Islay: Excavations at the centre of the Lordship of the Isles, 1989–1998*. Edinburgh: Society of Antiquaries of Scotland.  
<https://doi.org/10.9750/978190833256>

# EILEAN MÓR EXCAVATIONS IN THE GREAT HALL AND ADJACENT BUILDINGS

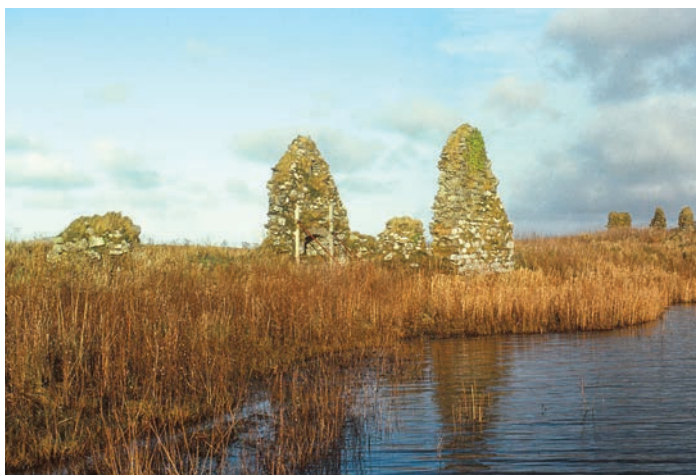
Illustration 11.2  
Building C from north-west in 1993

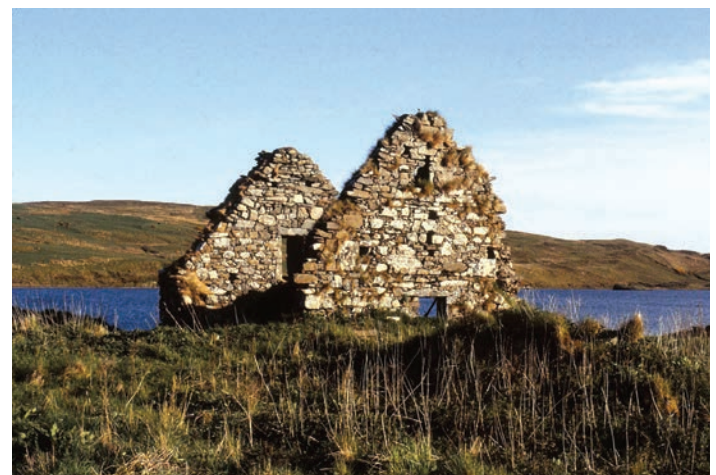
Illustration 11.3  
Building C from south-west in 1993

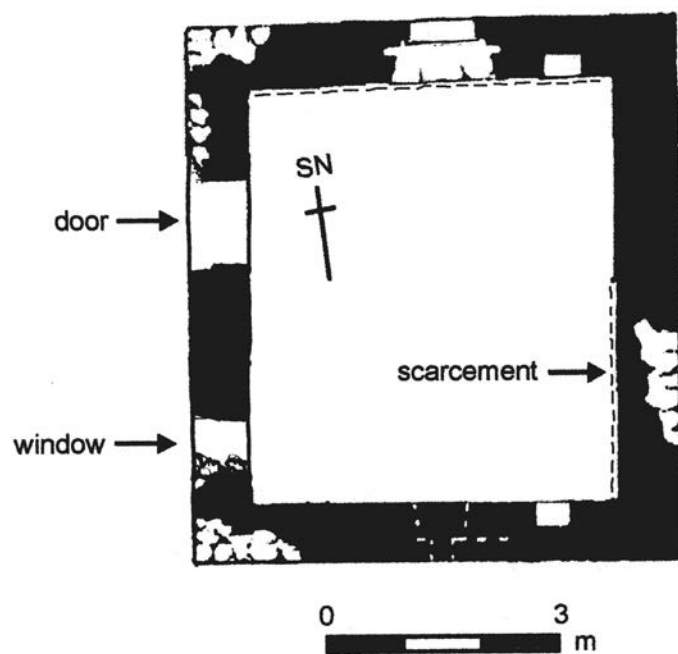
Illustration 11.4  
Building C, plan of ground floor

The upper storey of building C is essentially of the later phase. Both gables have intake courses near their apices but not level with each other. There is no evidence for a stair. A timber floor could have been supported on joists lodged in slots or on corbels in the west and east walls, but there are no traces of these now. There is a tall narrow window in the north gable at first-floor level, about 0.7 by 0.2m. Another, about 1m high and 0.4m wide, is positioned in the south gable, with its sill level with the (missing) floor. It has been fitted with an internal shutter with a sliding draw-bar (Illus 11.4, 11.8).

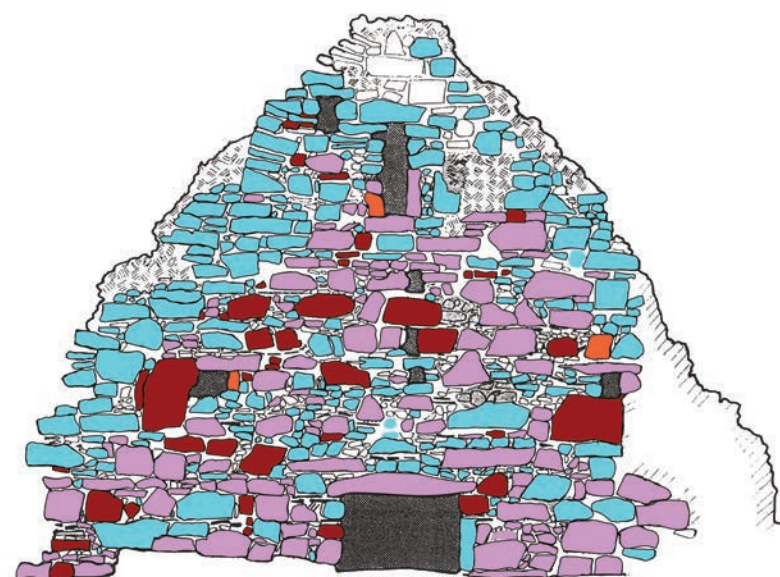
N gable exterior

Limestone

Dolerite

Quartzite, Port Askaig tillite

Sandstone

Illustration 11.5  
Building C, exterior of north gable

The upper portions of the gables are almost exclusively composed of blocks of limestone (Illus 11.5). This is interpreted as an indication that they represent a separate phase of construction, a remodelling of an earlier building. This earlier building had a ground-floor chamber with a rectangular window in its north wall, opening on to the paved passageway opposite to the entrance of the great hall. It is set in an embrasure with splayed jambs and segmental relieving arch, and has been fitted with a sliding bar to fix an internal shutter in place (Illus 11.4, 11.6). Adjacent to it is a small aumbry, and there is a similar aumbry in the south wall. It was evident prior to excavation that the entrance had been in the west wall.

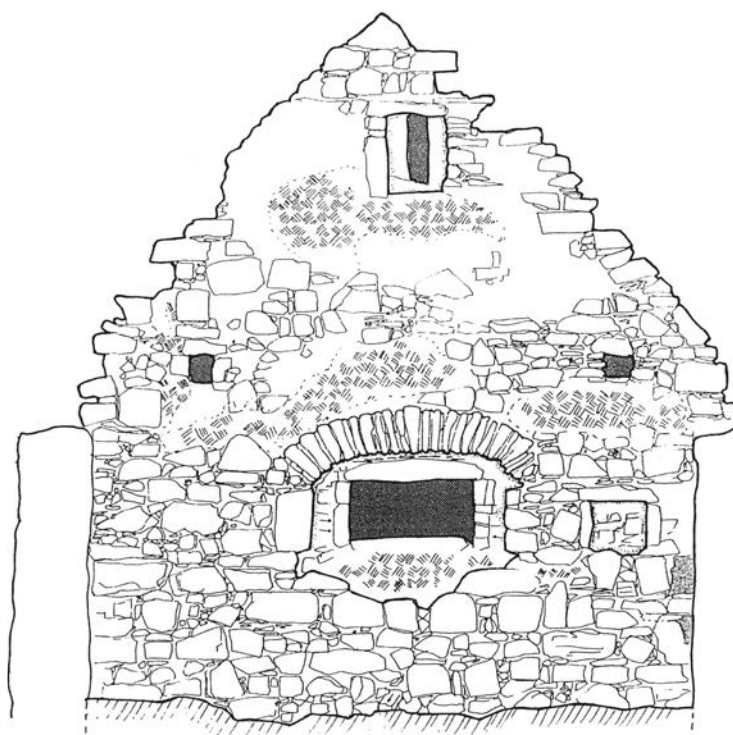
N gable interior

Illustration 11.6  
Building C, interior of north gable

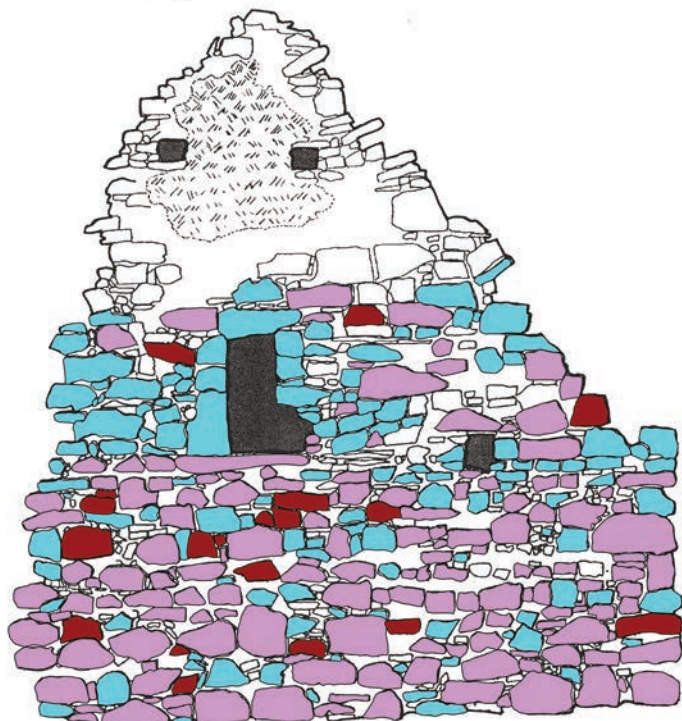
S gable exterior

Limestone

Dolerite

Quartzite, Port Askaig tillite

Illustration 11.7  
Building C, exterior of south gable

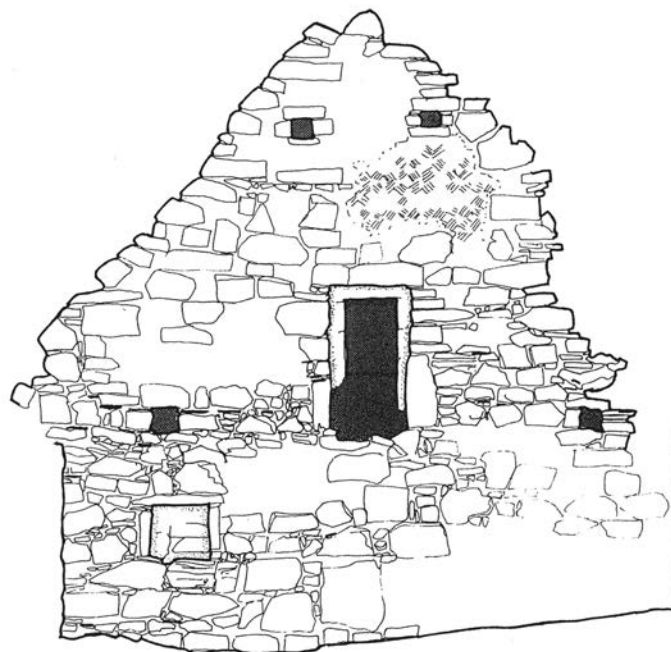
S gable interior

Illustration 11.8  
Building C, interior of south gable

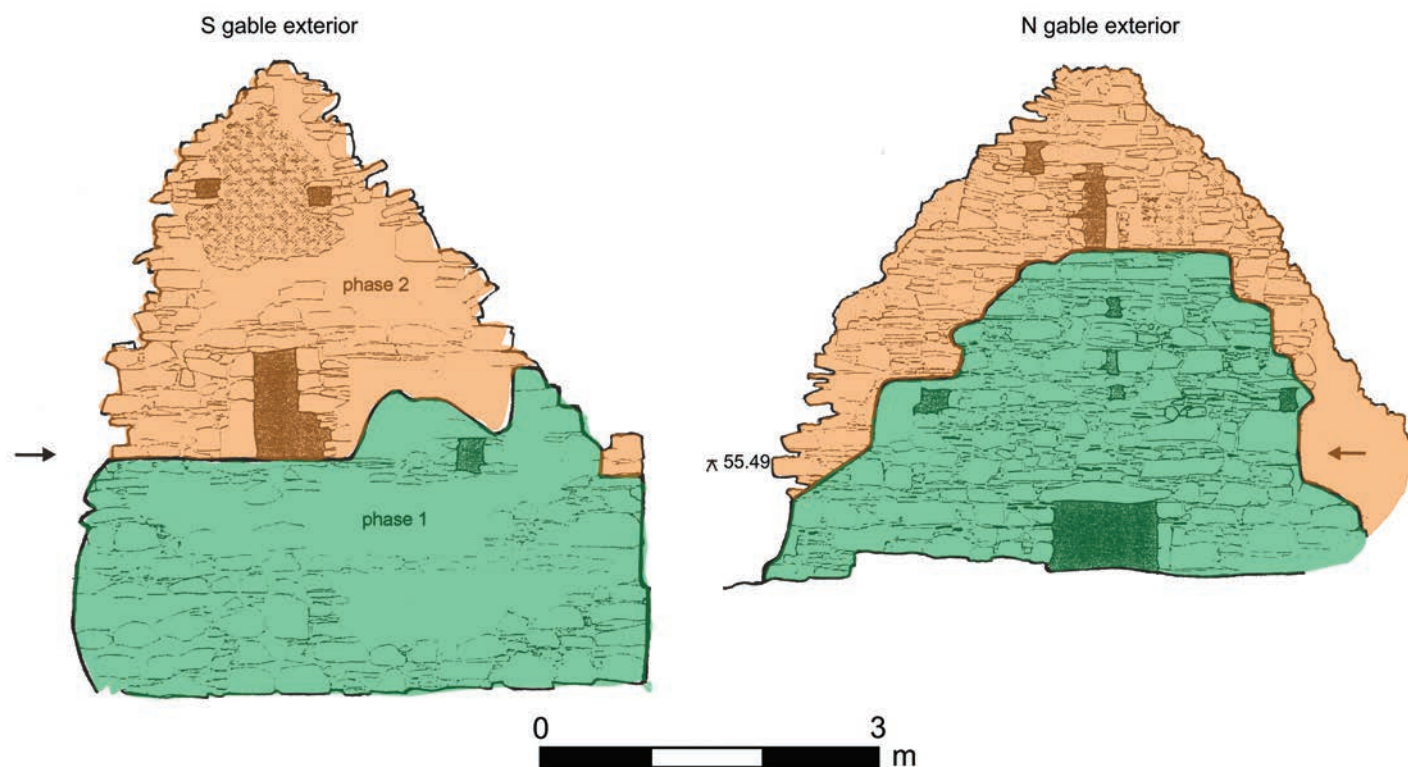
Illustration 11.9  
Building C, gable elevations showing phases 1 and 2. The arrows mark the level of the beam-slots

inwards for an unknown distance. Along with putlog holes in the lower gable walls, these belong to the building's earlier phase. There are also further putlog holes in the upper parts of the gables, two in the south gable and one in the north gable. The putlog holes in one gable did not match up in height with the similar features in the other gable (Illus 11.9). The slots are, however, at the same height.

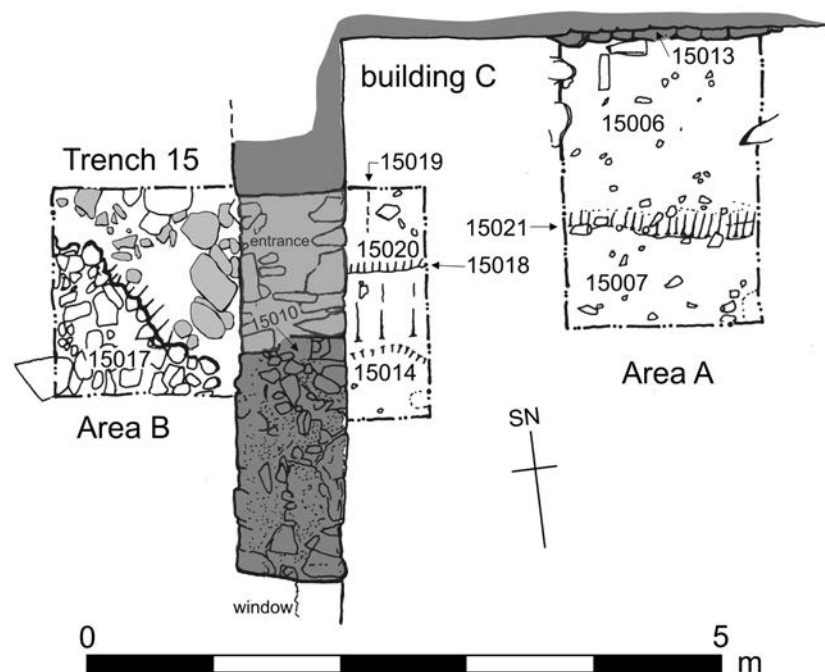
Illustration 11.10  
Trench 15, plan

Outside the entrance of building C there was an area of cobbling, probably a path leading from the main road running along the south side of the great hall (Illus 11.10, 11.15). Partially covering it was an area of tumbled stonework [15017], possibly tumble from the adjacent structure, house B (see trench 11 below).

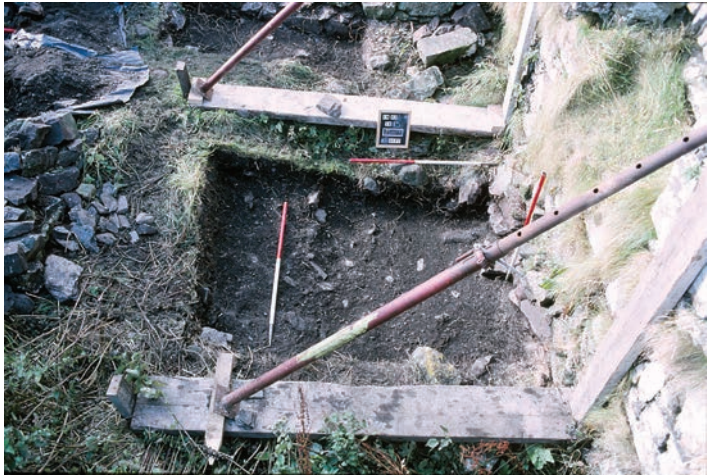
Illustration 11.11

Trench 15A, showing the surface of 15007 to the left and 15005 to the right

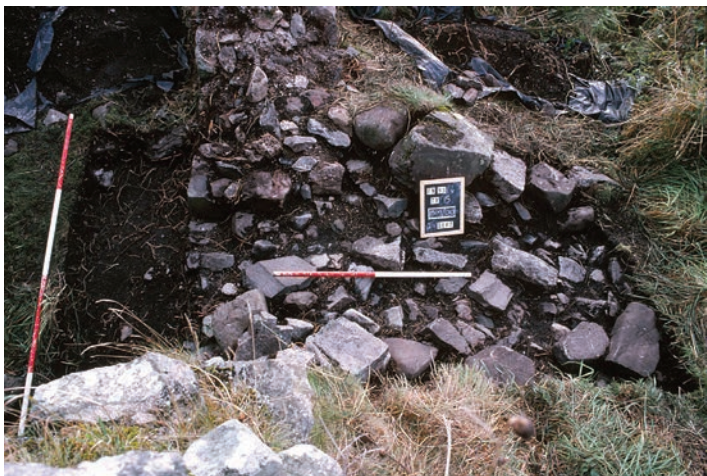
Illustration 11.12

Trench 15B, looking south, after removal of the turf

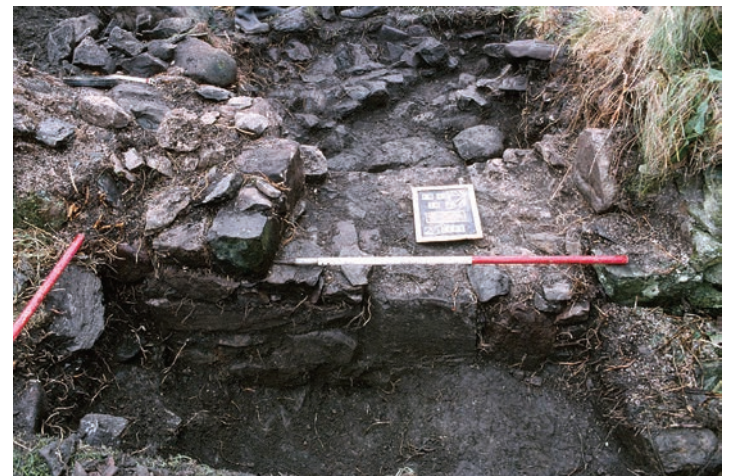
Illustration 11.13

Trench 15B, doorway from inside building C

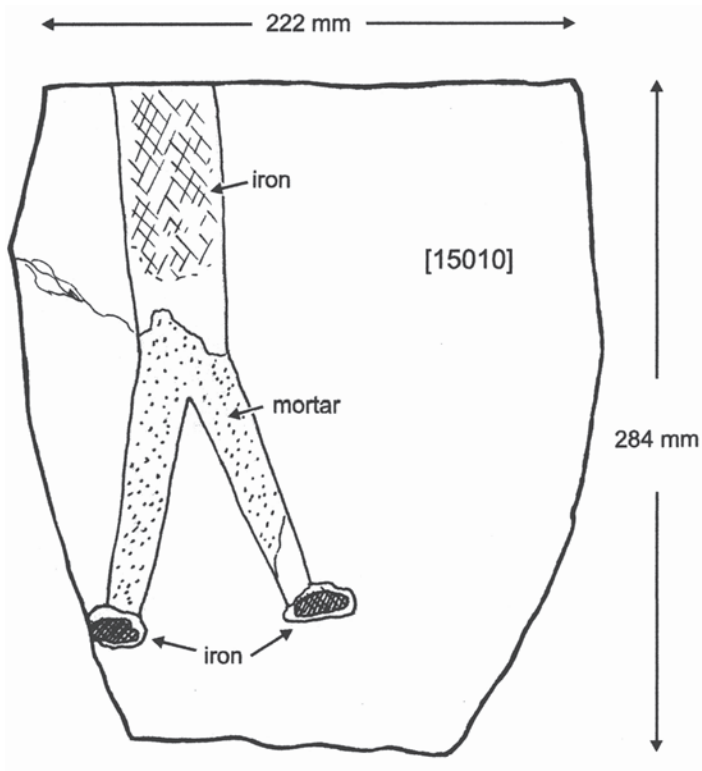
Illustration 11.14  
Trench 15B, jamb stone from doorway with traces of iron mount

The doorway to building C was found to be 1.15m wide. The door-sill itself had been robbed out, but there were dressings of buff sandstone remaining in both jambs. One sandstone block in the south jamb [15010] had its upper surface cut for an iron Y-shaped fixing, partially still in situ (Illus 11.14). This was the remains of a hinge arrangement for supporting a sturdy door. It might reasonably be supposed that the door in question would have been a yett, an iron door made of crossed bars, known to have been favoured as a protection for castles and towers in Scotland (Christison 1883 and 1888). They were normally hung on massive hinges projecting sideways which needed to be securely anchored. The exterior of the entrance of building C appears to have been rebated, presumably to house a wooden door shielding the yett behind. It should be noted, however, that the Y-shaped fixing was positioned back to front, suggesting either secondary use or inexperienced restoration.

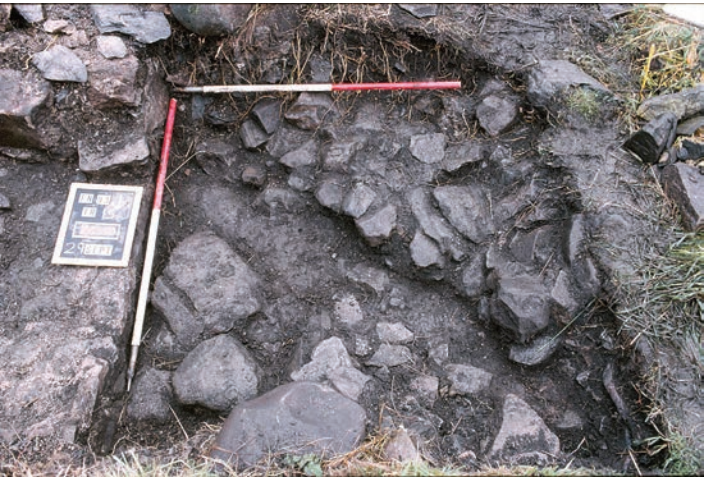
Illustration 11.15  
Trench 15B, showing cobbled surface outside entrance and tumble 15017

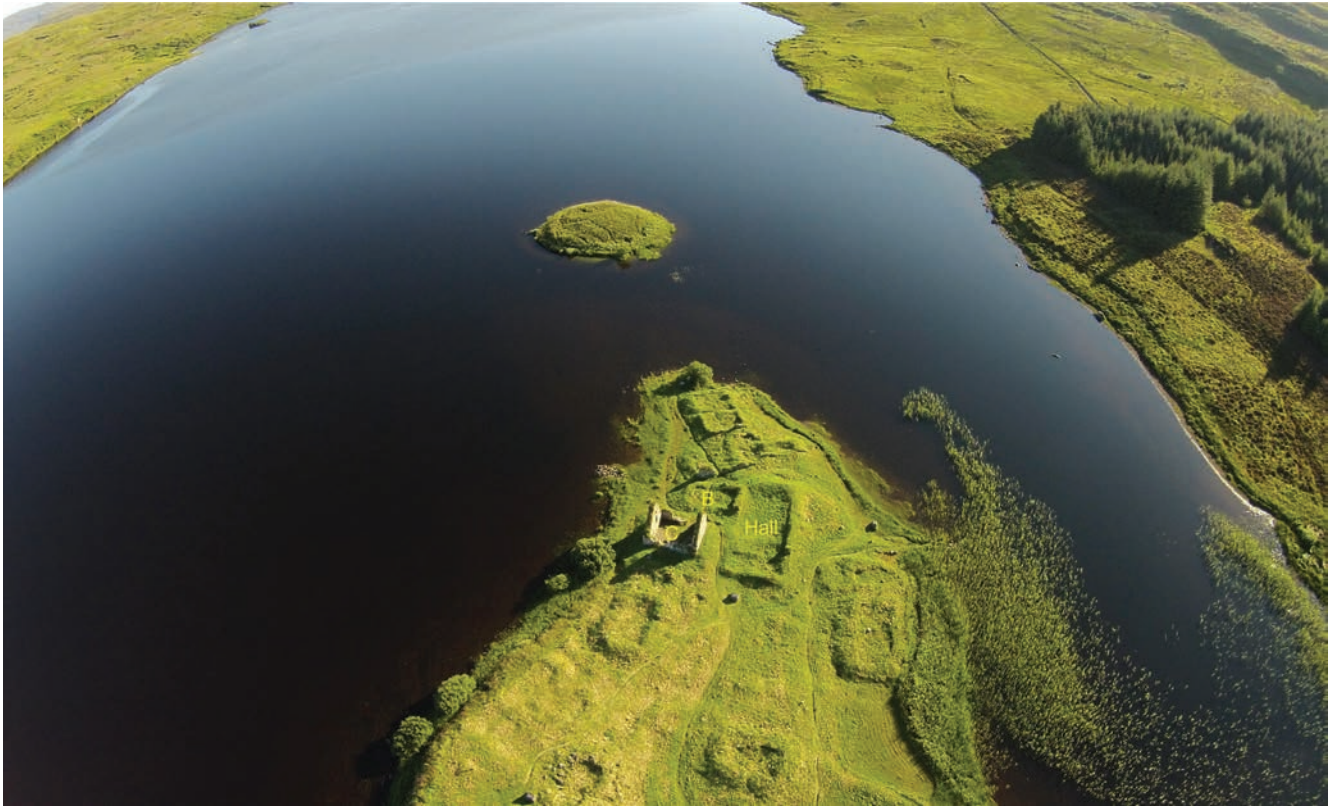
Illustration 11.16

Photograph taken from a drone showing the great hall with buildings C and B (Alan Miller)

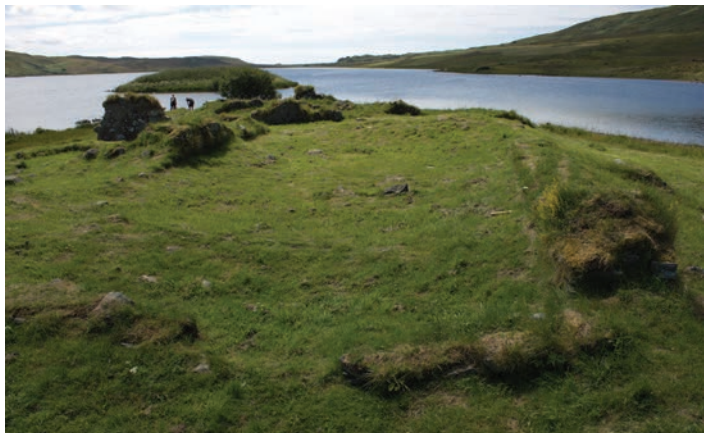
Illustration 11.17  
The great hall

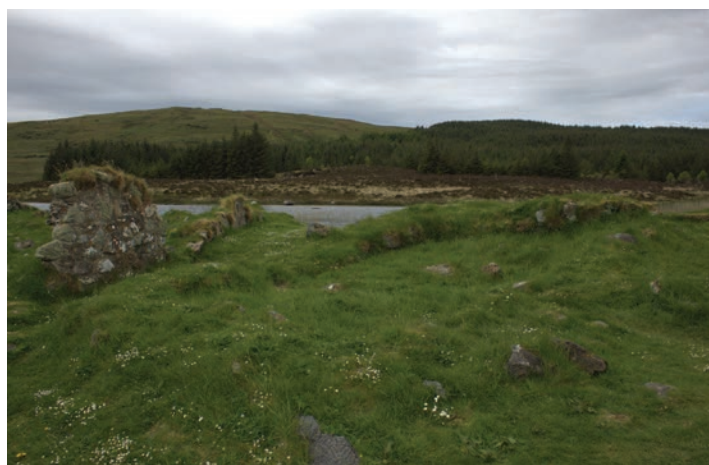
Illustration 11.18  
House B

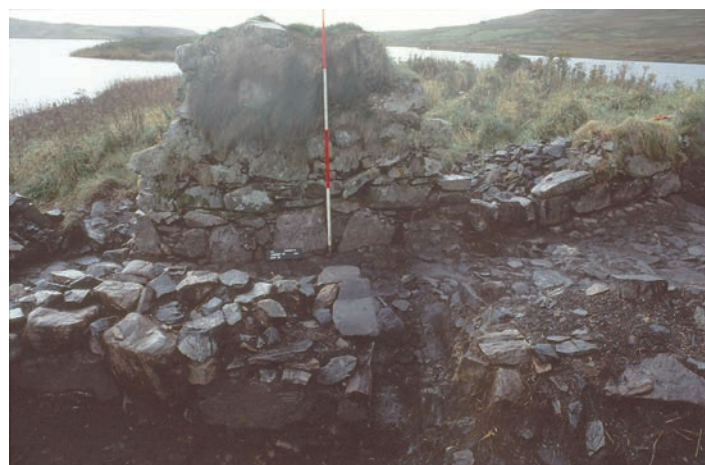
Illustration 11.19  
The cross-wall dividing off the west end of Eilean Mór during excavation of trench 11, the wall and entrance of house B in foreground

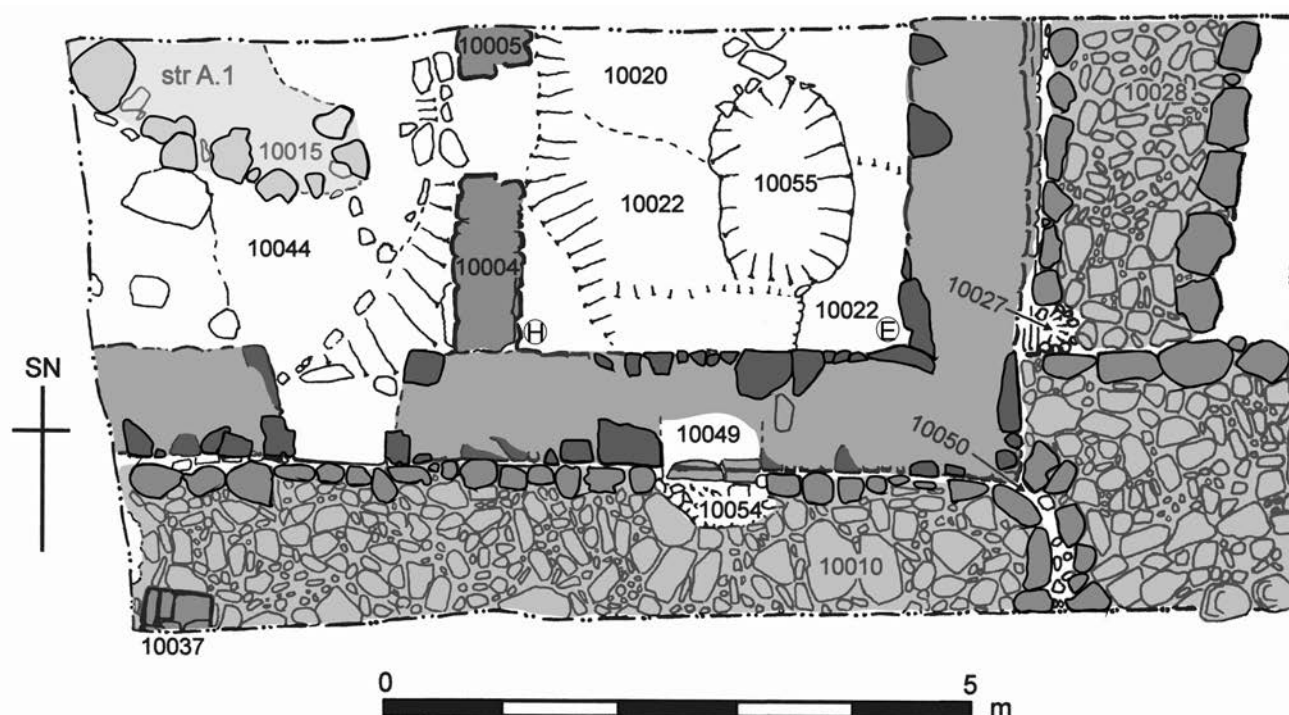
Illustration 11.20  
Trench 10, plan

fewer pieces of limestone, were found to run along the east and west sides of the hall (Illus 11.20, 11.37, 11.38). The joint between the east and south roads curiously did not correspond with the hall corner. Another paved road with kerbs [11022] ran south from the junction at the south-west corner of building A towards the loch's edge. It had no clearly defined edge here and it is possible that it originally turned south-west and/or north-east along an island edge which has since been eroded away.

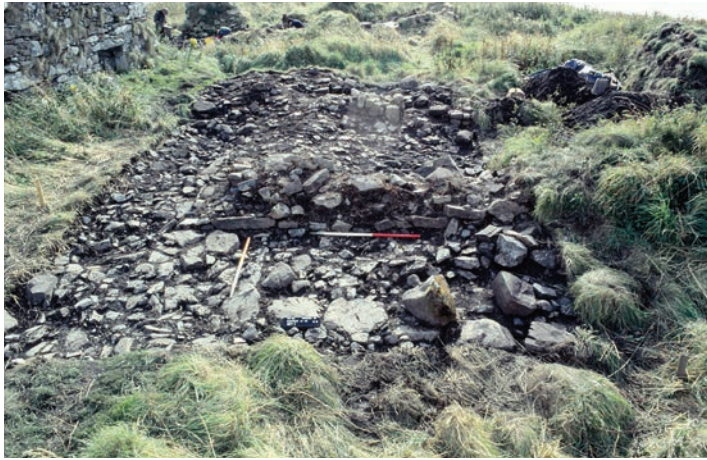
Illustration 11.21  
Trench 10, looking west, after removal of turf

The walls of building A were constructed of long low blocks of quartzite and dolerite with lesser quantities of limestone, well dressed to give smooth wall surfaces and held together by lime mortar (Illus 11.21, 11.34). Excavation in trench 10 revealed that the cross-wall in the interior [10004, 10005] was secondary. It was not bonded into the south exterior wall and its foundation trench [10056] cut the underpinning [10047] of the exterior wall (Illus 11.28, 11.29). It was lime mortared, set on a basal course of dolerite blocks, included other blocks of epidiorite and quartzite, and had string courses of type A and type C slates. Its rubble infill was mostly of phyllite and to a lesser extent limestone. The southern of its two doorways was within the area of trench 10. It was rebated for a door opening into the east chamber. The remaining two jamb stones facing the hall were of sandstone, one a fine-grained red sandstone, the opposite one a high-quality dressed sandstone of pale reddish-white colour with prominent parallel bedding. It was cut with a horizontal slot, possibly from previous use rather than relating to the hanging for a door. Just to the east of this doorway a white sandstone voussoir (R31) was recovered from rubble [10020]. It was checked for a door.

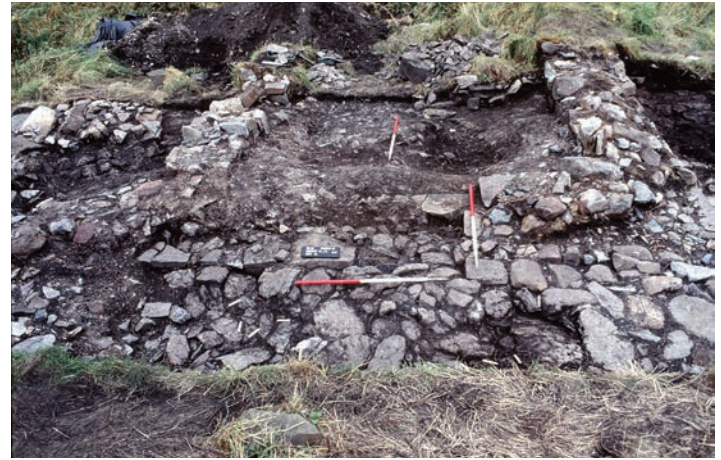
Illustration 11.22  
Trench 10, showing, top left, the wall of structure A.1, demolition deposits and pit 10055 in the service area

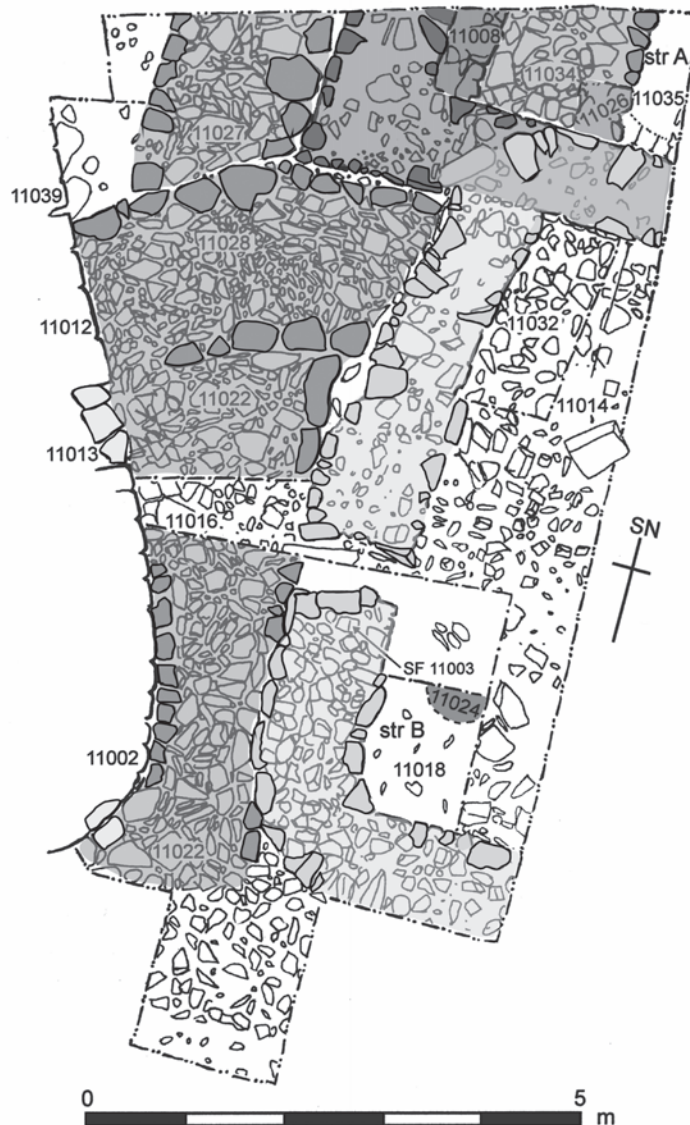
Illustration 11.23  
Trench 11, plan

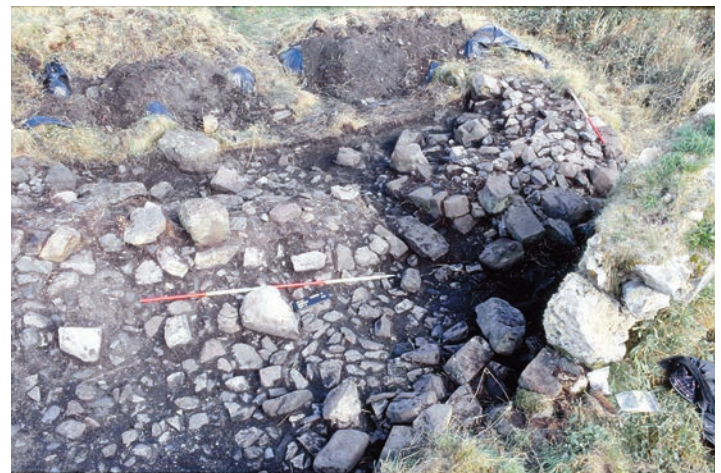
Illustration 11.24  
Trench 11, after the removal of the turf, looking from the cross-wall towards house B. Note the large slab – a lintel? – in the entrance to house B

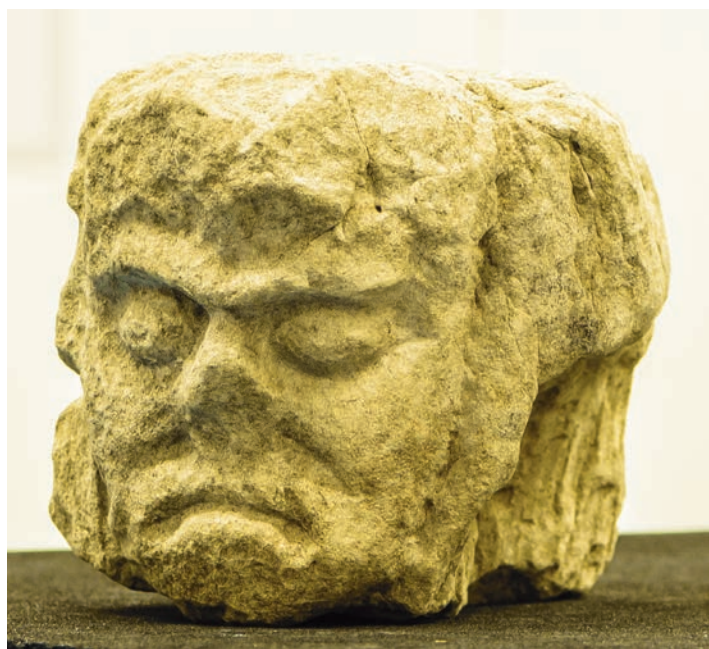
Illustration 11.25

The sandstone head (SF 11003) from the wall of house B (photo: Raymond Lafferty)

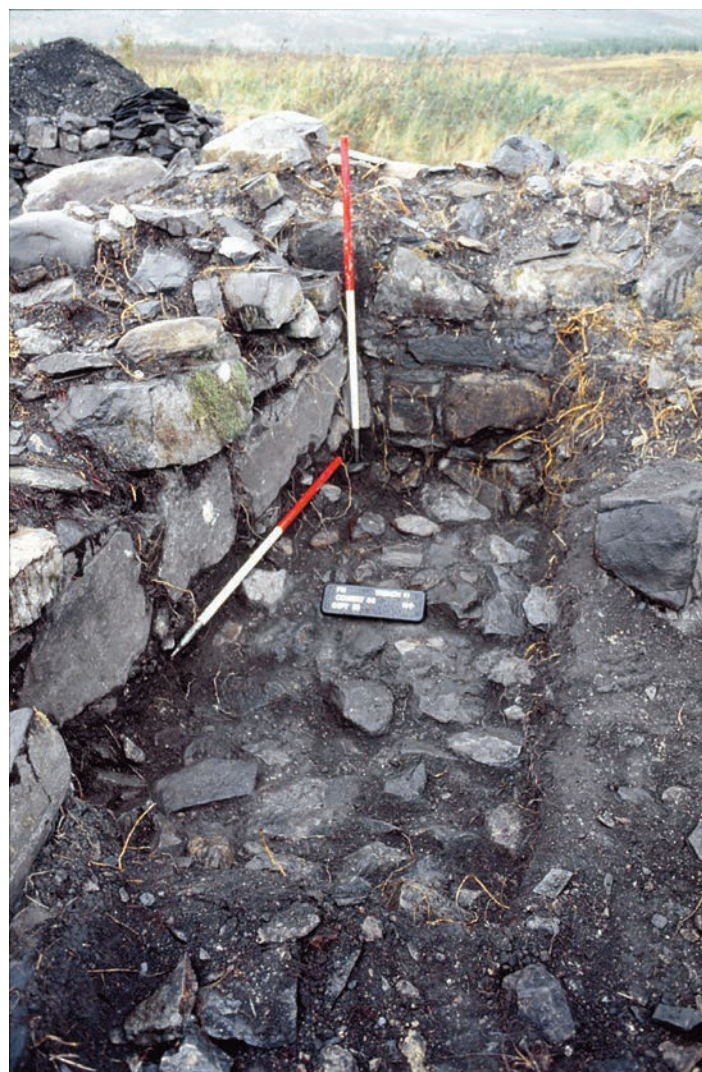
Illustration 11.26

Trench 11, the interior of house B excavated to the surface of 11032

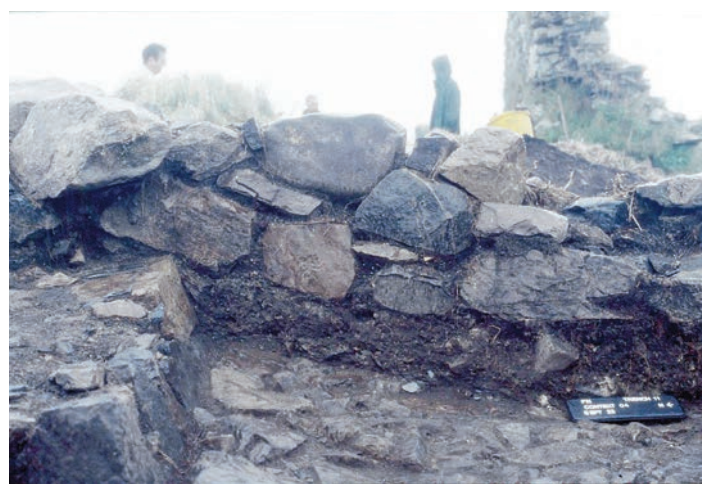
Illustration 11.27

Trench 11, the wall of house B riding over the foundation of the great hall, bottom left, and sitting on a layer of mortar debris [11015] over the surface of the medieval road

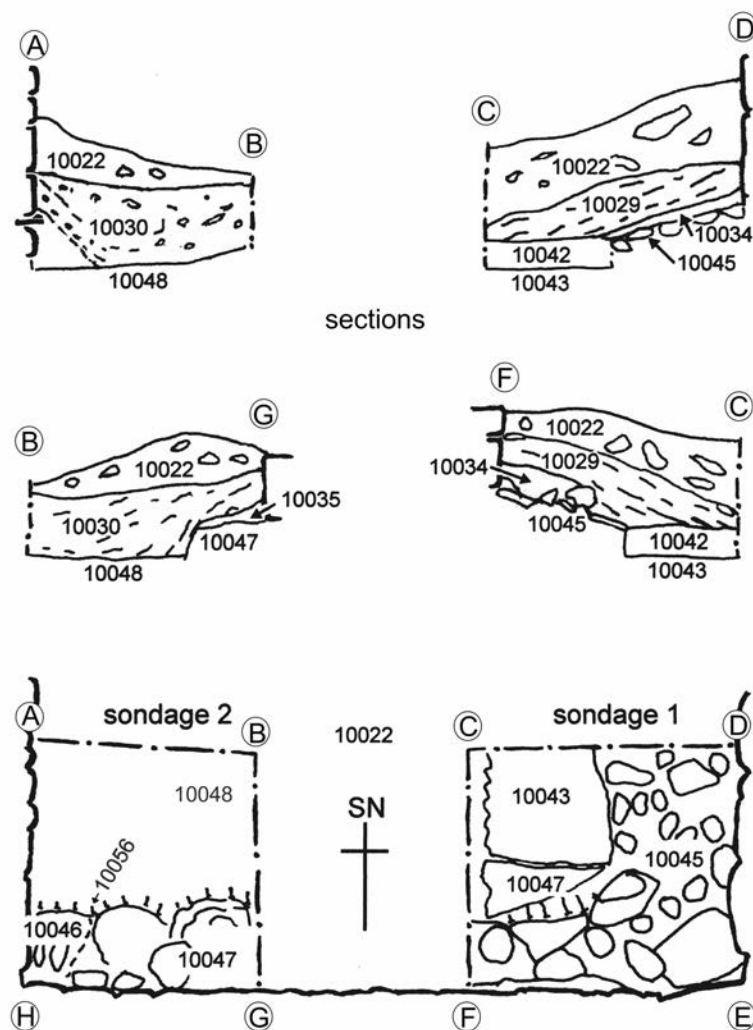
Illustration 11.28

Trench 10, plan and sections of two sondages excavated in the service area of the great hall

Two sondages, both approximately 1m square, were dug within building A in trench 10 in order to locate possible floor surfaces and evidence for the building's construction (Illus 11.28, 11.29). Sondage 1 was positioned in the south-east corner and sondage 2 in the corner formed by the south wall and the east face of the internal cross-wall. They were excavated from the mortar wash [10022] caused by weathering of the structure after it was already in ruins. This sealed tipped deposits [10029, 10030] of soil and broken roof slates relating to the collapse or dismantling of the roof. They covered a layer [10034, 10035, 10048] of slightly gravelly, mid-brown silty clay, deposited against and over a plinth of blocks of dolerite and other local stones [10045, 10047] which supported the exterior walls. This was taken to be all that was left of the make-up for an original floor, shovelled out while the building was still in use. The equivalent deposit in trench 11 was labelled 11035 and was wedged stratigraphically over 11037 and under 11034. The surface of 11035 was about 0.2m lower than the adjacent cobbled hearth. A likely explanation for the partial

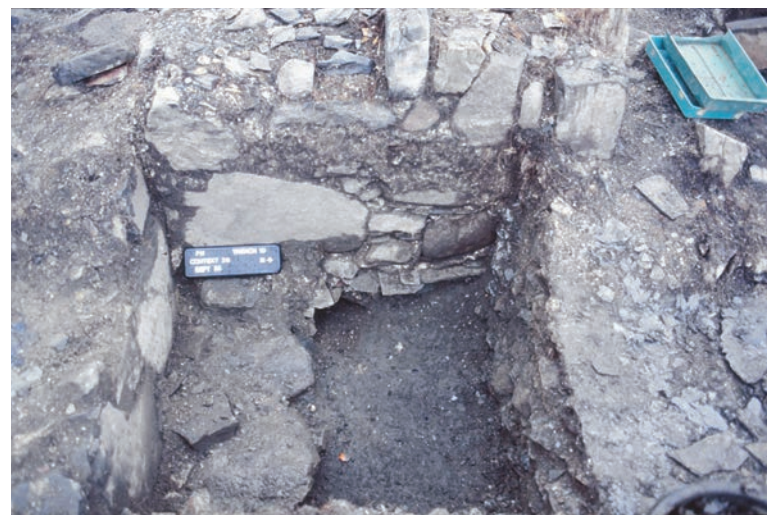
Illustration 11.29

Trench 10, the east-facing side of wall 10004 in sondage 2. The finds trays are positioned in the south doorway in 10004

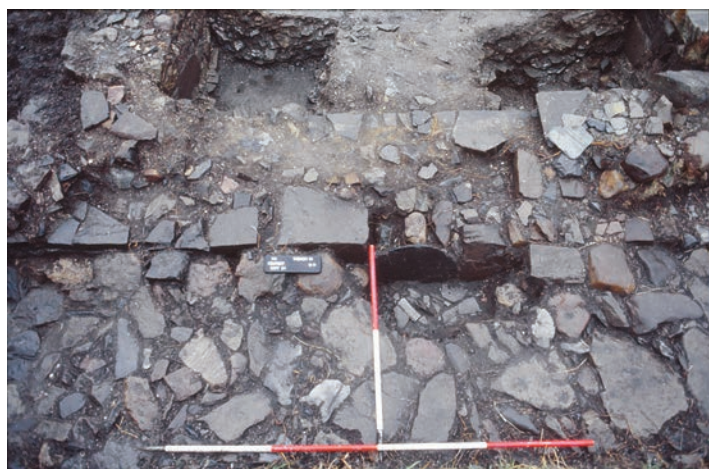
Illustration 11.30

Trench 10, the latrine chute 10049 with the patch in the road in front of it (immediately to the right of the vertical ranging rod) excavated to the surface of 10054; sondages 2 and 1 in background

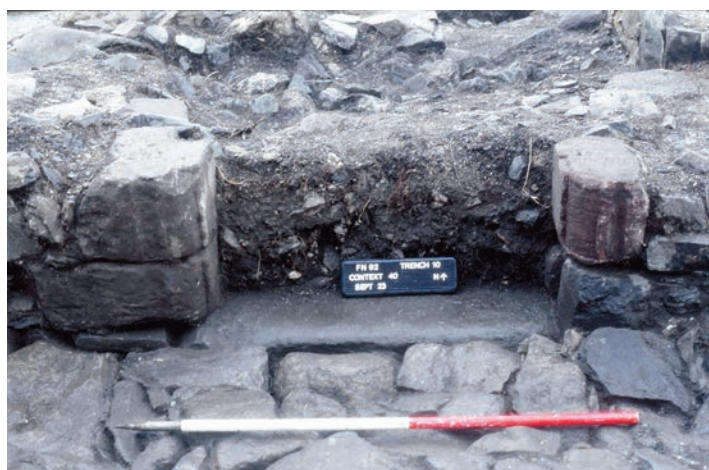
Illustration 11.31

Trench 10, entrance to the great hall, blocked with midden material [10031]

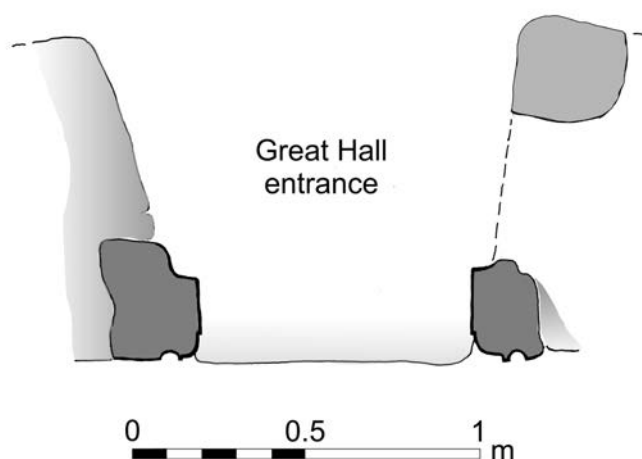
Illustration 11.32

Trench 10, plan of the great hall entrance

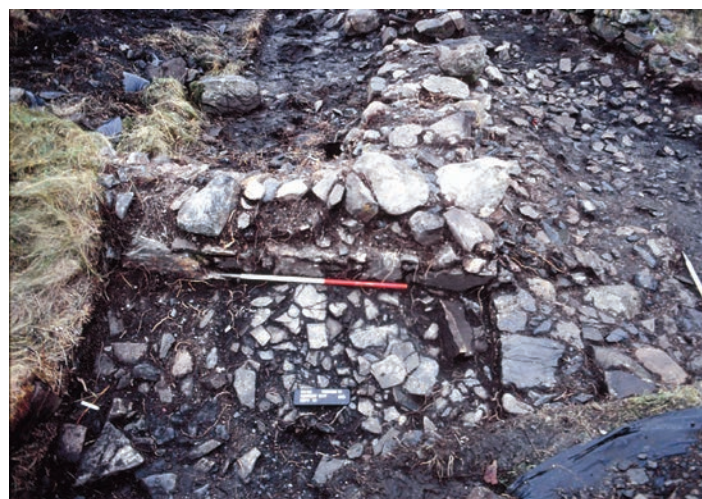
Illustration 11.33

Trench 11, looking from the interior of the great hall southwards to house B. In foreground note the dump of slates [11017], including a piece of roof ridge (SF 11017), and to the right of that the wall thickening [11008]

A small portion of the south-west corner of building A was exposed in trench 11 (Illus 11.33). The west wall had been thickened internally with a masonry skin 0.5m thick [11008] of lime-mortared quartzite and limestone blocks. In front of this was a cobbled surface [11034] 1.45m wide, and on top of its front edge, hard against the south wall, was a square patch of mortar [11026]. All of this was interpreted as evidence for the insertion of a large fireplace, probably stretching the full width of the room. The thickening of the rear wall would have been necessary to support a chimney stack. The cobbled surface acted as a hearth, while the mortar patch marked the position of one of a series of jambs supporting the front of the chimney piece, either carried on a series of arches or lintels (Illus 11.34).

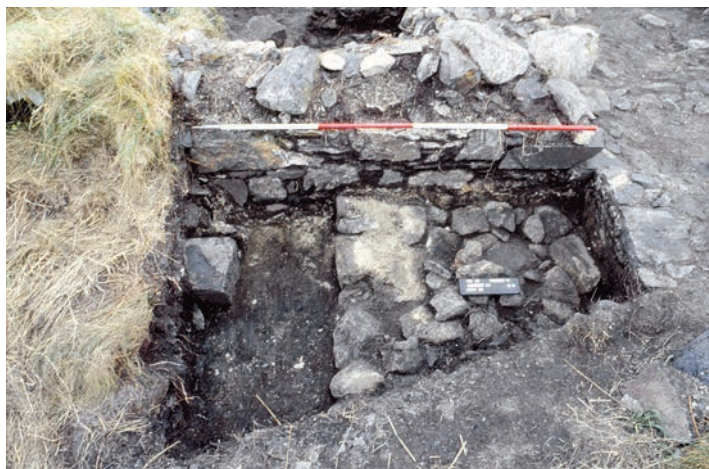
Illustration 11.34

Trench 11, the interior south-west corner of the great hall showing the cobbled surface of the fireplace and the mortar patch left by the fireplace jamb

In the south-west corner an internal plastered surface [11037] on the south wall survived in part and extended behind the cobbled hearth of the fireplace as a horizon of debris left by the plasterers. This was interpreted as a clue that the floor level of the building was originally at a lower level.

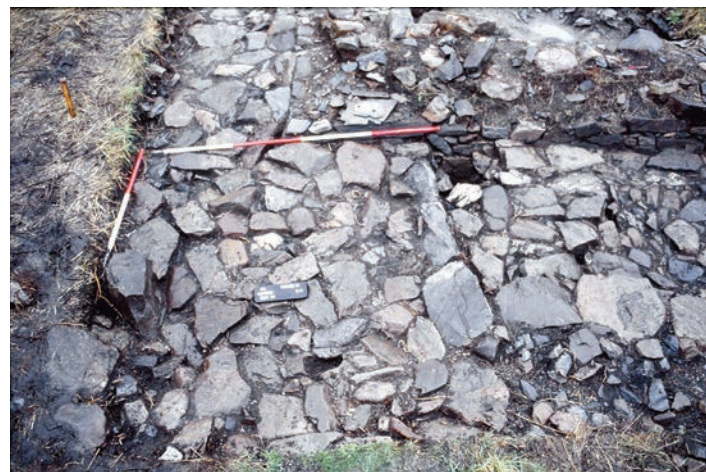
Illustration 11.35

Trench 10, the roads at the south-east corner of the great hall, looking west

An extension [10010] of the paved road from the chapel to the jetty continued along the south front of building A (Illus 11.35), here mainly of pieces of quartzite and limestone, but further west in trench 11 [11028] of quartzite and dolerite with some pieces of worn sandstone. There was a drain [10050] to take rainwater away from the south-east corner of building A. Past its entrance, heading westwards, the end of a mortar-bonded wall [10037], standing only two courses high above the road surface, was encountered jutting from the south section of the trench, apparently forming the side to a gateway across the road at this point. It consisted of blocks of dolerite with a thin course of limestone above (Illus 11.36). A post-hole [10027] in the side of the road adjacent to the exterior of the east wall of building A may mark another gateway, perhaps screening or controlling access to the kitchens.

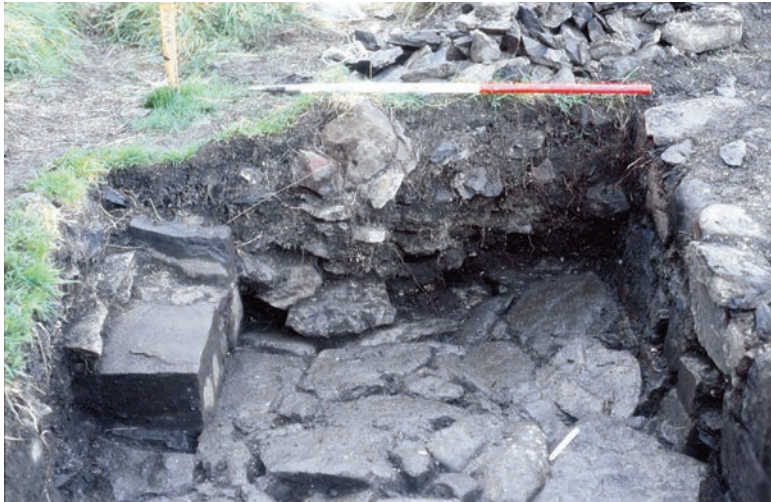
Illustration 11.36  
Trench 10, the jamb of a gate (?) [10037], looking west

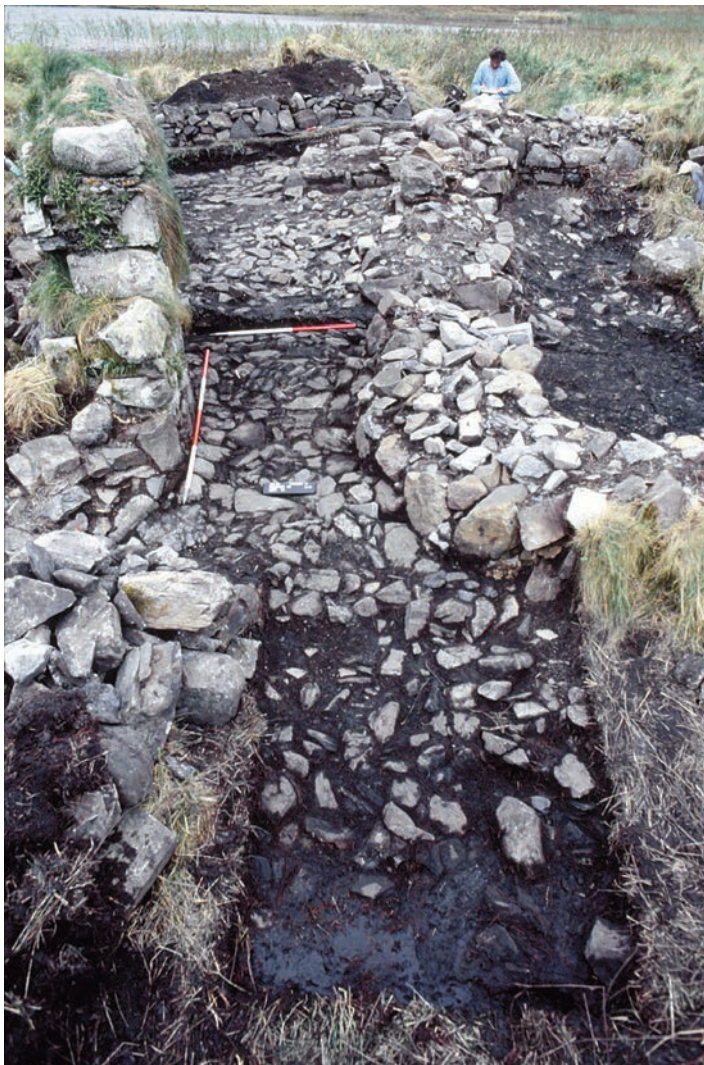
Illustration 11.37  
Trench 11, the paved road between structure N and house B, looking north

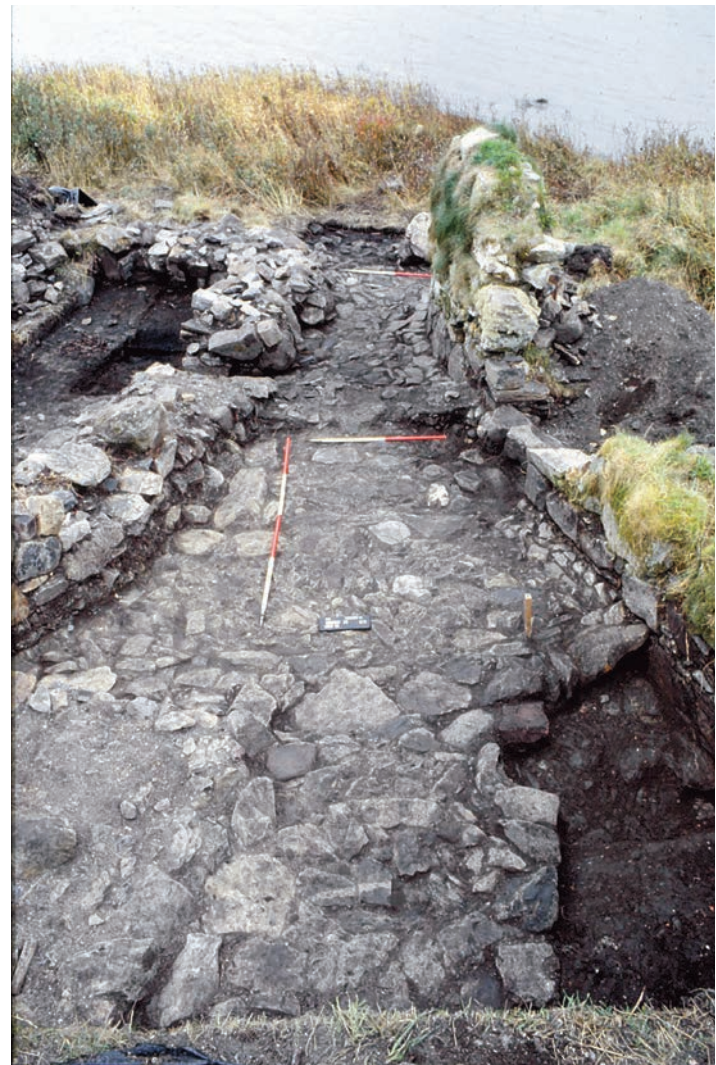
Illustration 11.38  
Trench 11, the paved road between structure N and house B, looking south

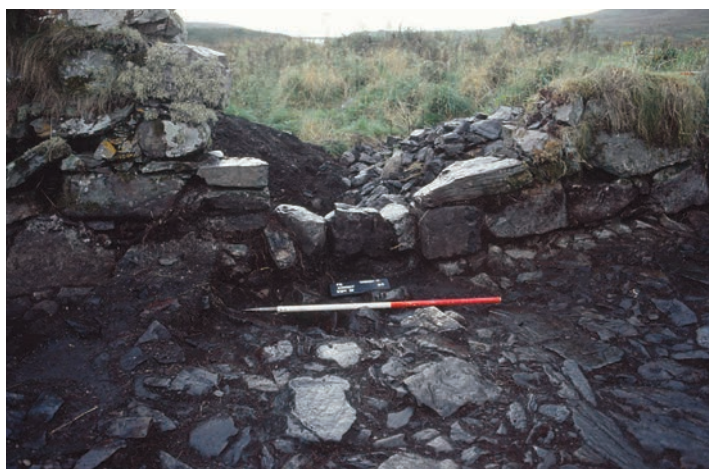
Illustration 11.39  
Trench 11, blocked doorway 11013

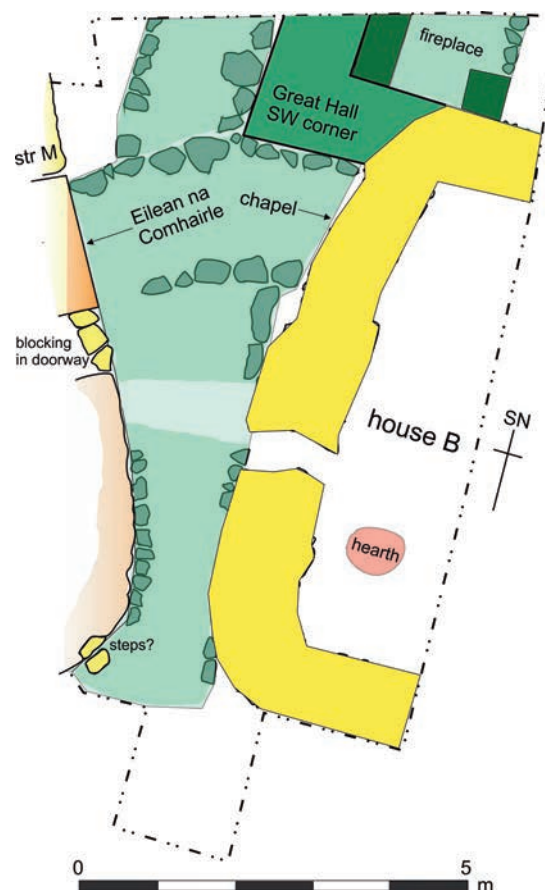
Illustration 11.40  
Trench 11, interpretative plan of main features
