# The Archaeology of Finlaggan, Islay

Caldwell, D H 2025 *The Archaeology of Finlaggan, Islay: Excavations at the centre of the Lordship of the Isles, 1989–1998*. Edinburgh: Society of Antiquaries of Scotland.  
<https://doi.org/10.9750/978190833256>

# EILEAN MÓR EXCAVATIONS IN THE GREAT HALL AND ADJACENT BUILDINGS

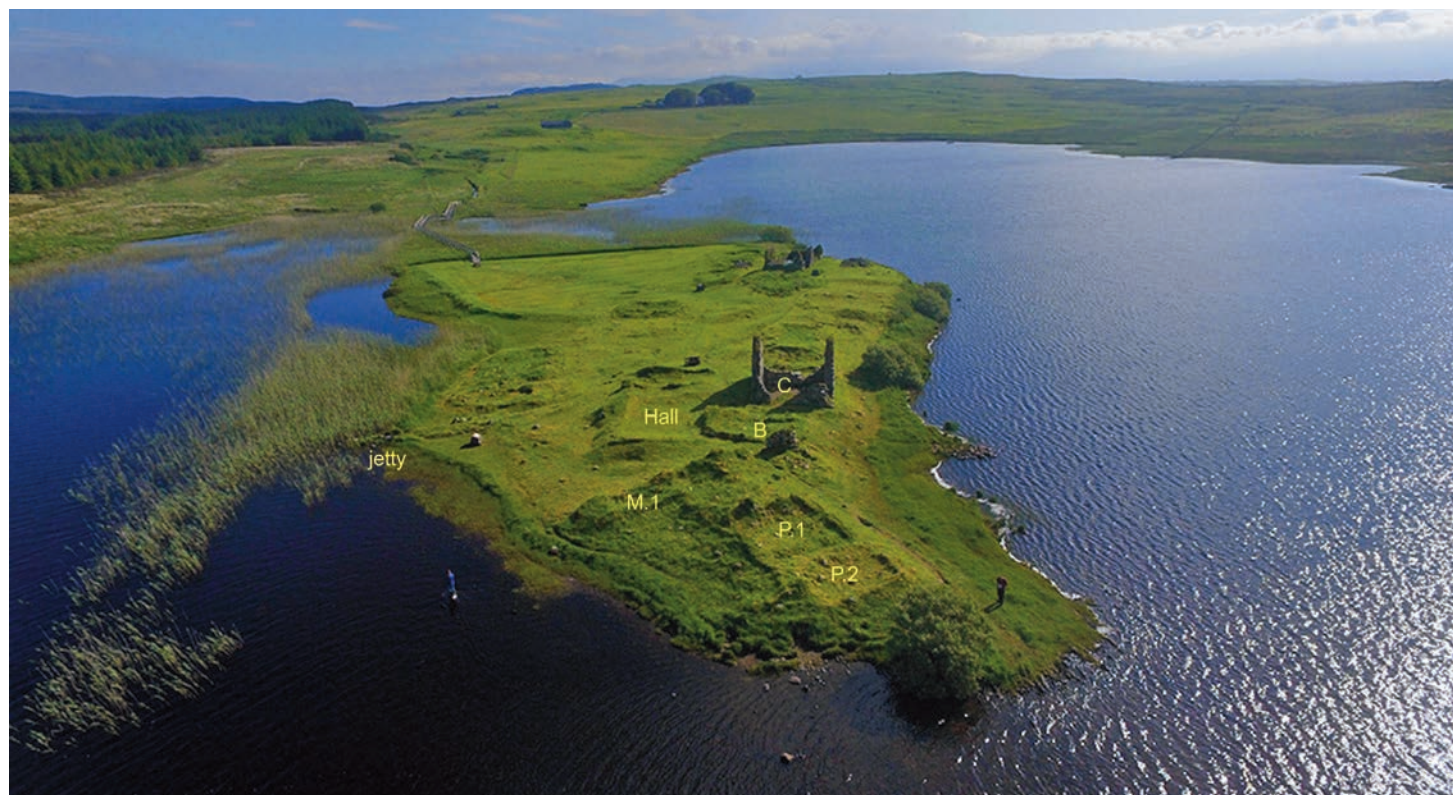
Illustration 11.41  
Photograph taken from a drone of building P and adjacent structures (Alan Miller)

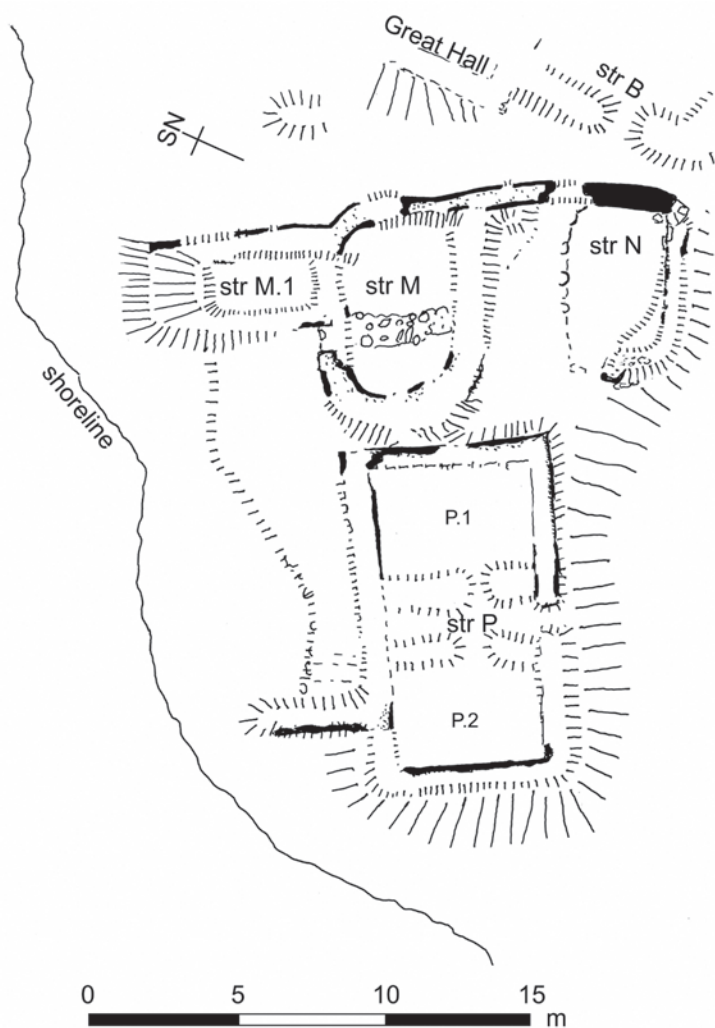
Illustration 11.42  
Plan of building P and related structures, redrawn from the original survey made by RCAHMS

Building M as described and planned by RCAHMS appeared as a rectangular structure up to 9.5m long by 5.5m wide, its north-east end wall forming part of the wall crossing the island at this point. It was noted as having markedly rounded internal corners and a wing or an annexe on its north-west side. This wing, which was not included in any of our excavations, has been labelled by us as structure M.1. The original RCAHMS on-site survey drawing suggested that M.1 was erected over the side wall of structure M and was, therefore, of more recent date (Illus 11.42). On the basis of our own observations we were happy to agree with that provisional conclusion.

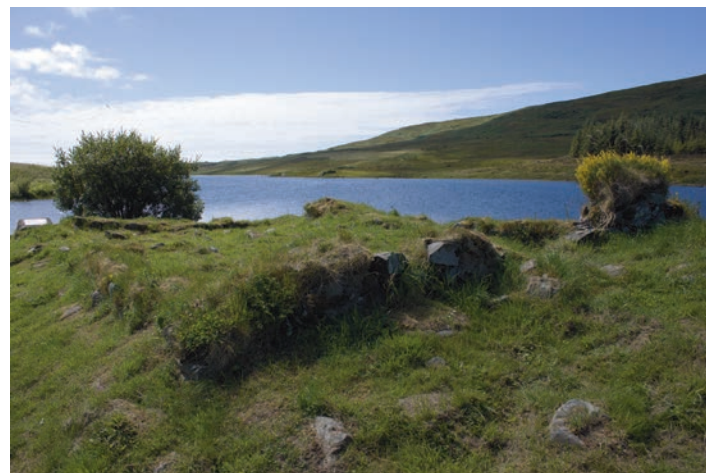
Illustration 11.43  
Building P from south-east

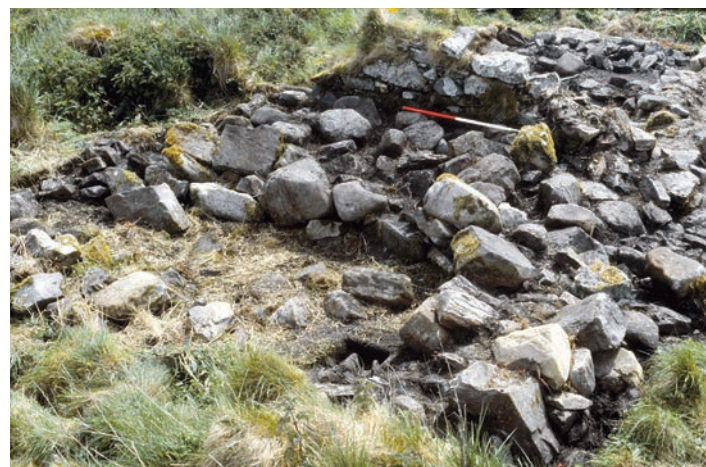
Illustration 11.44  
Trench 5, looking south, after the removal of the turf. Structure M is in the foreground; the ranging rod is in front of the south-west wall of building P

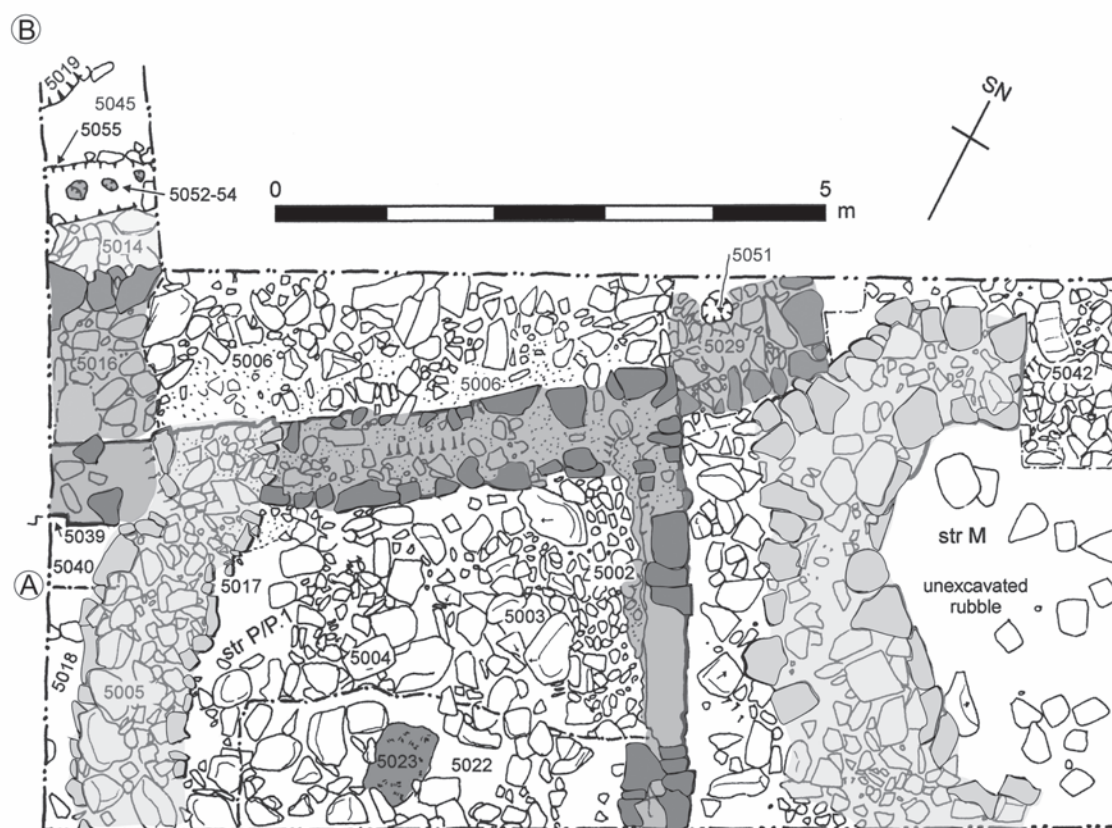
Illustration 11.45  
Trench 5, plan

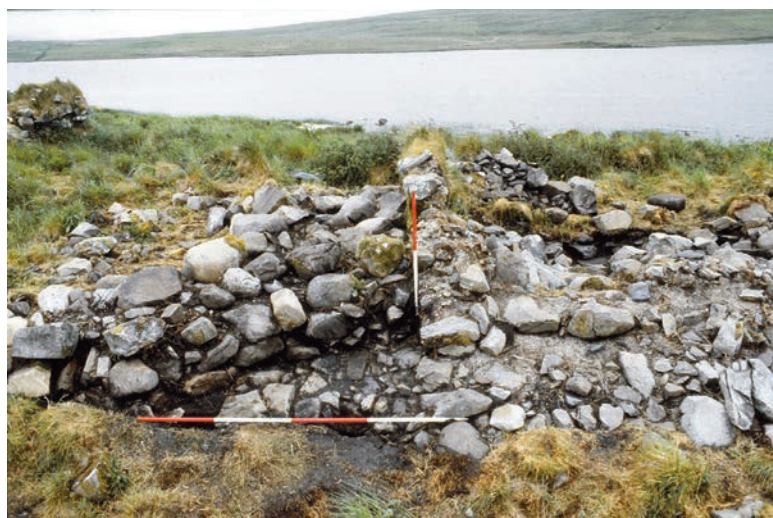
Illustration 11.46

Trench 5, the wall of structure M overlying the surface of cobbled path 5029. The surface of the tumble [5006] is exposed in front of the wall of building P

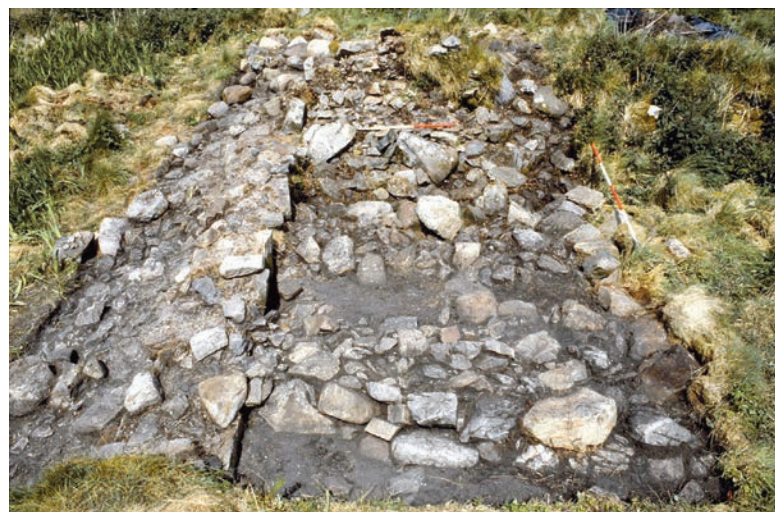
Illustration 11.47

Trench 5, the interior of building P with the south-west wall of structure P.1 in the foreground

Only the north quarter of the building was included in trench 5. The interior of P was choked with debris forming a complex series of dumps (Illus 11.47). The most recent was 5002 against the north-east wall, which had almost entirely lost its face. The dump was dated by fragments of bottle glass and a pen knife to the 19th or 20th century, and appeared to be a backfilled hole dug through earlier tumble [5004]. The latter seemed to be derived not so much from the collapse of P but from a secondary structure (P.1) inserted in its ruins, possibly contemporary with building M. It utilised the ruins of P's walls for three of its sides, and was enclosed on its south-west by a drystone wall [5005], slightly bowed, interpreted by the Commission as part of the original structure of P. Its stones included quartzite and limestone with rare blocks of Port Askaig tillite. In a small sondage adjacent to 5005 it could be seen to be founded on a deposit of clay impregnated with peat ash [5040], the floor of building P (Illus 11.45, 11.48). Inspection of the other cross-wall in P to the south-west of the trench showed it also was of drystone construction and presumably formed one side of another secondary building (P.2) within the south-west half of P. Each was apparently accessed by doorways opposite each other in their adjacent walls.

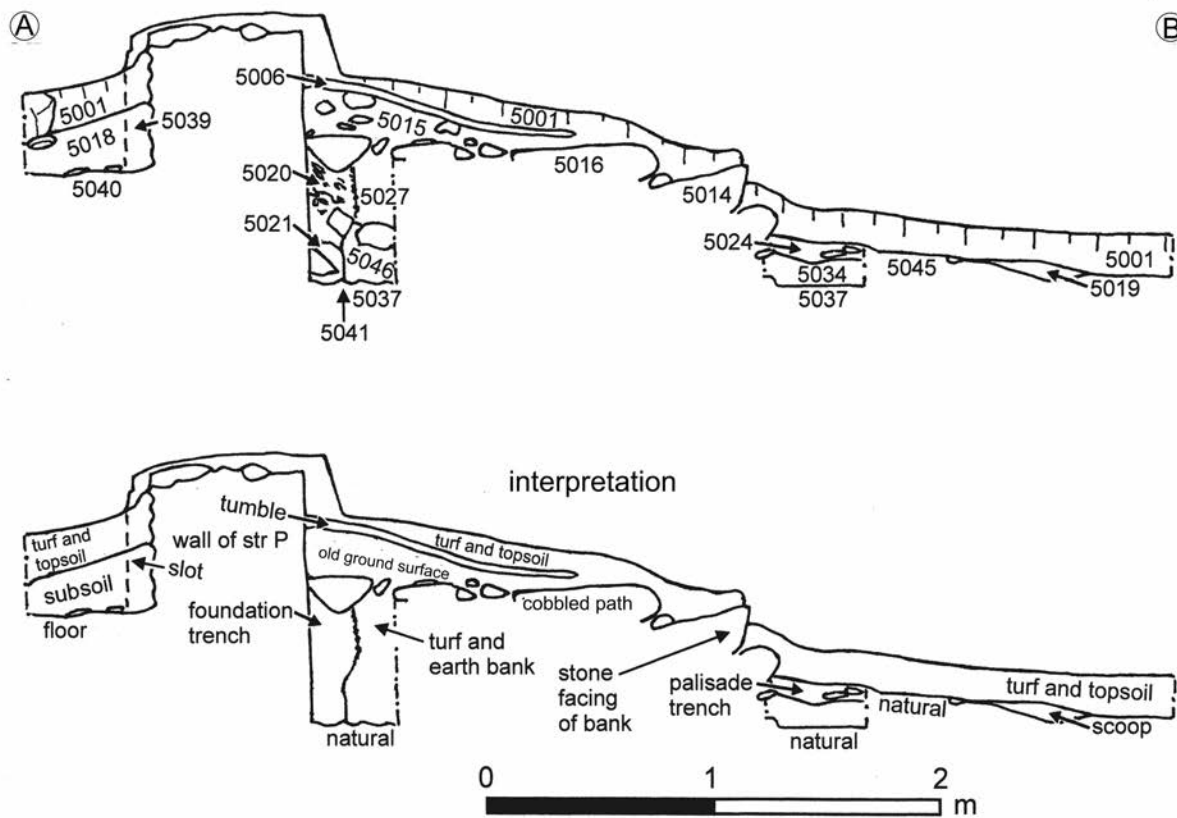
Illustration 11.48

Trench 5, section A-B, north-east facing across the wall of building P, the cobbled path and palisade bank

The north-west wall of P was cut into the back of a bank of an earlier timberwork fortification. The building P foundation trench [5041] was backfilled with builders' debris [5020/5021] and included a sherd (SF 5030) of reduced gritty pottery.

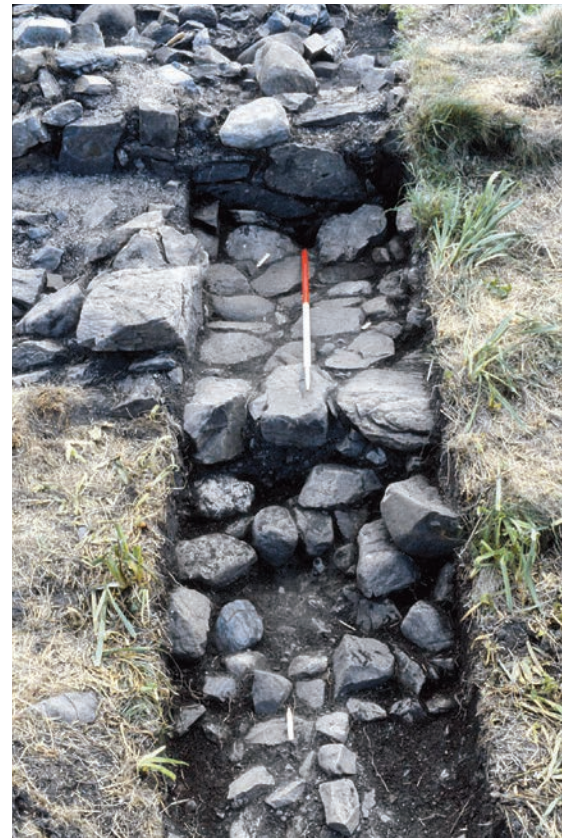
Illustration 11.49

Trench 5, the cobbled path [5016] overlying the stone facing [5014] of the palisade bank

Along the exterior of the north-west wall of P was a cobbled stone path [5029, 5016], 1.5m wide with a well-defined kerb (Illus 11.49). It extended north-eastwards beyond and round the north corner of P. In that it overlay the foundation trench for P's north-west wall it was obviously constructed after it, but it had every appearance of having been designed to be an integral part of P. A post-hole [5051], 330mm in diameter, cut into terrace 5029, was positioned at the north corner of building P, perhaps to inhibit, in some way, access to the narrow space between buildings P and M. Sherds of organic-tempered handmade pot were recovered from a horizon of dark soil [5015] lying over the path and representing its abandonment as a roadway.

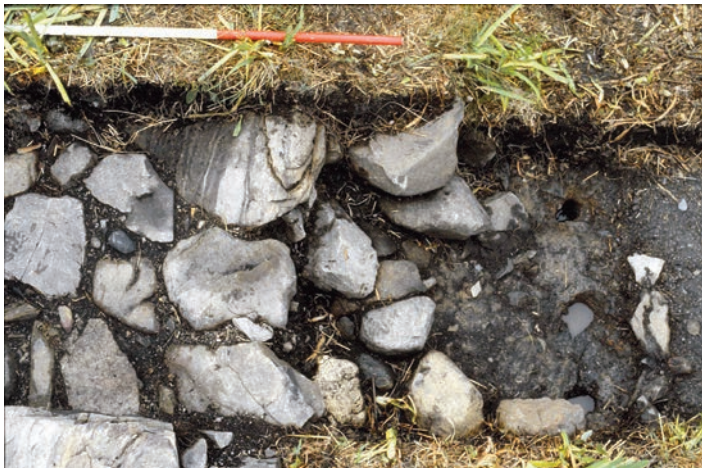
Illustration 11.50  
Trench 5, the palisade trench with truncated post-holes

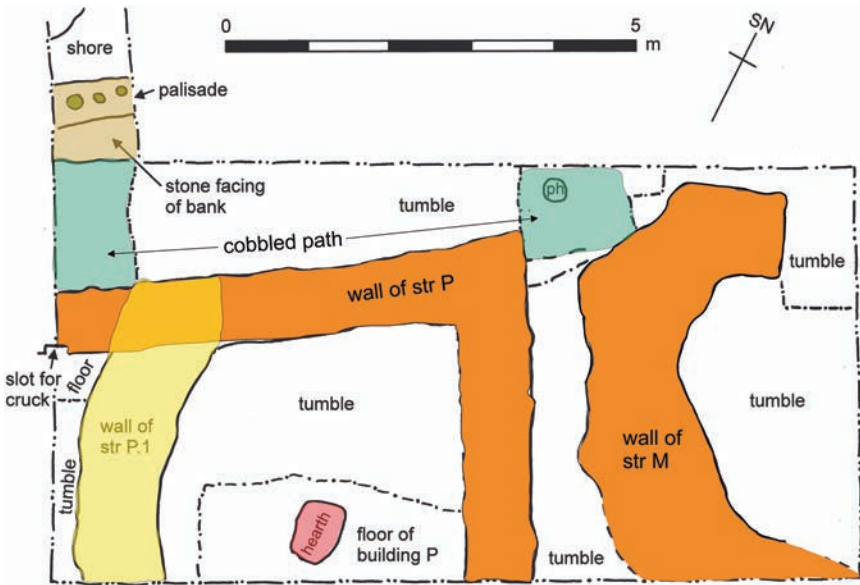
Illustration 11.51  
Trench 5, interpretative plan of main features
